Home Inspection Report

38201 JONES ROAD (house)

Mission, BC V0M1H0

Inspected on Tue, Apr 23 2024 at 12:00

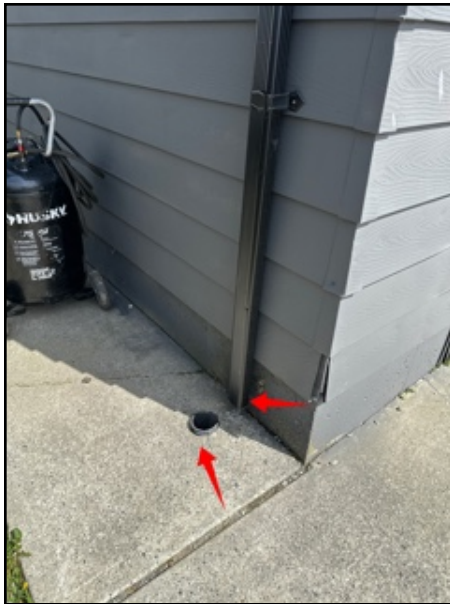
Figure 1-1

Downspouts have been disconnected from its drainage leaders. I cannot confirm if this is due to a failed perimeter drainage or intentional.

Inquire with current owner regarding working conditions to the perimeter drainage of this home. Scoping is recommended by a drainage technician to determine any defects or failure and needed repairs. This is important to prevent a wet basement or hydrostatic pressure against the foundation wall.

Scoping and hydroflushing is also needed as part of regular maintenance. At a minimum, this should be performed once every decade. Maintenance required.

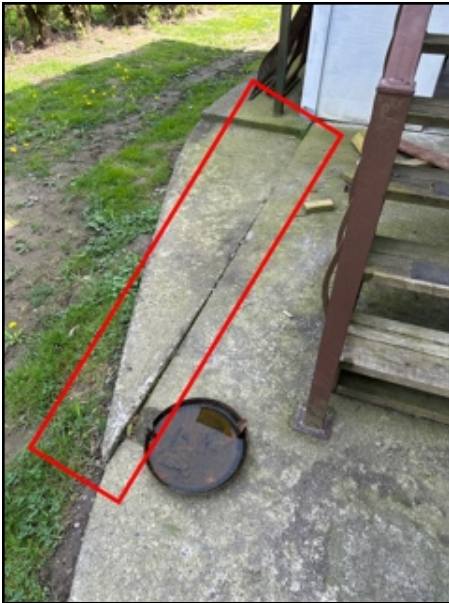
Figure 2-1

Heaving and settlement are noted on concrete walkway at the rear. Monitor for further shifting and repair as needed.

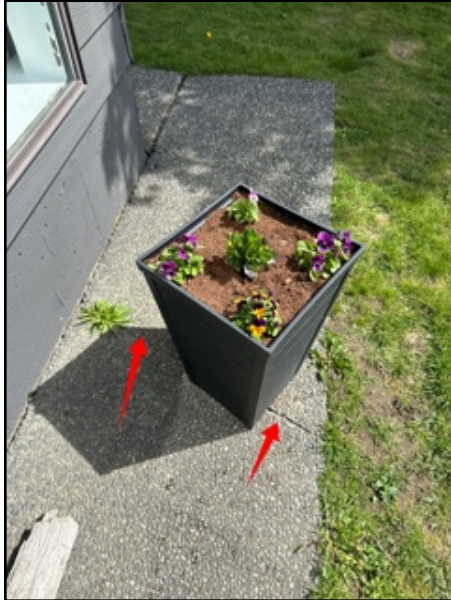
Figure 3-1

Cracking on driveway/sidewalk is typical with settlement and age. Patching/repairs is recommended to prevent water entry, freezing and further shifting or settling.

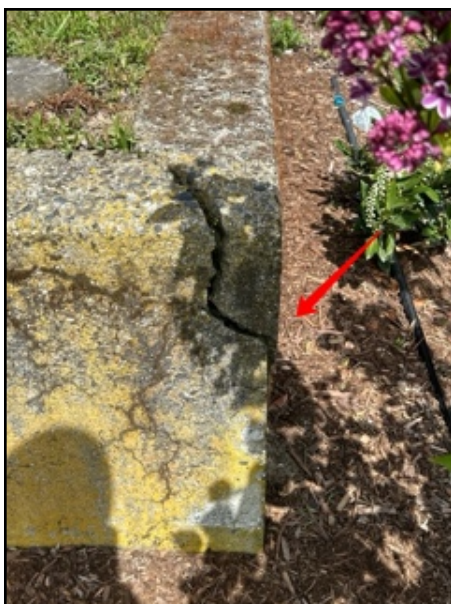
Figure 4-1

The concrete retaining wall on the east side has cracking observed and minor leaning. Anticipate repairs.

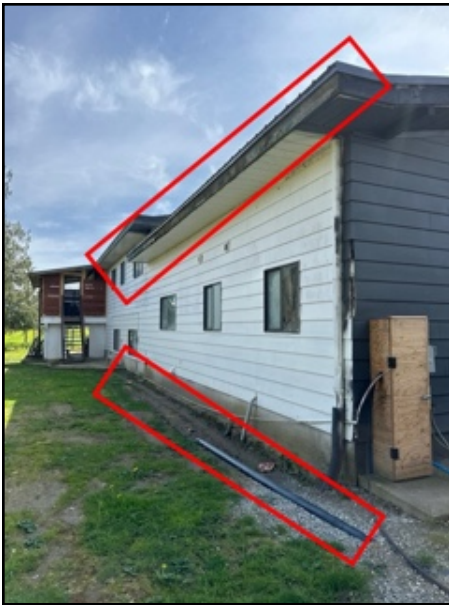
Figure 5-1

There are sections of the roof line that are missing gutters. This has resulted in soil damage at the rear. Have repaired by a gutter technician.

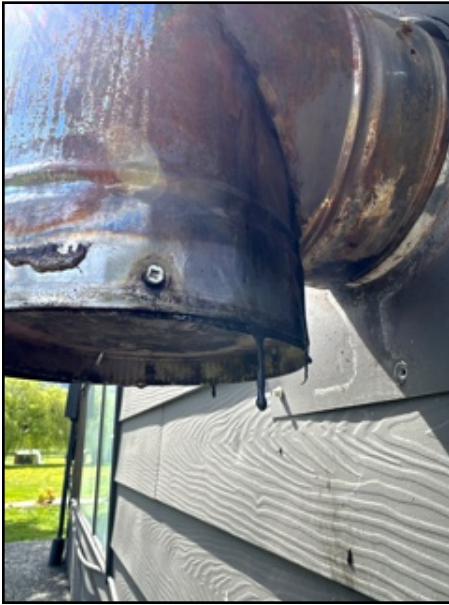
Figure 6-1

There is soot build up noted seeping out from the bottom of the metal chimney for the wood fired stove in the basement. This is a potential fire hazard that needs maintenance by a chimney sweep.

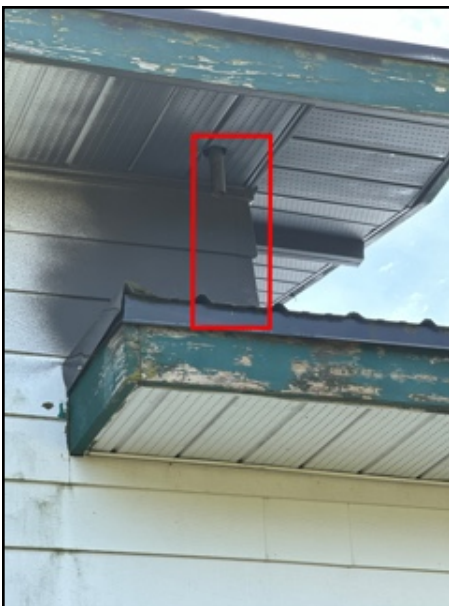
Figure 7-1

Downspouts discharging on lower roof surfaces will shorten the life of the roof product in this area. Recommend extending the downspout to lower gutters or directly to ground level.

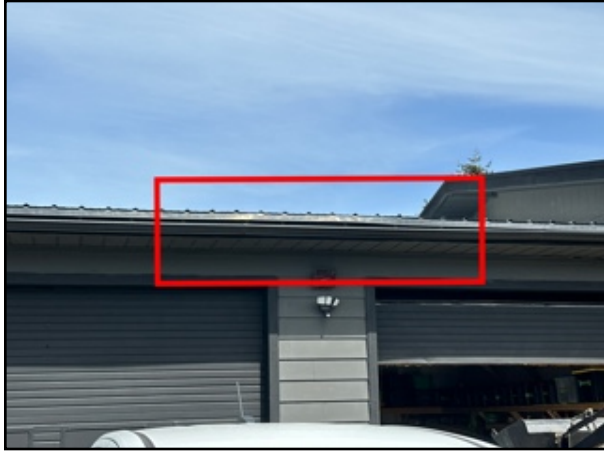
Figure 8-1

Roofing material and gutter has a bulge at one section of the garage roof line. Further evaluation is needed by a roofing contractor to assess if repairs are needed.

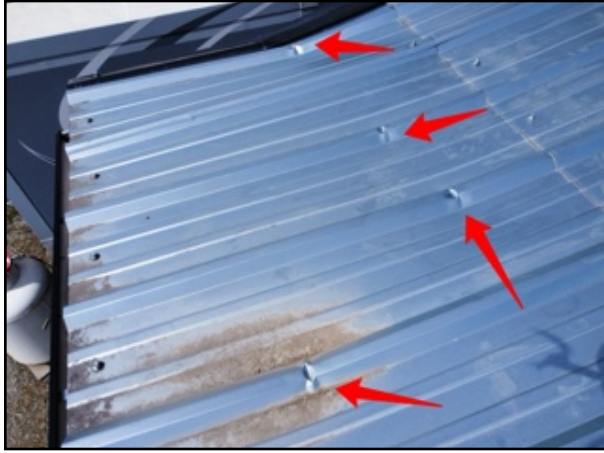
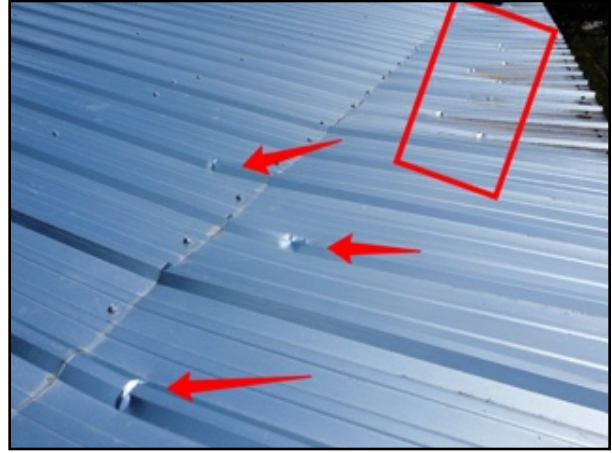
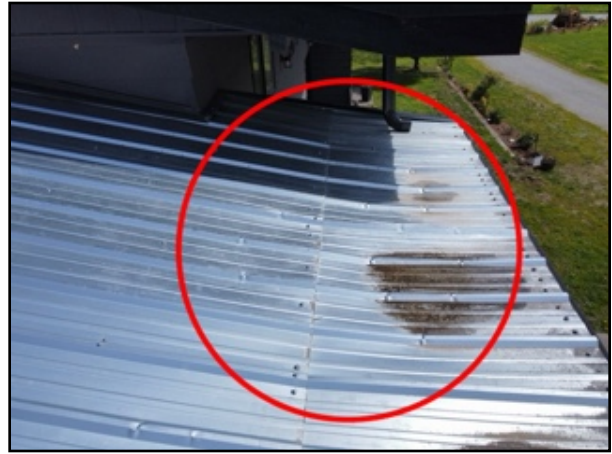
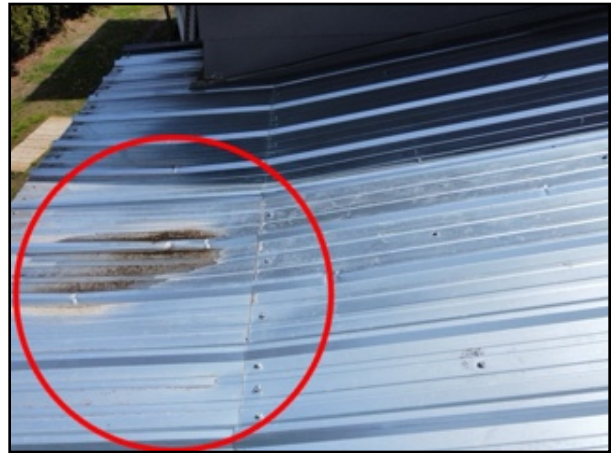
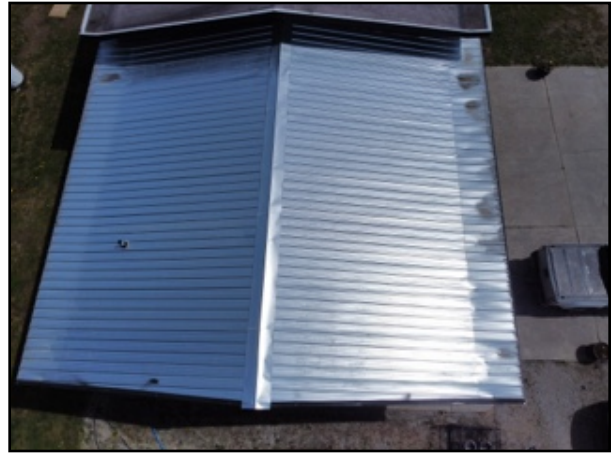
Extensive creases and denting are observed on the garage addition metal roof. These areas are vulnerable to cracking. Creases and damage on the material are vulnerable to cracking from expansion and contraction. The vent stack flashing is also missing a cap.

I recommend further evaluation by a roofing contractor to determine the extent of mechanical damage to the roofing material. Anticipate repairs or replacements in order to prevent any potential roof leaks or premature failure.

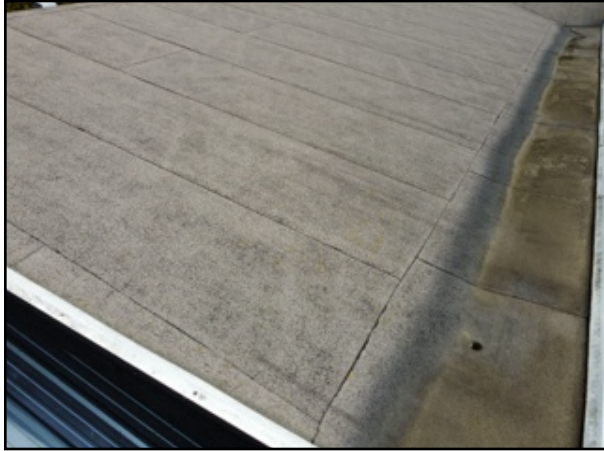
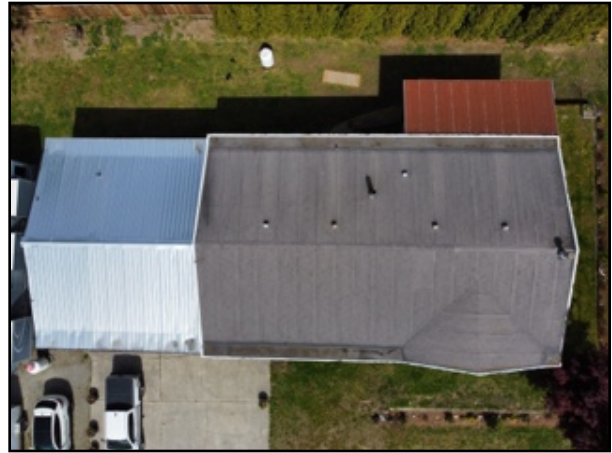
Modified bitumen roofing for the main house is at or nearing the end of its service life. There is extensive alligating throughout the surface of the material typical with its age. The abandoned chimney in the mechanical room is also missing a rain cap and is vulnerable to water ingress.

Further evaluation is needed by a roofing contractor for isolated repairs and maintenance. Have assessed for remaining life service left and budget for replacements.

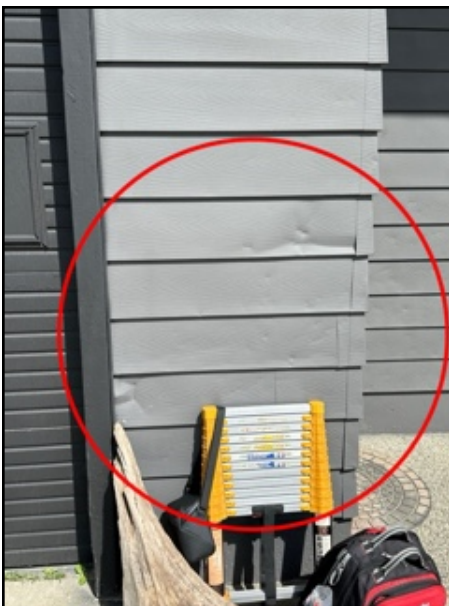
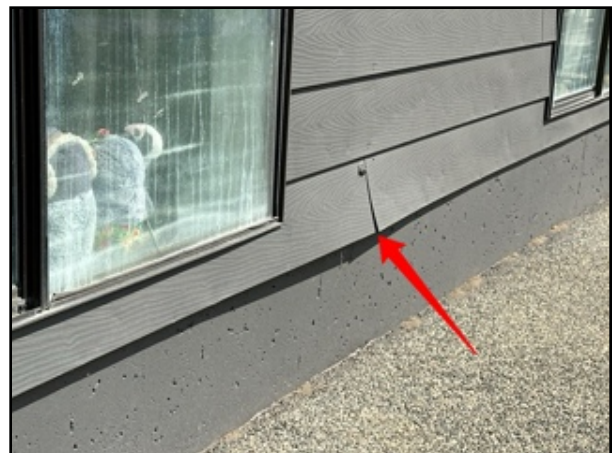
Aluminum siding material and corner caps are damaged/missing at several locations. Repairs are needed to prevent water ingress and hidden water damage. Have repaired by a siding contractor.

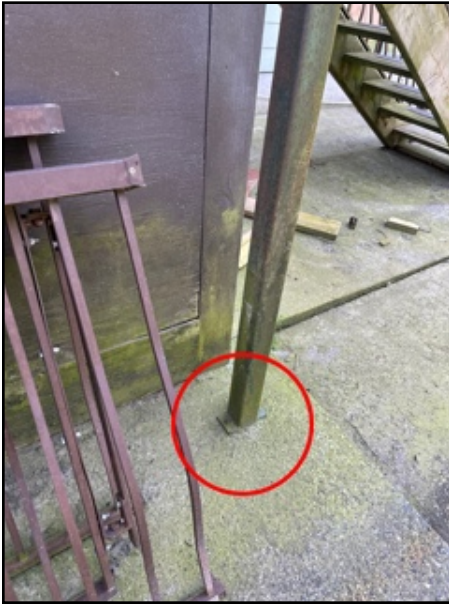
Figure 17-1

Comment 17:
Deck posts are missing poured in place footings that extend to the frost line.

Improper footings are prone to settling/heaving during the winter time. I recommend further assessment by a general contractor for risk assessment and needed improvements for structural stability.

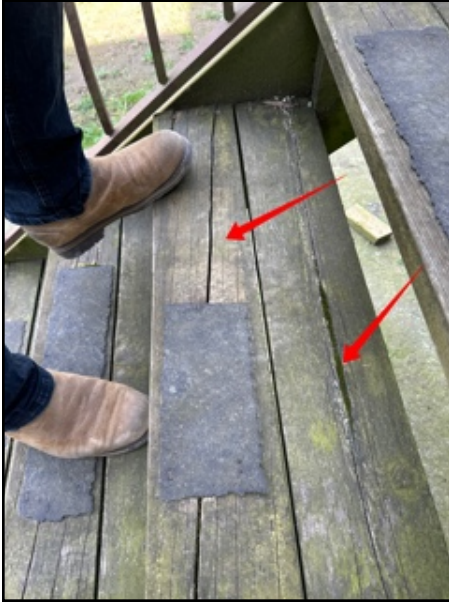
Figure 18-1

The deck stair treads have splitting noted and are deflecting. Consider repairs and isolated replacements to prevent a fall hazard.

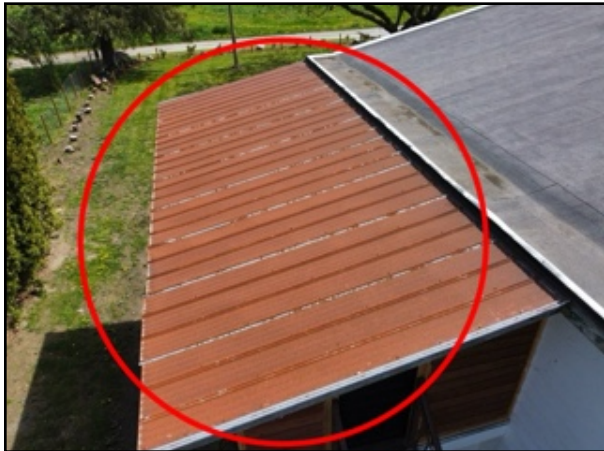
Figure 20-1

Heavy rust damage noted on the deck roof is vulnerable to roof leaks. Further assessment is needed by a roofing contractor for repairs or replacements.

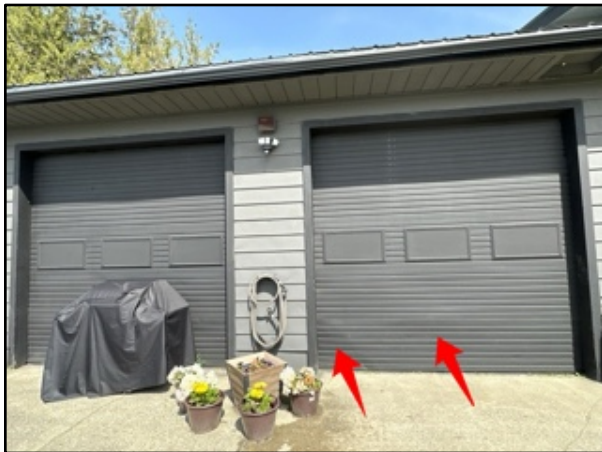
Figure 21-1

Denting noted on door panels. Loose rollers are also noted which need repairs.

West door is not able to open due to broken rollers. Anticipate repairs.

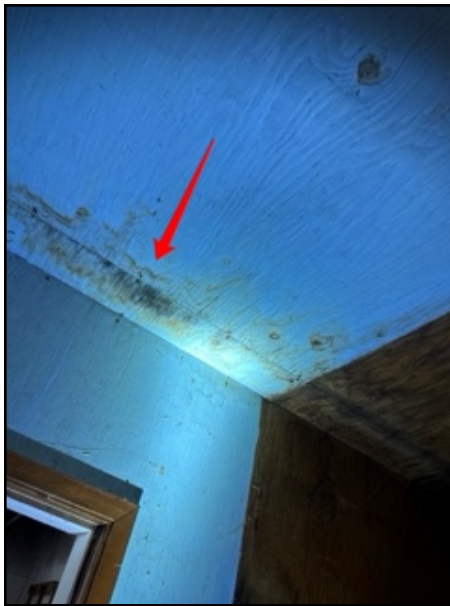
Figure 22-1

There is water staining observed on the addition garage sheathing at several locations. I cannot confirm if this is still an active leak. Further evaluation is needed by a roofing contractor to ensure that this is not due to an active leak.

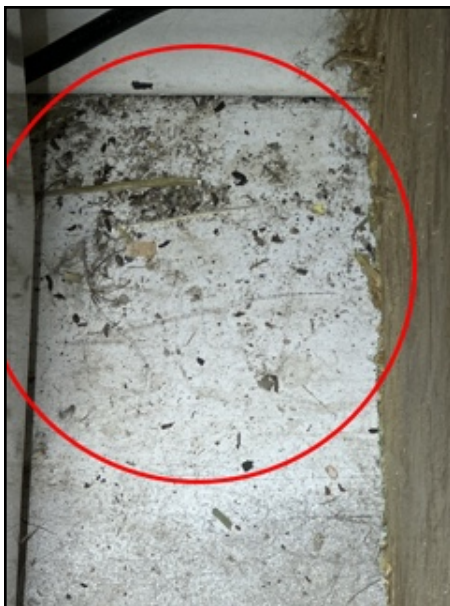
Figure 23-1

There are rodent droppings observed in the garage. Set traps as a precautionary measure and seal all gaps and penetrations from the exterior. Alternatively, consult a pest exterminator for remediation.

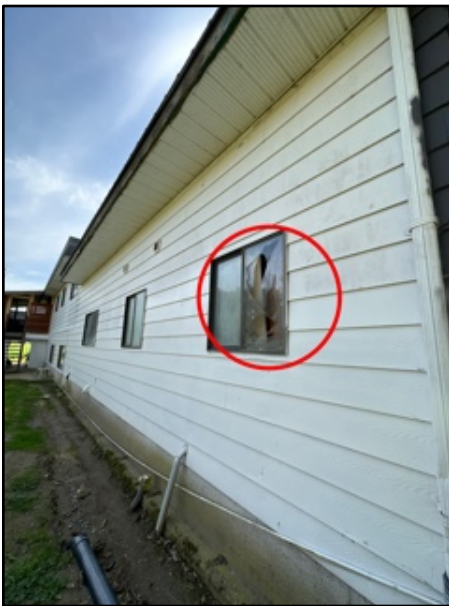
Figure 24-1

The windows around the home have failed seals, cracking, and mechanical damage observed. The front door is also damaged.

Materials for replacements were observed in the barn. Anticipate repairs and replacements.

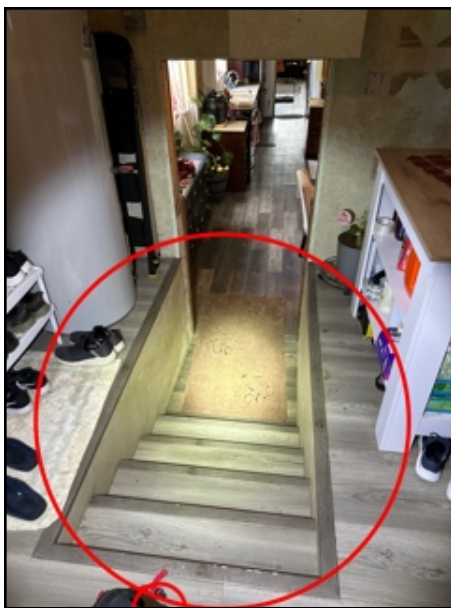
Figure 27-1

Basement stairs is missing hand rails and guard rails. This is a fall hazard that needs improvement to prevent an accident.

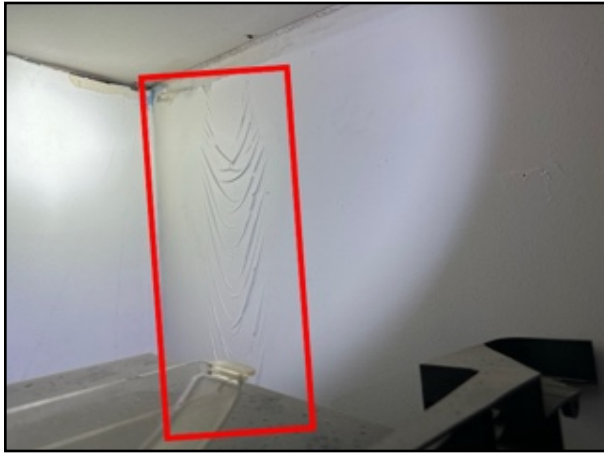
Figure 28-1

No moisture levels recorded on water damaged drywall in the basement kitchen. It is recommended to contact current owner on further information on possible repairs made.

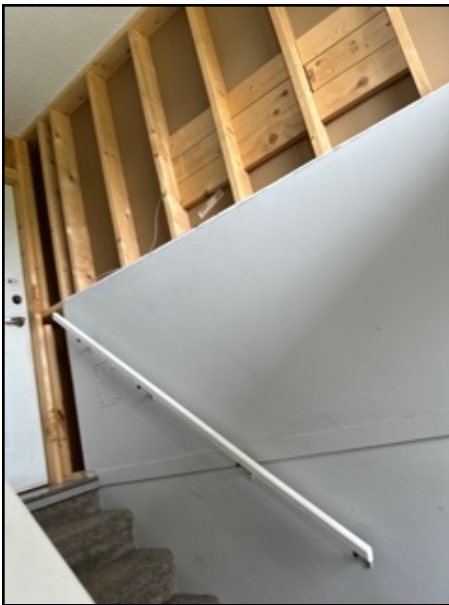
Figure 31-1

Areas of unfinished construction are observed at several locations in the basement and main floor. Anticipate repairs.

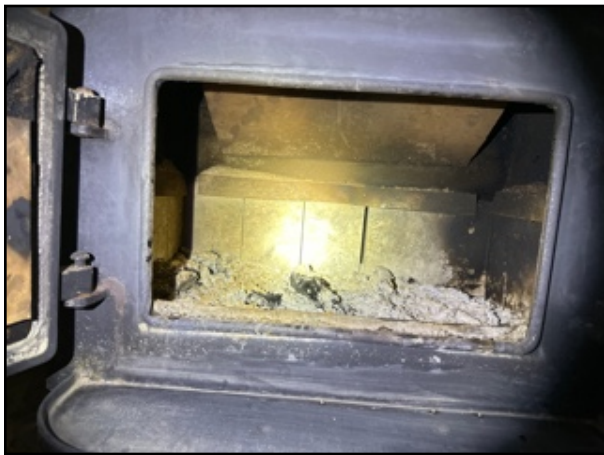
Figure 32-1

Damaged tiles for the stove hearth will need to be repaired. The door is also missing a seal.

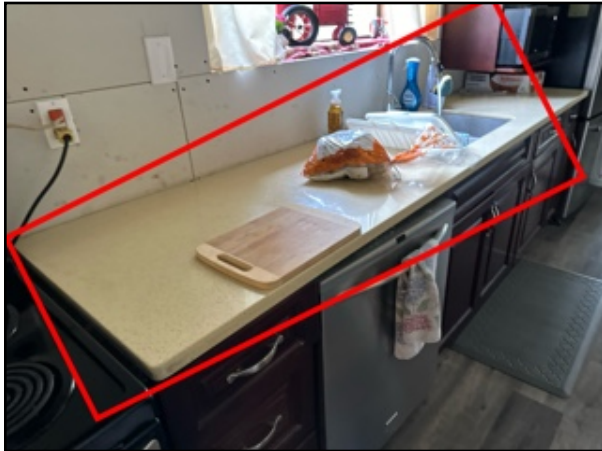
Figure 33-1

Comment 33:
Basement kitchen countertops need repairs.

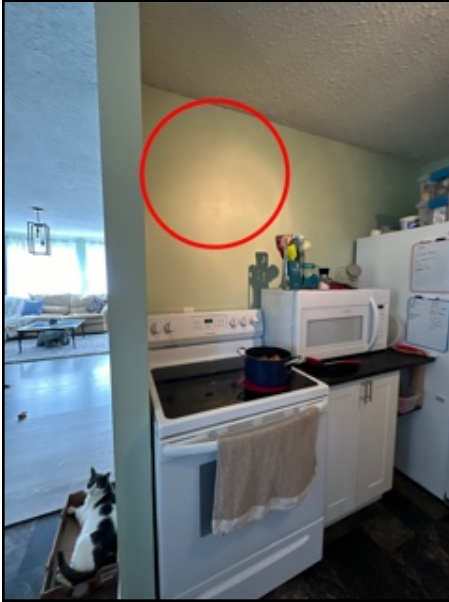
Figure 37-1

Missing hood fan for the main kitchen needs repairs. This is also missing for the basement kitchen.

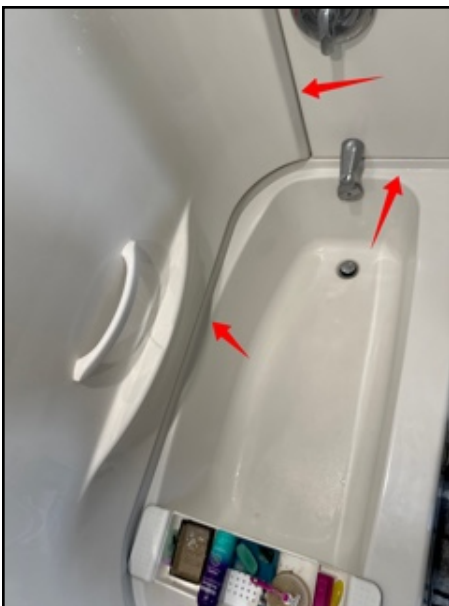
Figure 41-1

Caulking missing on the tub seams. Have installed to prevent water seepage.

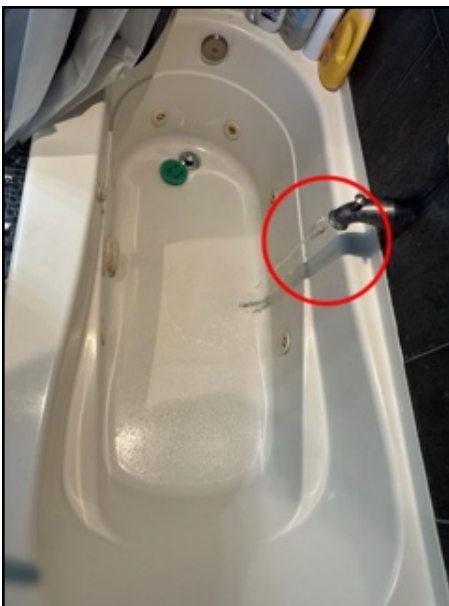
Figure 43-1

Jacuzzi tub in the second floor hallway bathroom was not able to be tested due to a low water pressure for the tub filler and time constraints. Verify working conditions with current owner as needed.

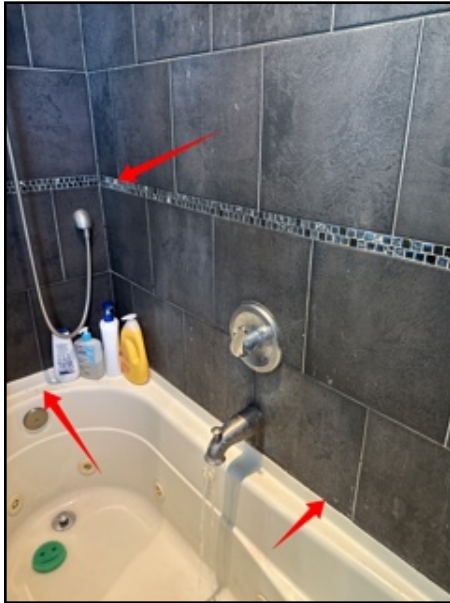
Figure 44-1

Caulking renewal is due around tub surround and tile corners. This is needed for a watertight seal. Have repaired. This is part of ongoing regular maintenance to prevent moisture seepage.

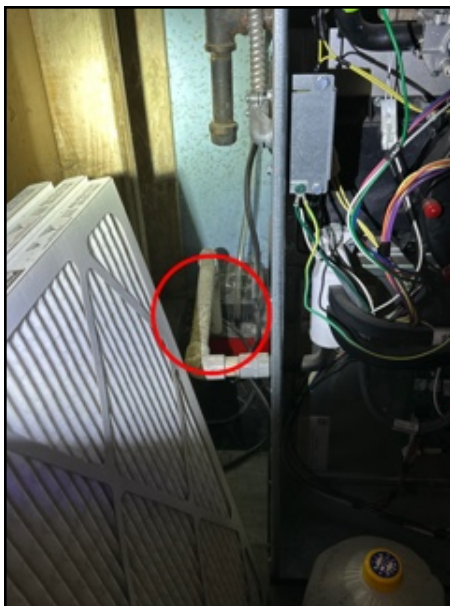
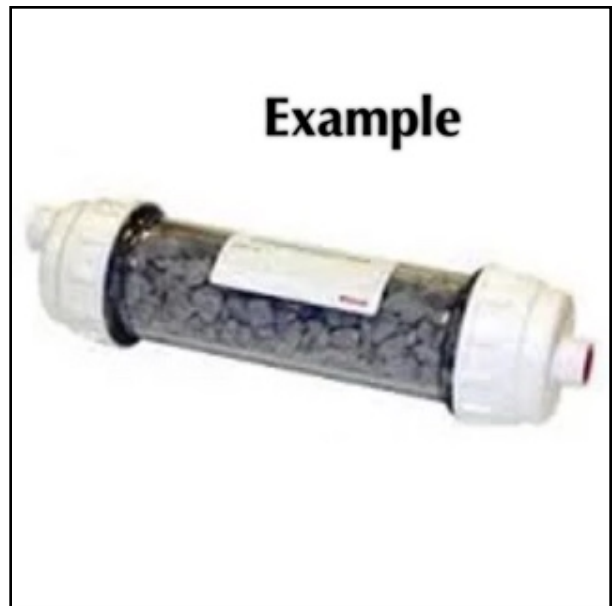
Neutralizing trap is not visible for the condensate drain line. This is needed to prevent discharging acidic condensate in the plumbing drains that may result in premature deterioration to the materials. Consult an HVAC technician for repairs.

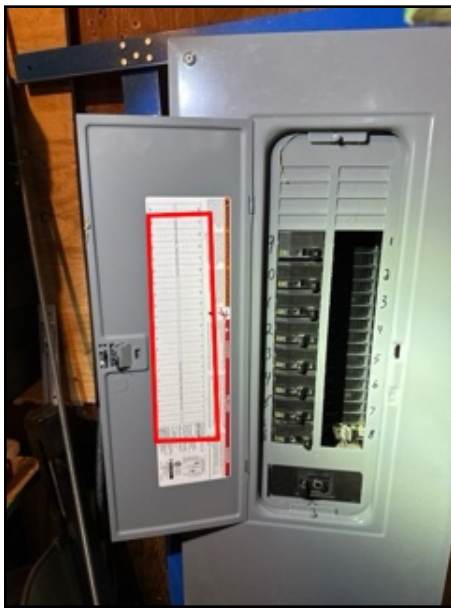
Figure 51-1

Knockout cover is missing in the main electrical panel. This is needed to prevent someone from sticking their fingers or a tool inside the panel and being electrocuted. Have knockout cover installed.

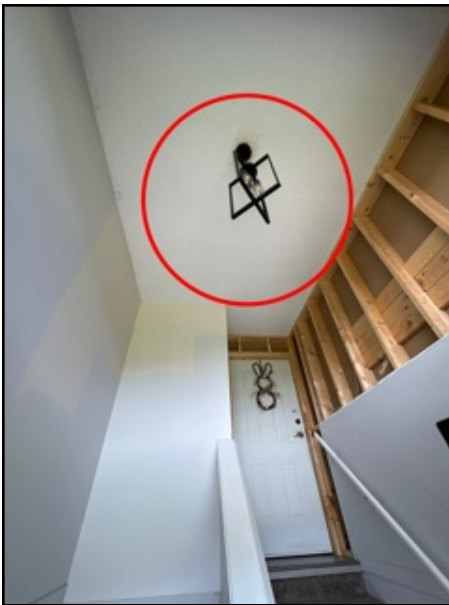
Figure 52-1

Possible lightbulb burnt out/missing or incorrect three way switch installation. Have further assessed by an electrician for troubleshooting and repairs.

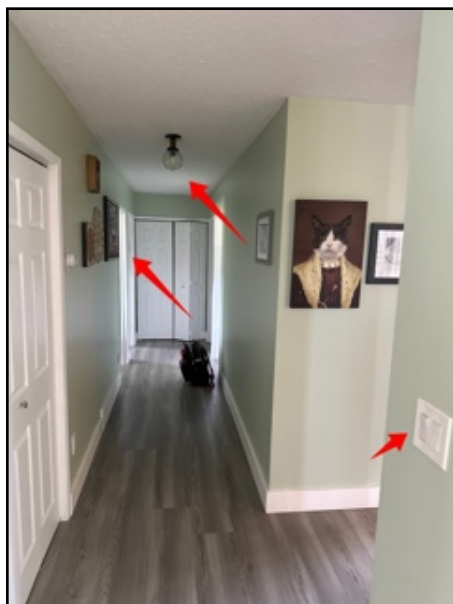
Figure 53-1

Incorrect three way switch installation is noted in the second floor hallway. This is potentially due to incorrect wiring installation. This light fixture should be able to turn on at either location. Have further assessed by an electrician for repairs.

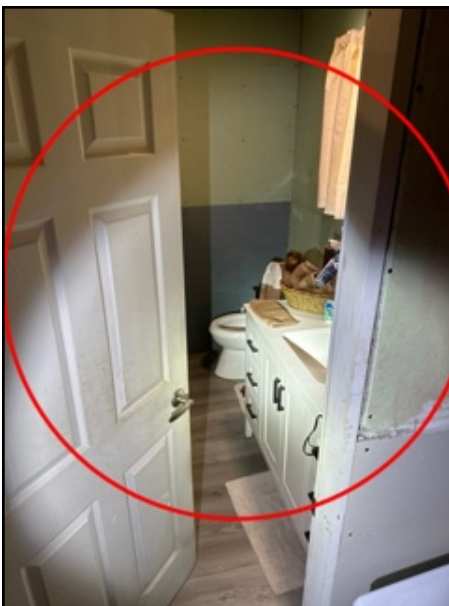
Figure 59-1

Foul smell observed in the basement. I cannot confirm if this is due to an issue with the septic or sewer drainage. Further evaluation is needed by a plumber for troubleshooting and potential repairs.

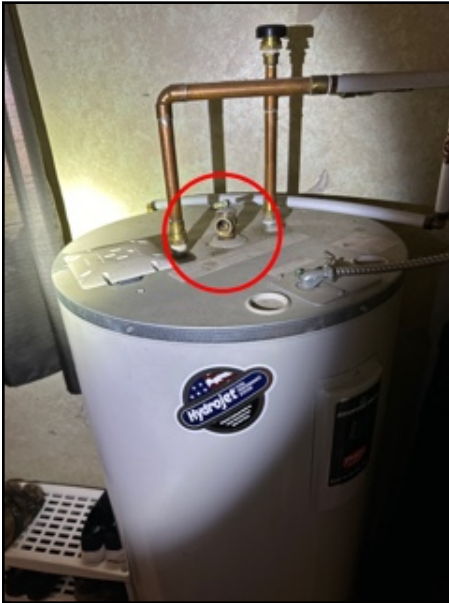
Figure 63-1

Temperature pressure relief valve downspout is missing on this hot water heater. This downspout will prevent high temperature water from discharging horizontally in this area. It is recommended that they be installed on hot water heaters.

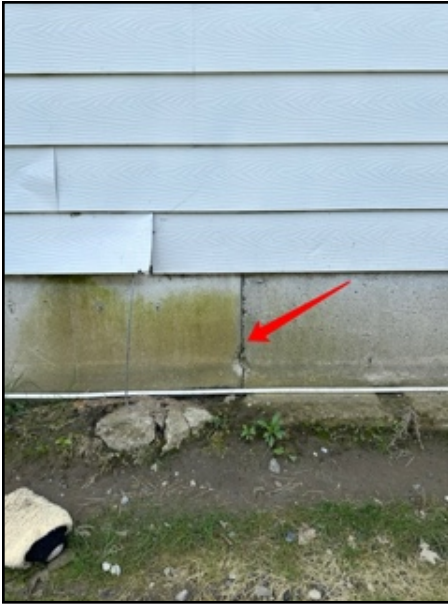
Figure 64-1

Comment 64:
Cold pour between the main house and garage addition should be sealed and patched to prevent water entry and damage. Improvements recommended.

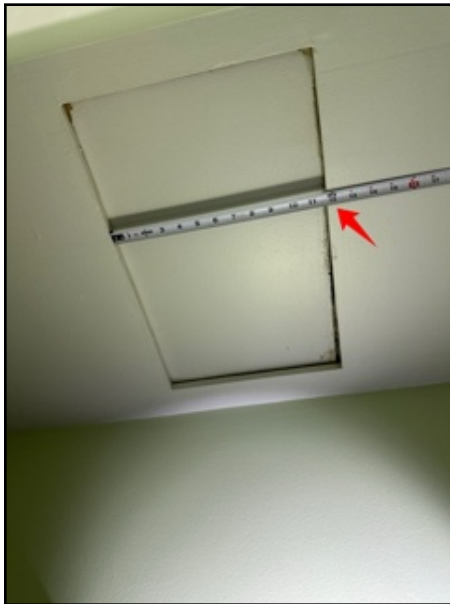
Figure 66-1

I recommend improving the opening and removing shelving that is blocking the hatch for easier access. This is needed in order to inspect the condition of the attic space. This was a limitation to the inspection.
