Home Inspection Report

38201 JONES ROAD (mobile home)

Mission, BC V0M1H0

Inspected on Tue, Apr 23 2024 at 08:45

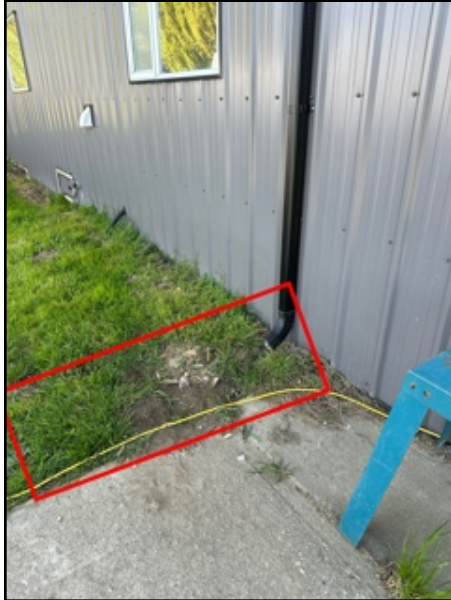
Figure 1-1

I recommend adding downspout extensions to the downspouts that are located around the house to discharge water away from the home.

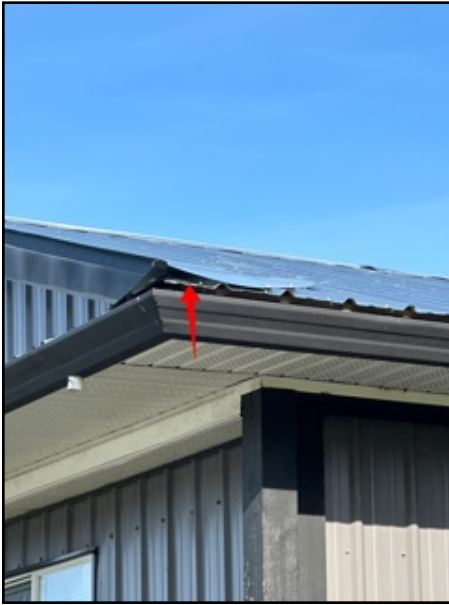
Figure 2-1

Poor installation is noted for this metal roof. Incorrect ridge cap detail is observed on the corners. Poor installation of fasteners are evident from the canted fasteners and warped gaskets. There are holes, mechanical damage, and denting observed at several locations. Poor flashing detail is also noted on the valleys. This roof does not appear to be installed by a professional roofing contractor and has a high risk of failure and leaking.

There are no visible plumbing vents observed on the roof. Plumbing vents may have been covered with the new roof from existing.

I recommend further evaluation by an accredited roofing contractor for a thorough assessment of the current installation and condition of this roof. Anticipate major repairs or replacements.

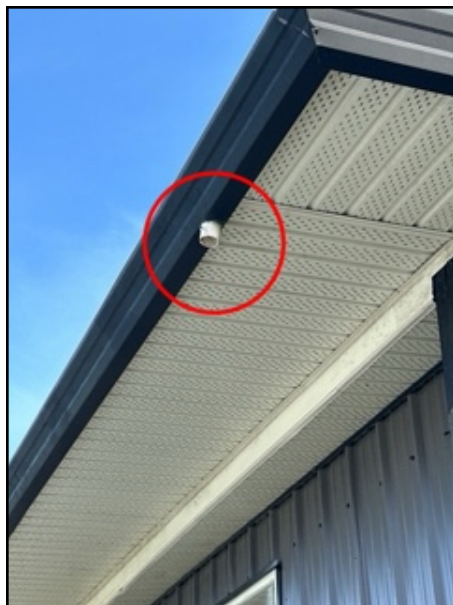
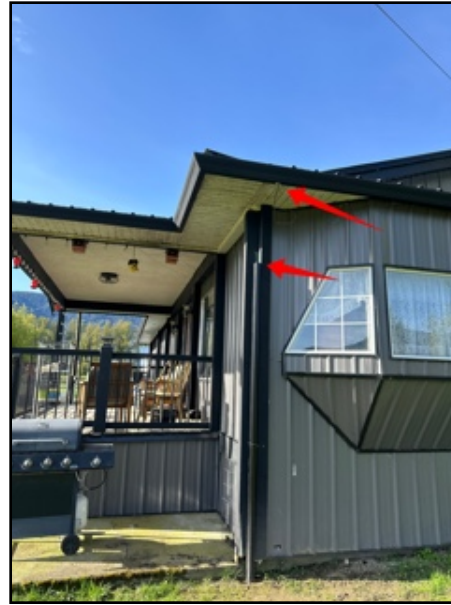
Downspouts need to be connected to the gutters for proper drainage. Anticipate repairs by a gutter technician.

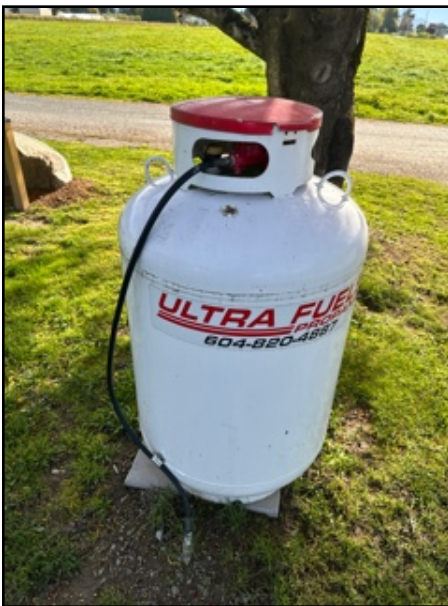
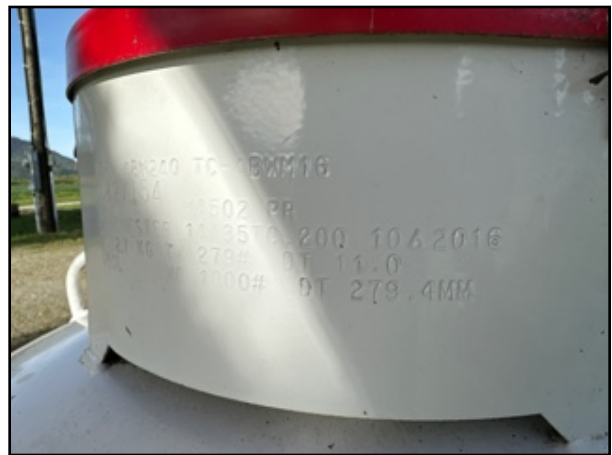
Propane tank reservoirs need to be recertified following their manufacturing date every 5-10 yrs.

For added safety, consider securing this tanks to the ground for seismic stability. I recommend replacing rubber hose connection near the regulator at the exterior with a protected line to minimize the risk of mechanical damage and gas leaks.

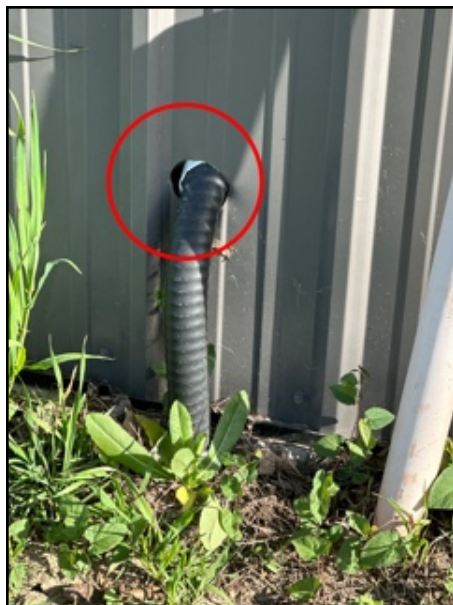
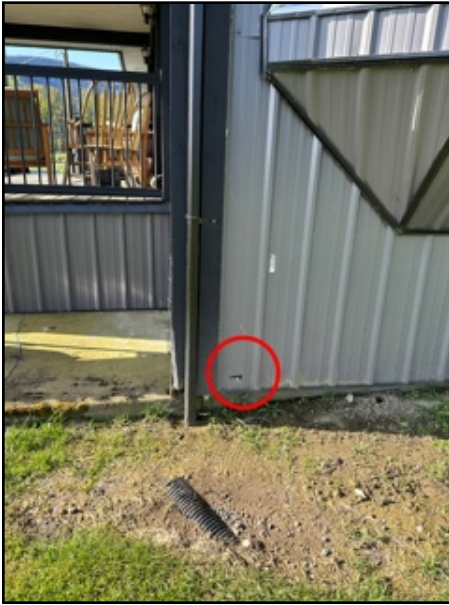
Seal all holes and gaps in the siding material. This will prevent insects and vermin from entering into the home and also prevent hidden water damage. Have repaired.

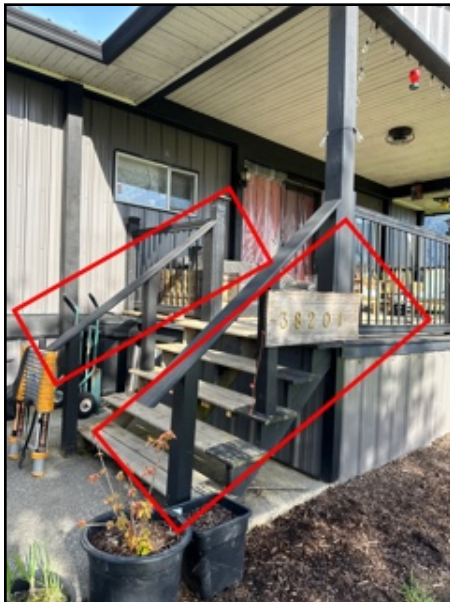
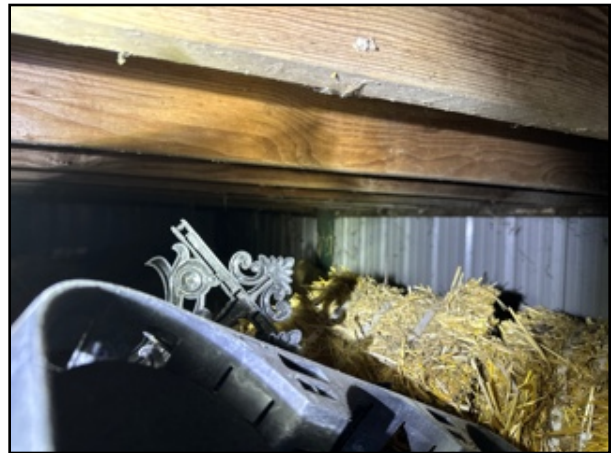
Incorrect configuration noted for the deck stairs. The stair treads are also deflecting and are leaning which is a fall hazard. This is a safety concern that needs repairs or replacements.

The middle edge section of the deck has settled and has bulging observed to the flooring on this area. This could be due to a structural concern to the deck. This is a safety concern that needs further evaluation by a general contractor or carpenter. Have assessed for structural integrity and repairs for safety. From the crawlspace, this deck appears to be missing a post and beam structure and is a poor installation. Anticipate improvements or replacements.

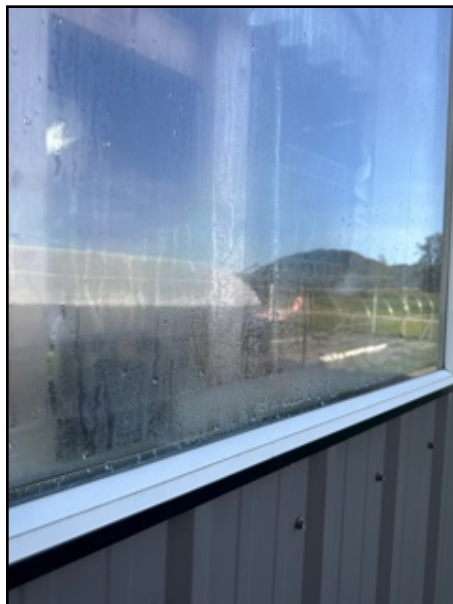
Figure 8-1

The seals on the windows have failed at several locations. There are also cracked windows observed. Anticipate repairs or replacements.

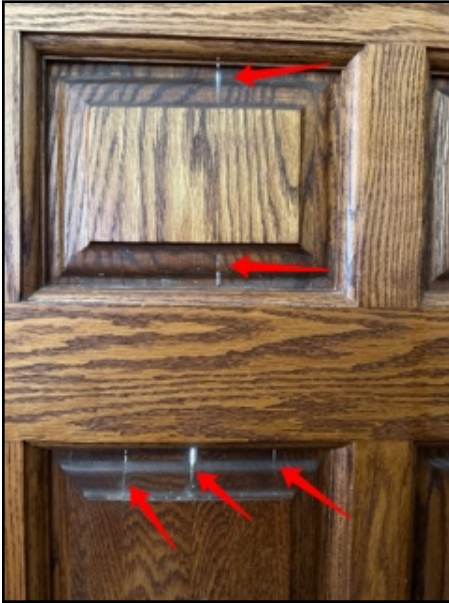
Figure 9-1

**Comment 9:**
The main entry door is damaged. Anticipate repairs or replacements.

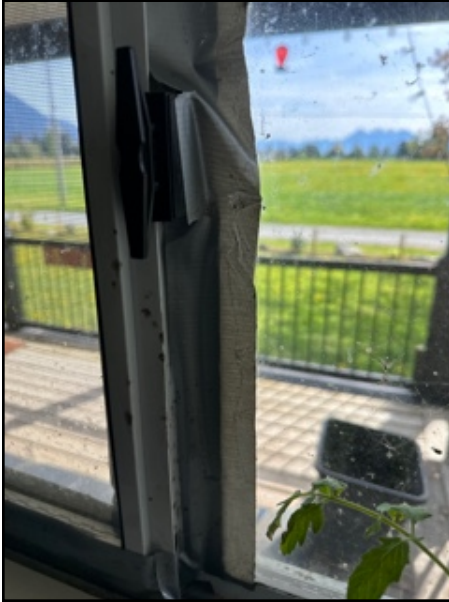
Figure 10-1

There is duct tape observed to several of the windows most likely due to poor window seals. Anticipate repairs or replacements.

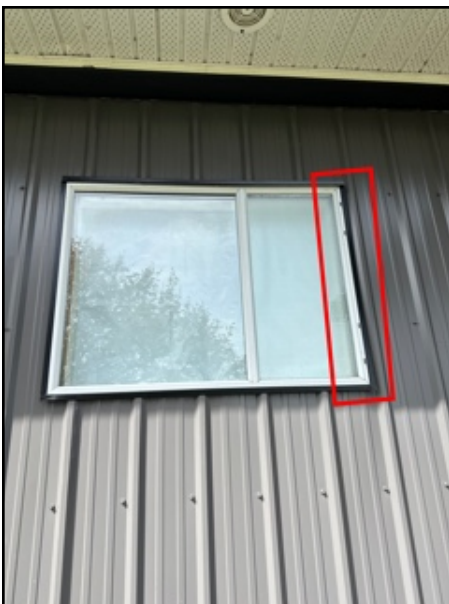
Figure 11-1

The weep holes for the windows are not at the bottom for a several of the windows due to poor installations. Anticipate repairs.

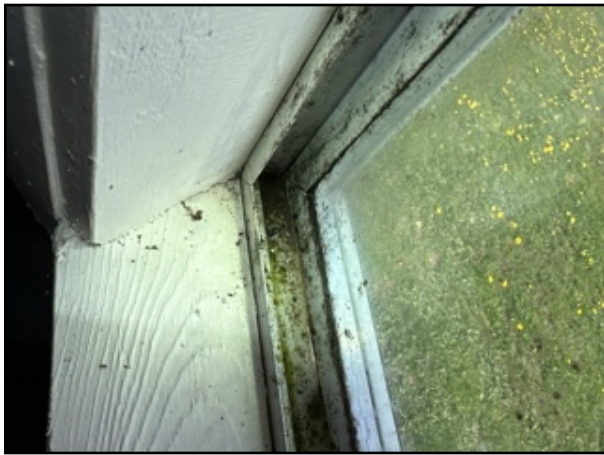
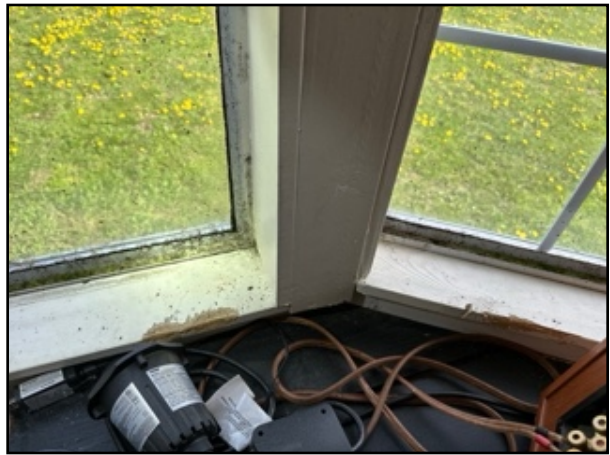
Organic growth around the windows and water pooling on sills are signs of high humidity and moisture. There is also organic growth observed on bedroom ceiling. Running exhaust fans while showering and cooking is advised. Clean organic growth off windows and control moisture in home. Further evaluation is needed if organic growth returns.

Ensure to also open window blinds to allow for air circulation in this space.

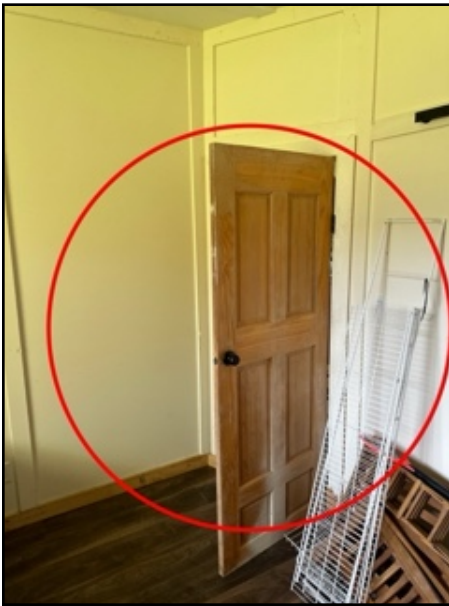
Figure 13-1

Binding noted on interior door in the guest bedroom needs repairs.

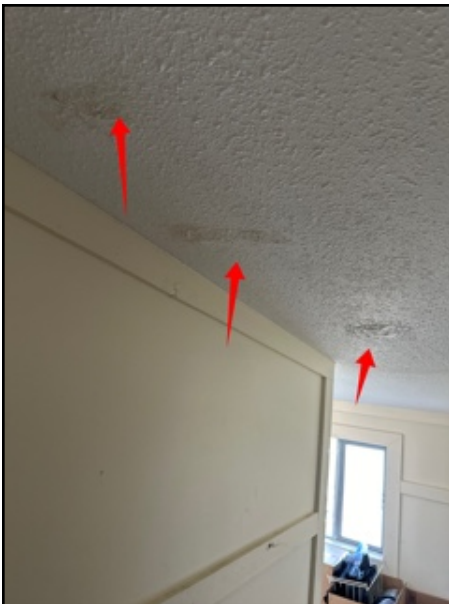
Figure 14-1

No moisture levels recorded on previous ceiling repairs. It is recommended to contact current owner on further information on possible repairs made.

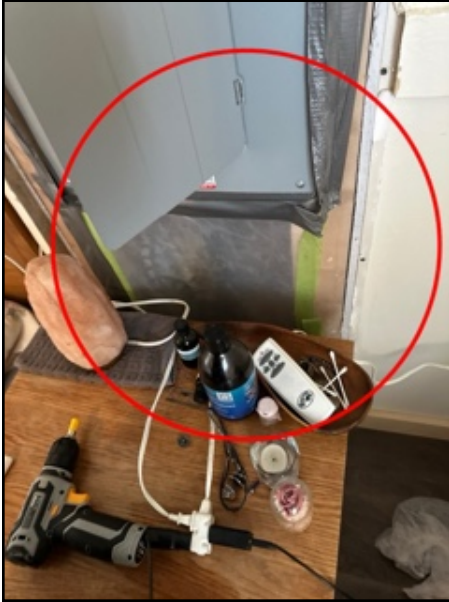
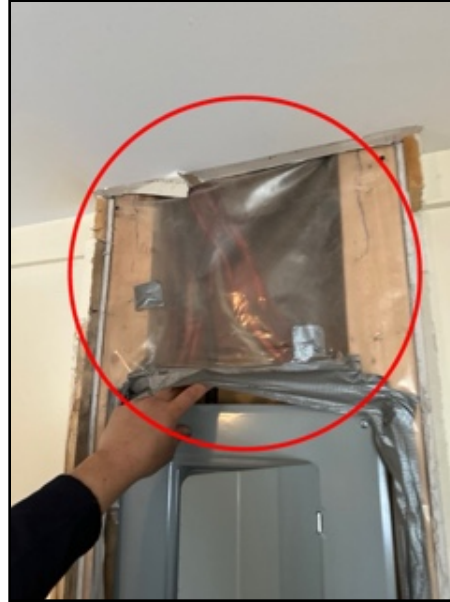
There are gaps and missing insulation observed to the exterior wall. Repairs are needed for improved thermal efficiency.

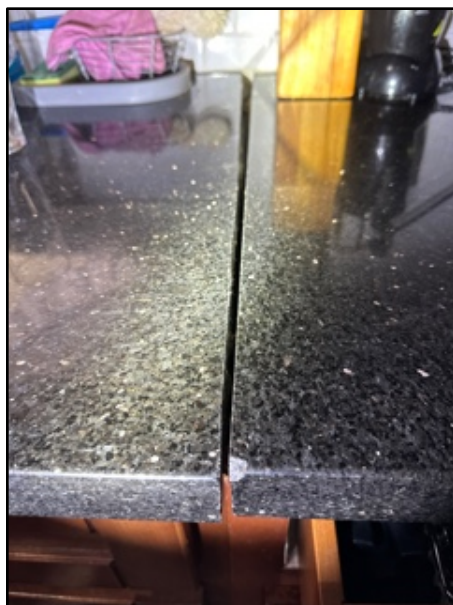
Figure 16-1

**Comment 16:**
Kitchen countertop is loose and not properly installed. Anticipate repairs or replacements.

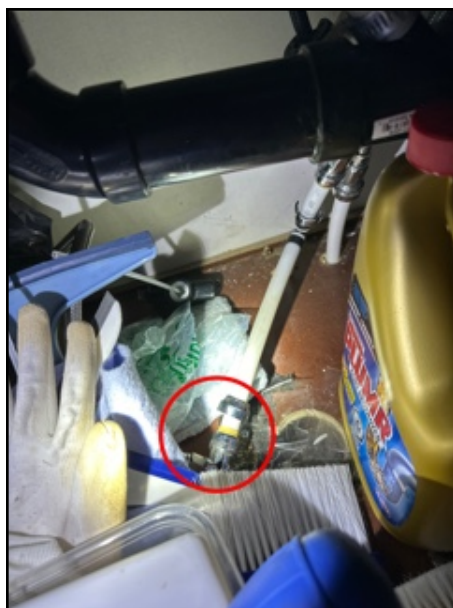
Figure 18-1

Dishwasher is missing a water hammer arrestor. Monitor and have installed to minimize banging of the supply pipes as needed. This can be repaired by a plumber.

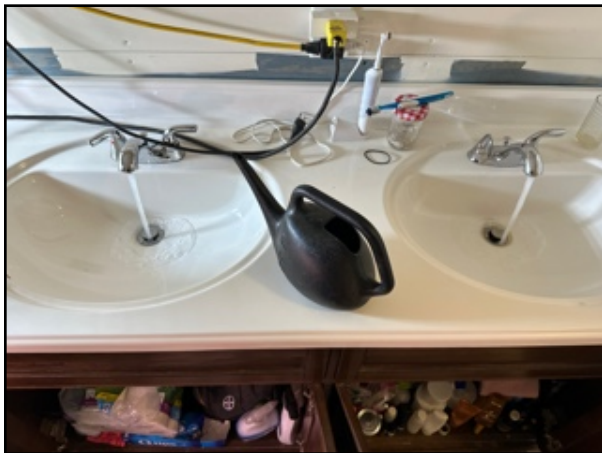
Figure 21-1

No visible heat source noted in this bathroom. One should be provided when the bathroom is on an exterior wall. Monitor and improve as needed.

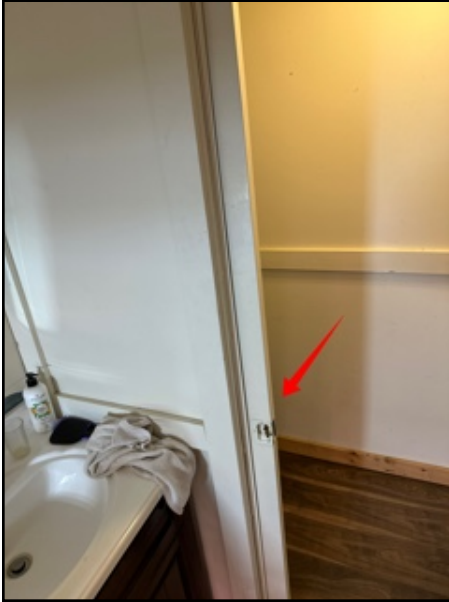
Figure 24-1

**Comment 24:**
The pocket door for the hallway bathroom is damaged and does not properly open/close. Anticipate repairs.

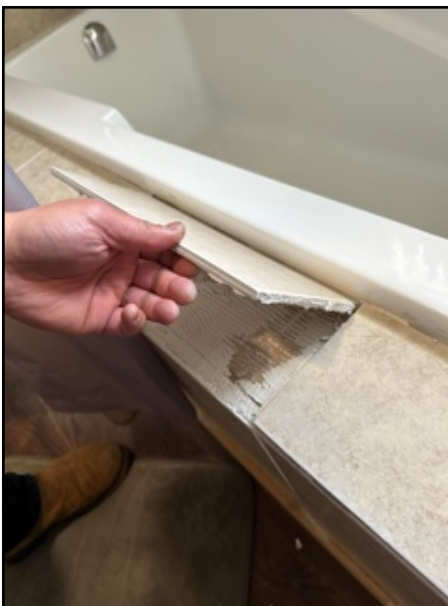
Figure 27-1

**Comment 27:**
The tiles around the tub surround are loose/damaged. Anticipate repairs.

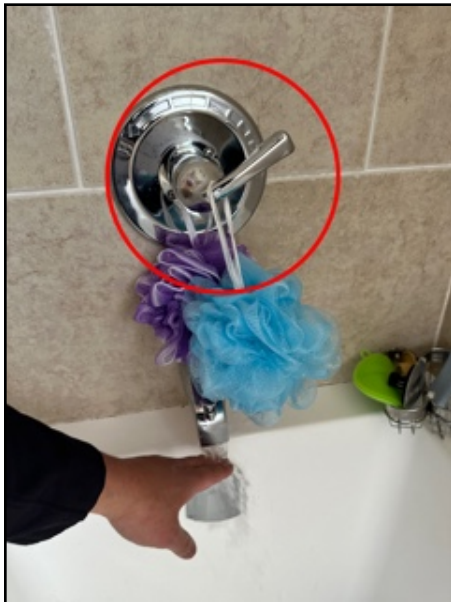
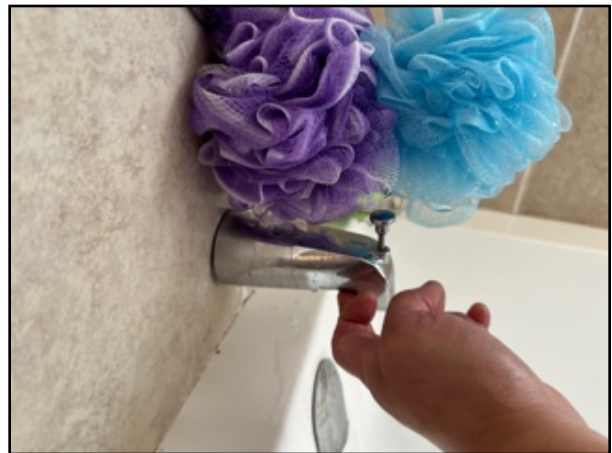
Caulking also needed on faucet penetration and escutcheon plate to prevent moisture seepage.

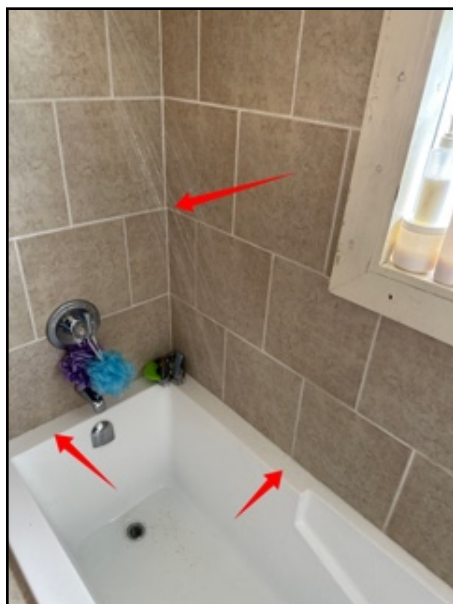
Figure 29-1

Caulking is missing in the corners of the tile and tub surround. Grout will crack with deflection and that's why caulking or silicone is recommended. Consider improving.

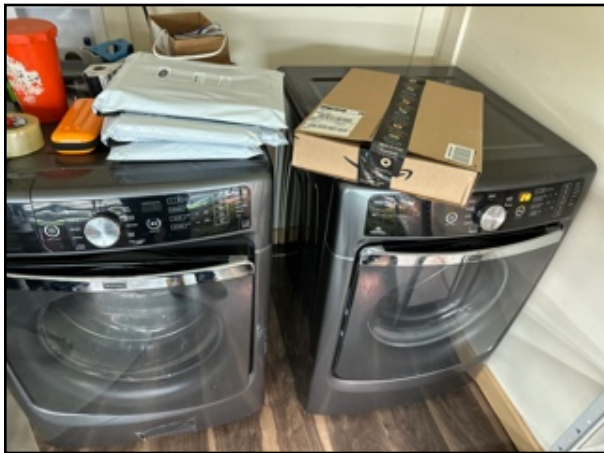
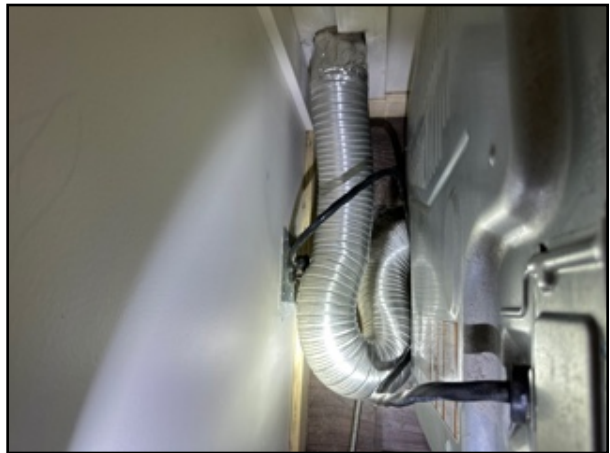
We recommend replacing rubber hot and cold hoses on wash machine with steel braided hoses to prevent risk of leaking over the long term. Water hammer arrestors are also missing. Have installed.

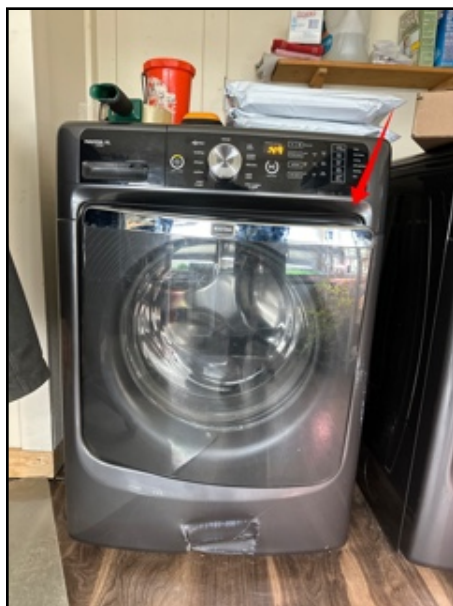
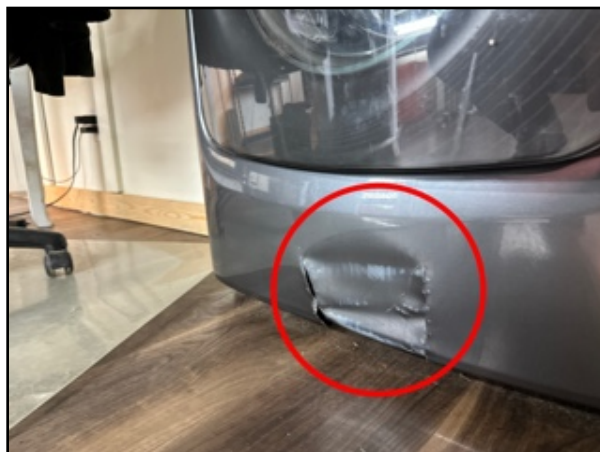
The washer door is sagging and may not properly seal during its cycle. There is also mechanical damage noted to the appliance at the bottom. Anticipate repairs or replacements.

Washer was not tested for a cycle to prevent potential leaking.

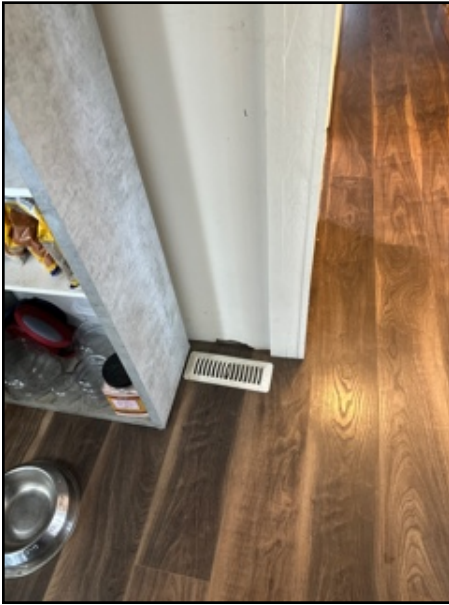
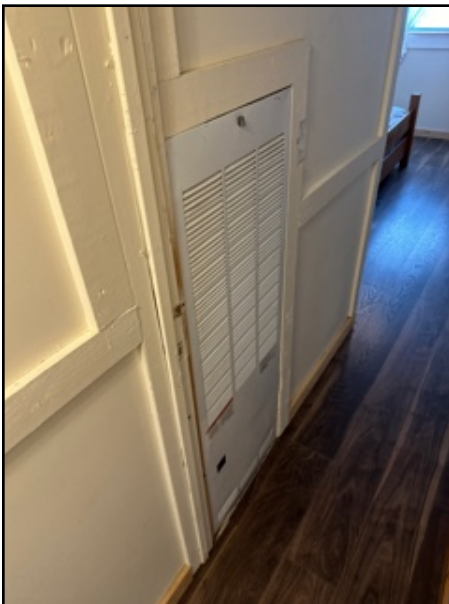
The furnace was not able to be tested due to no propane left in the tank. This was a limitation to the inspection of the furnace, thermostat, and heat registers.

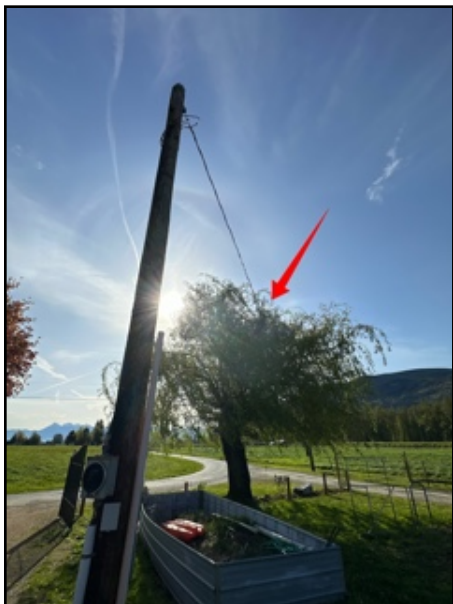
Figure 35-1

-
- Comment 35:**
Recommend trimming the branches away from the service drop to prevent mechanical damage during strong winds.

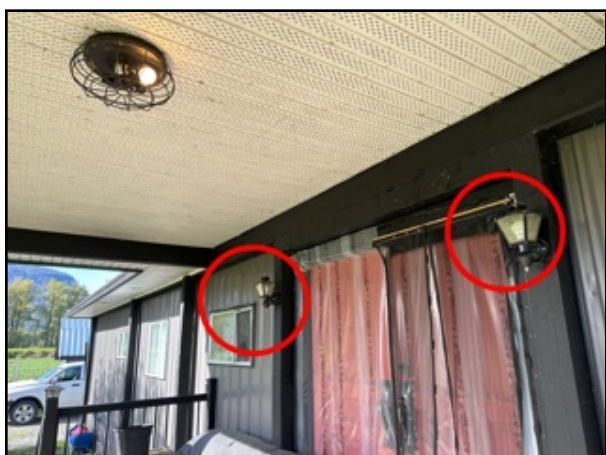
Figure 36-1

-
- Comment 36:**
Possible lightbulb burnt out/missing. Have bulb replaced and circuit tested to verify working order.

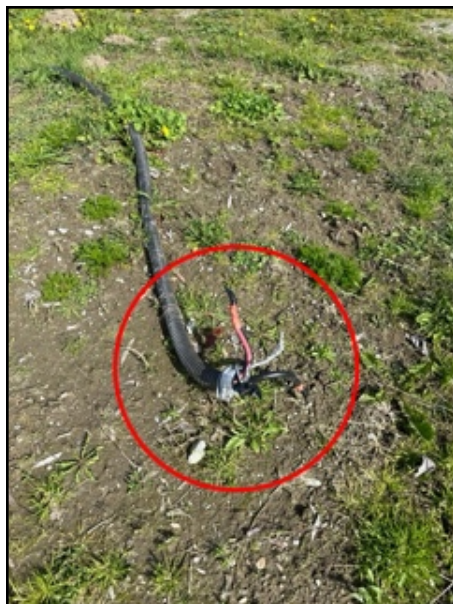
Figure 39-1

There is an exposed wire observed at the rear connected to a 125 amp breaker in the main panel. This is a life safety concern and a shock hazard in case this breaker is turned on. I recommend removal or properly terminating this loose wire by an electrician to prevent an accident.

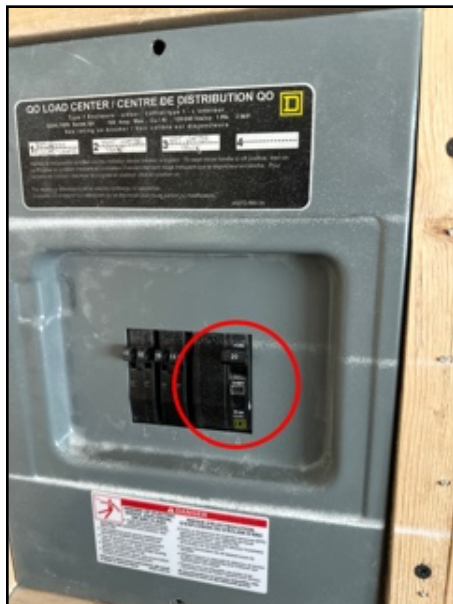
Figure 41-1

The dryer and the hot water heater are on the same circuit. This is a poor installation and a safety concern. Further evaluation is needed by an electrician for proper installation and repairs.

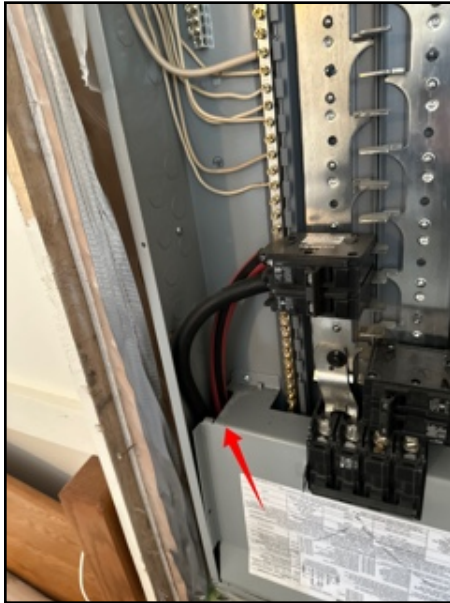
Figure 42-1

It is not good electrical practice to have conductors coming from the main disconnect panel. Ideally this should enter from the sides of the main panel through dedicated knockouts. This can be repaired by an electrician.

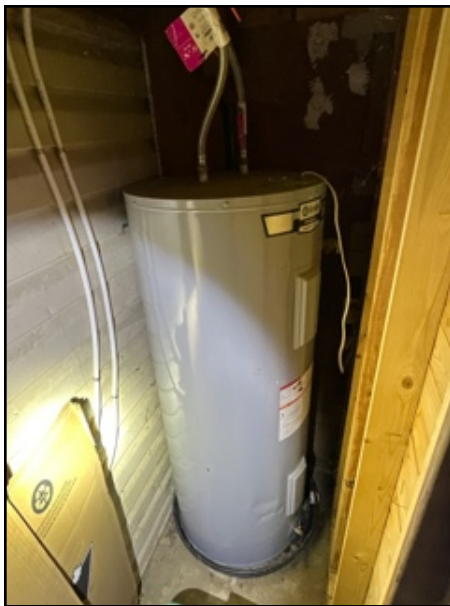
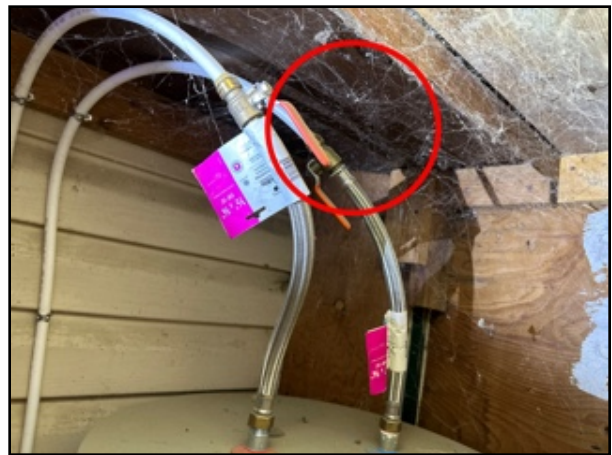
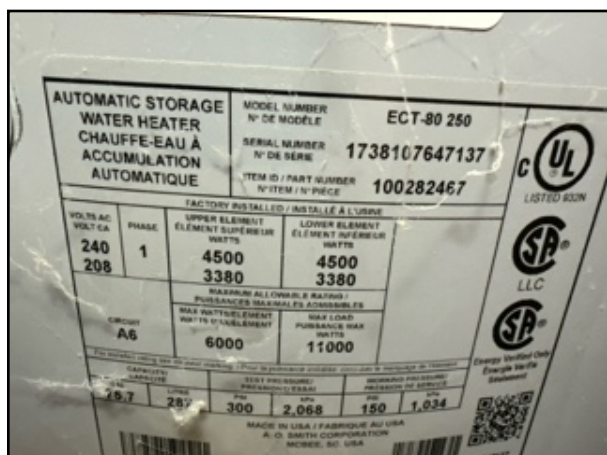
The vacuum breaker and the TPR discharge line is missing. There is denting observed to the exterior of this tank. This tank has been plugged into an outlet which is a poor installation. Normally, electric water heaters should be hard wired with its own dedicated circuit for proper installation. I recommend further evaluation by a plumber for improvements and repairs.

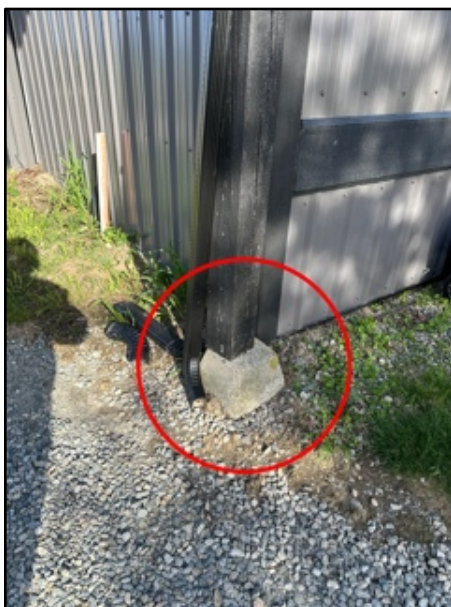
Figure 49-1

There are exterior posts noted around the home on the east side with pier block footings which appear to be structural support for the roof of the home. The post on the south east is loose from the footing and may be due to settlement. I recommend a general contractor further evaluate the structural integrity and installation of this roof for adequate load bearing support and safety.

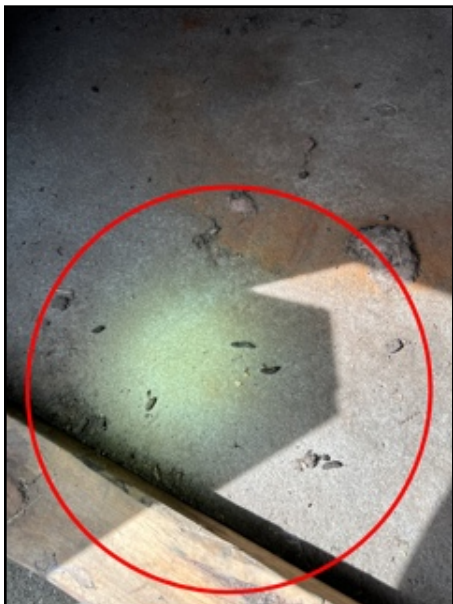
Figure 55-1

**Comment 55:**
There are rodent droppings observed in the crawlspace. Set traps as a precautionary measure and seal all gaps and penetrations from the exterior. Alternatively, consult a pest exterminator for remediation.
