Address of Property:

392055 Range Road 62
AB

2023-07-28

HouseMaster Serving Central Alberta

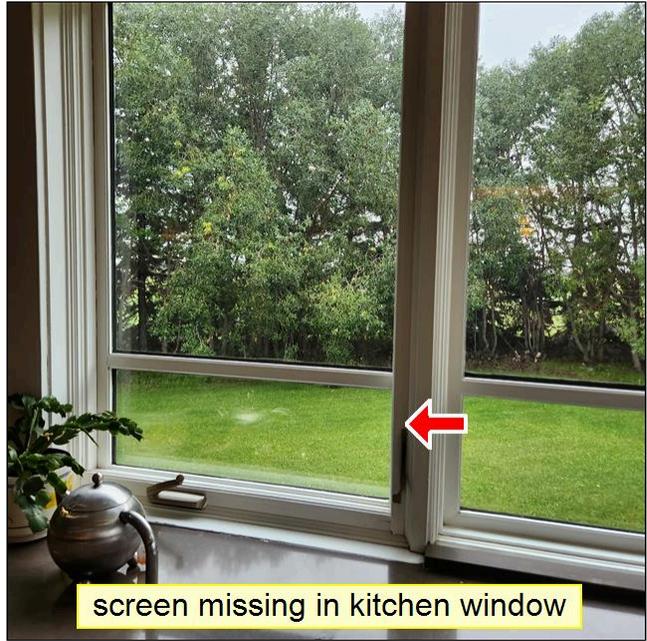
9.6 INTERIOR WINDOWS (Picture 2)

screen missing in kitchen window

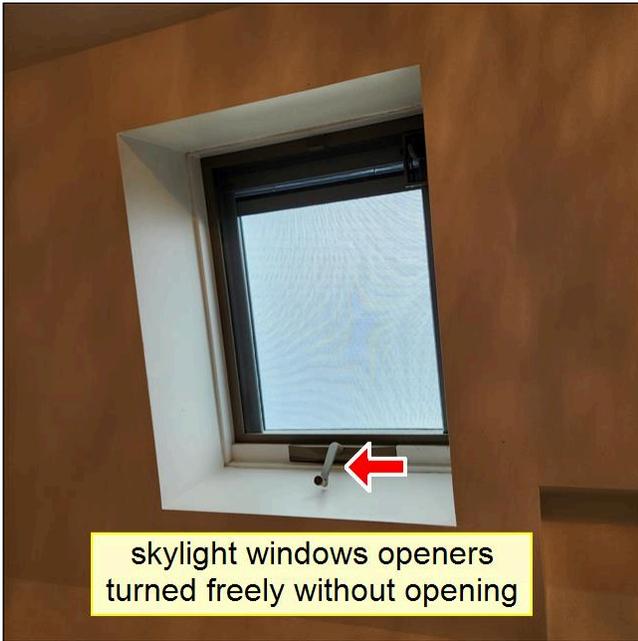
9.6 INTERIOR WINDOWS (Picture 3)

skylight windows openers turned freely without opening

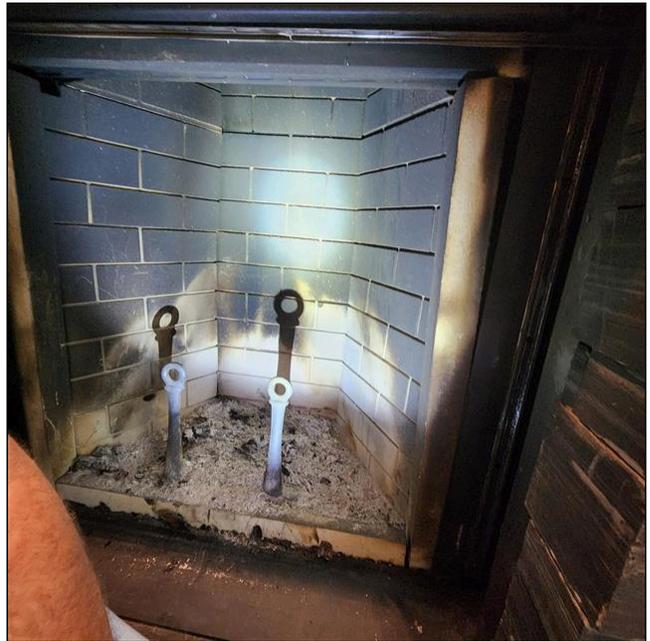
9.10 BASEMENT WOOD FIREPLACE (Picture 1)

loose fire stone

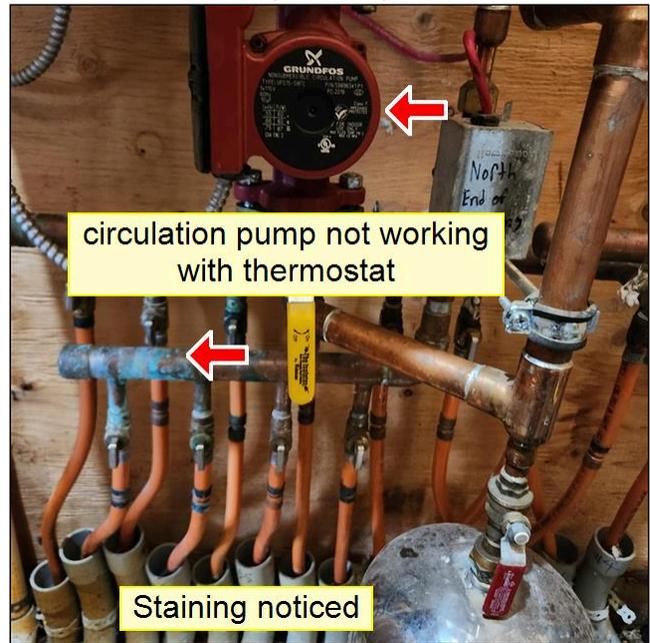
14.4 STABLE INFLOOR HEATING/PLUMBING (Picture 3)

circulation pump not working with thermostat

Staining noticed

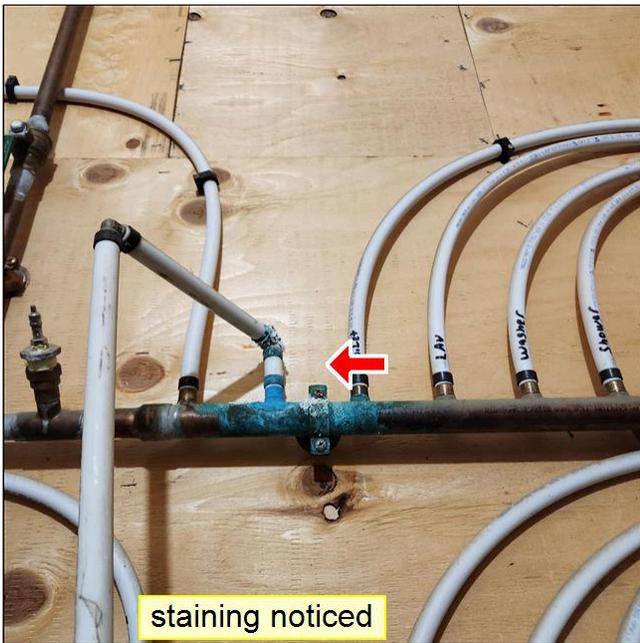
14.4 STABLE INFLOOR HEATING/PLUMBING (Picture 4)

staining noticed

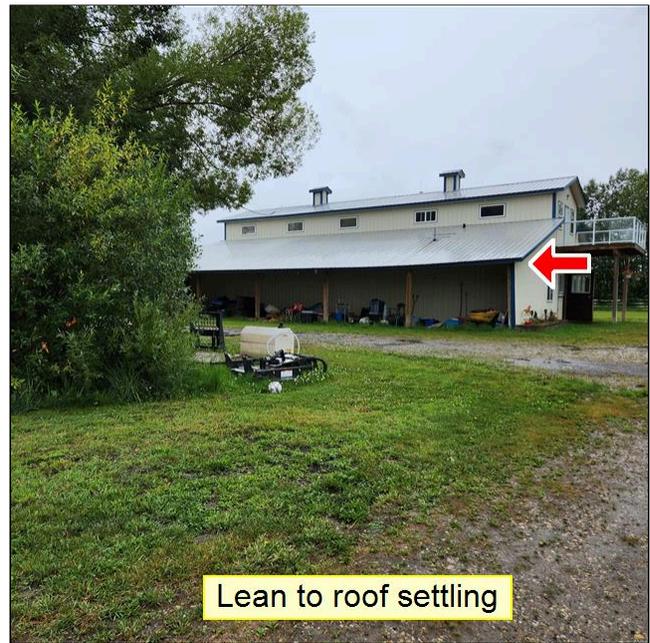
14.5 LEAN TO ROOF ON STABLE (Picture 1)

Lean to roof settling

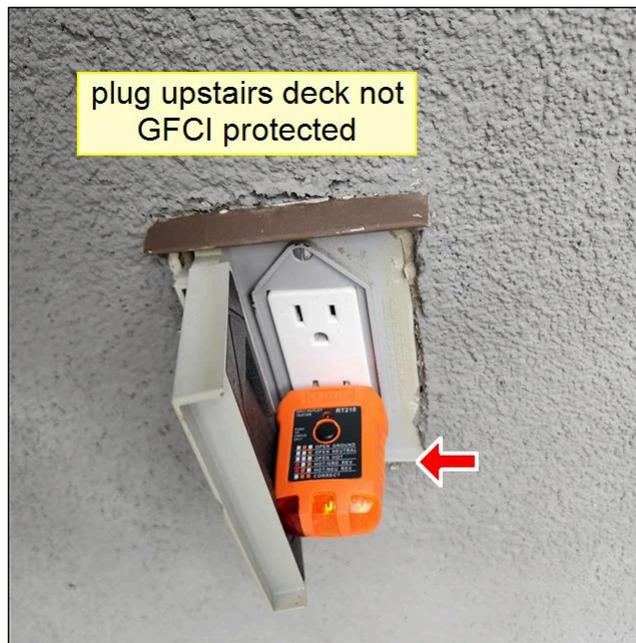
2.11 (Picture 1)

Exterior plugs not GFCI protected. Recommend upgrading to GFCI protection for personal safety.

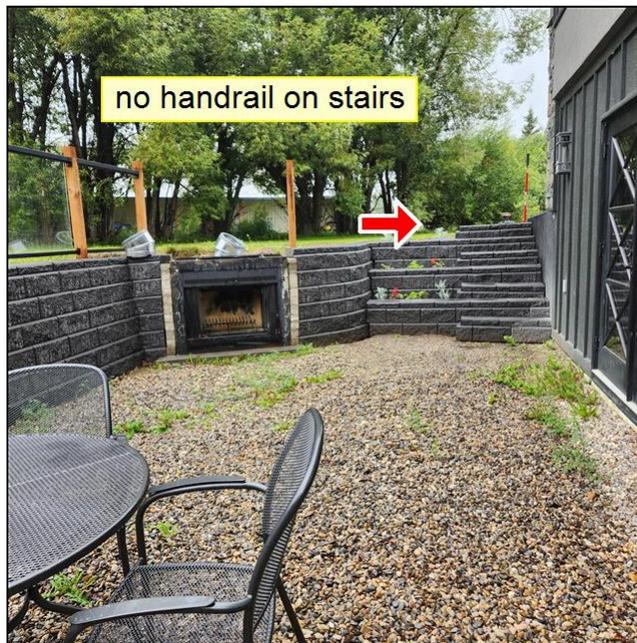
3.7 (Picture 1)

No handrails on stairs to walk out. Recommend adding stairs for personal safety.

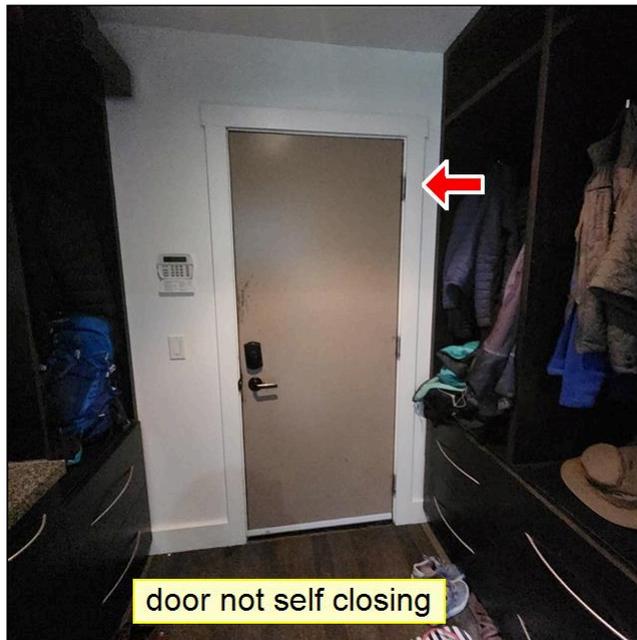
5.8 (Picture 1)

Garage door isn't self closing. Recommend ensuring door has self closing hinges for personal safety.

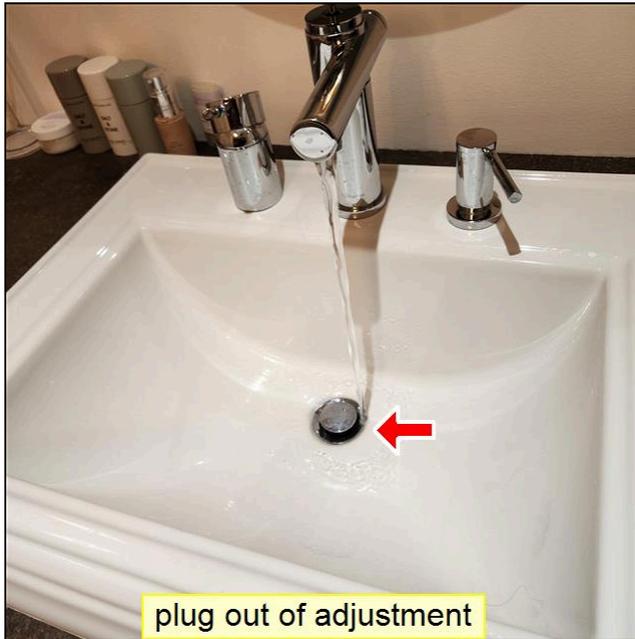
6.0.B (Picture 1)

Plug in left sink doesn't function fully. Repair as needed.

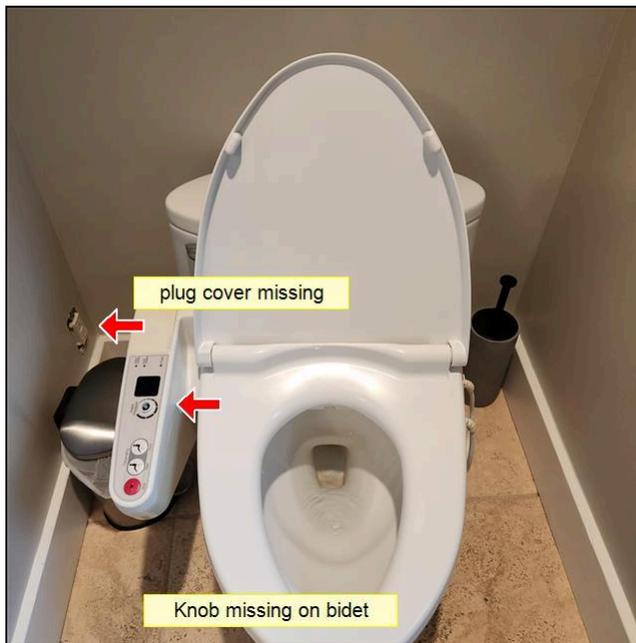
6.1.B (Picture 1)

Bidet not functioned. Missing adjustment knob. Toilet tested and works satisfactory.

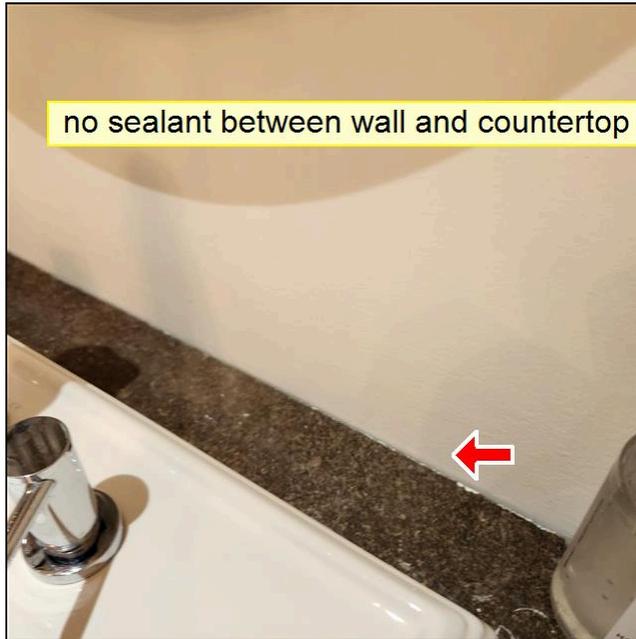
6.5.B (Picture 1)

Not sealed along back of counter top. Recommend sealing to prevent possible water intrusion into building materials.

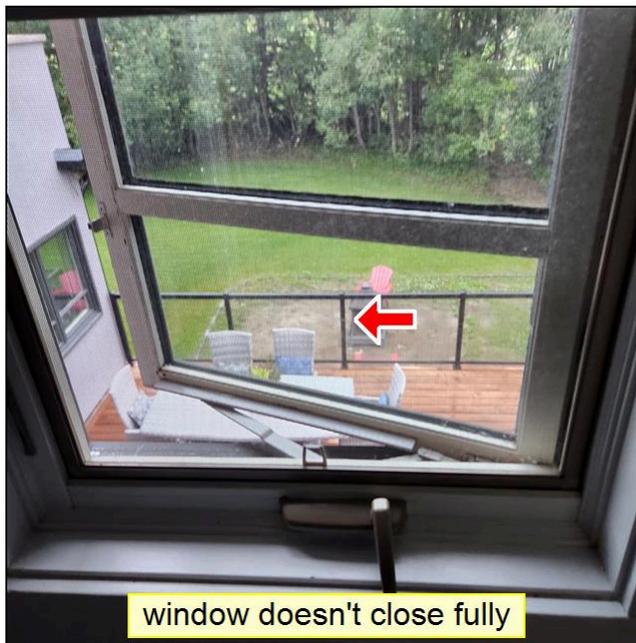
6.8.B (Picture 1)

Window doesn't close all the way. Recommend adjusting so window closes correctly.

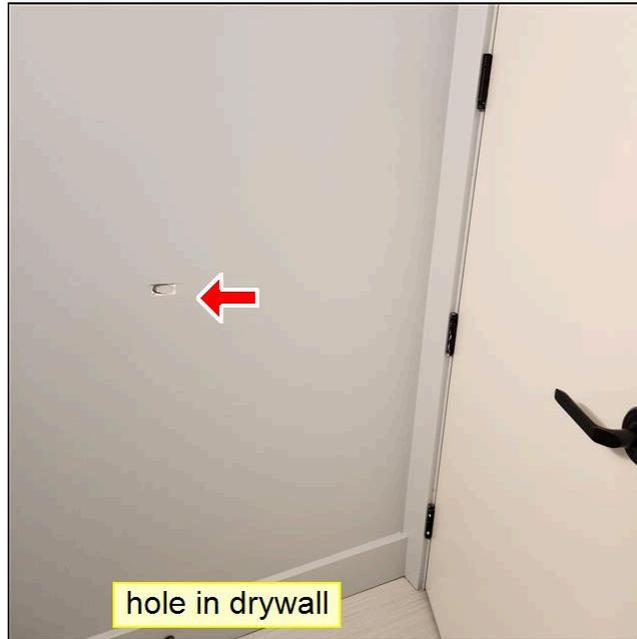
6.10.C (Picture 1)

Hole in wall behind door. Repair as needed.

Hole repaired

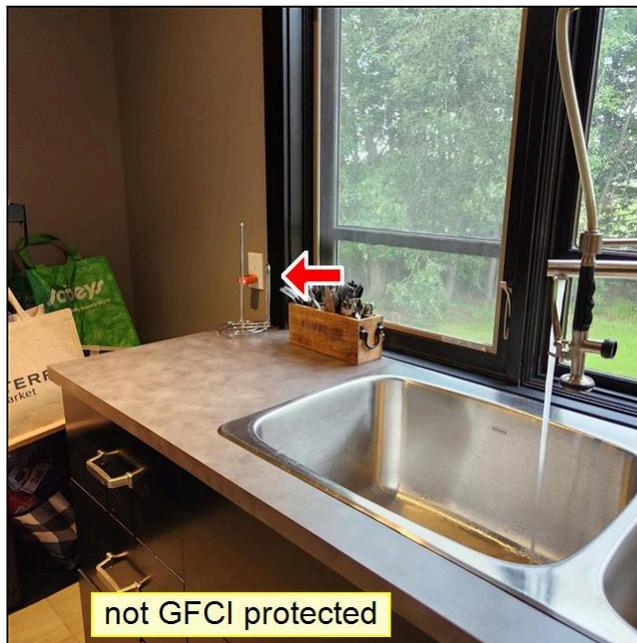
8.2 (Picture 1)

Receptacles near sink not GFCI protected. Normal for age of house. Recommend upgrade to bring to newest safety codes.

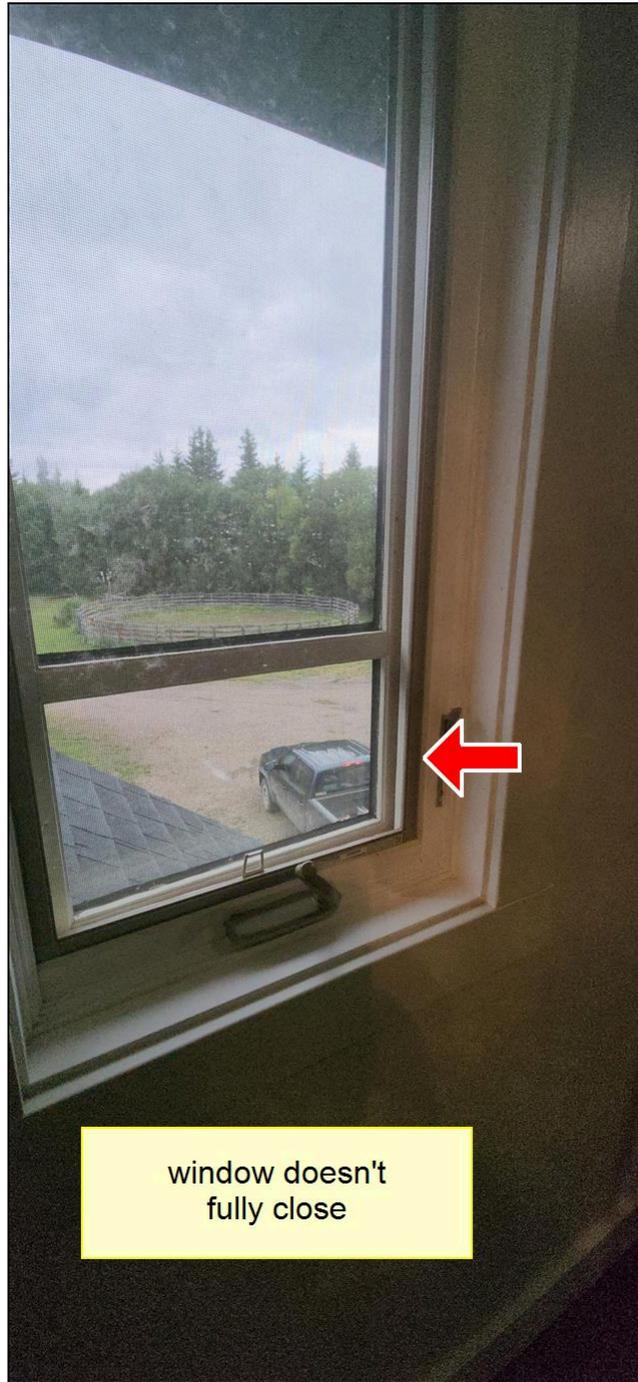
9.6 (Picture 1)

window doesn't
fully close

Adjusted and closes fully

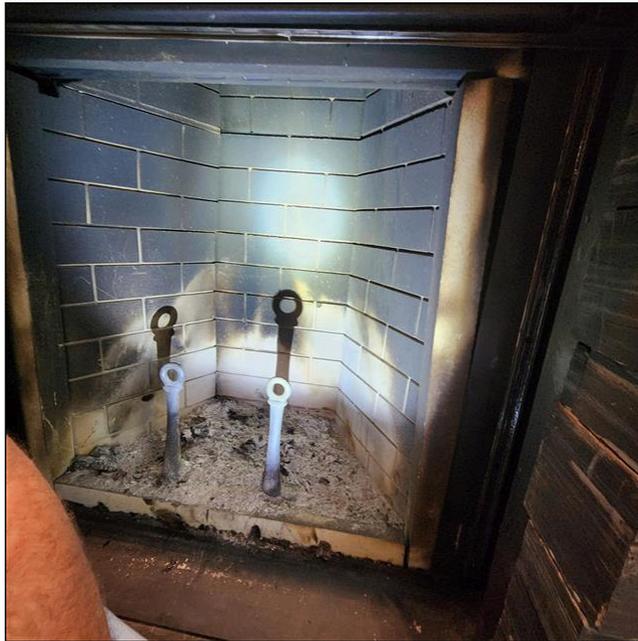
9.10 (Picture 1)

Fireplace has loose bricks and appears to be missing refractor brick missing. Recommend assessment by a qualified fireplace technician to pass WETT inspection.

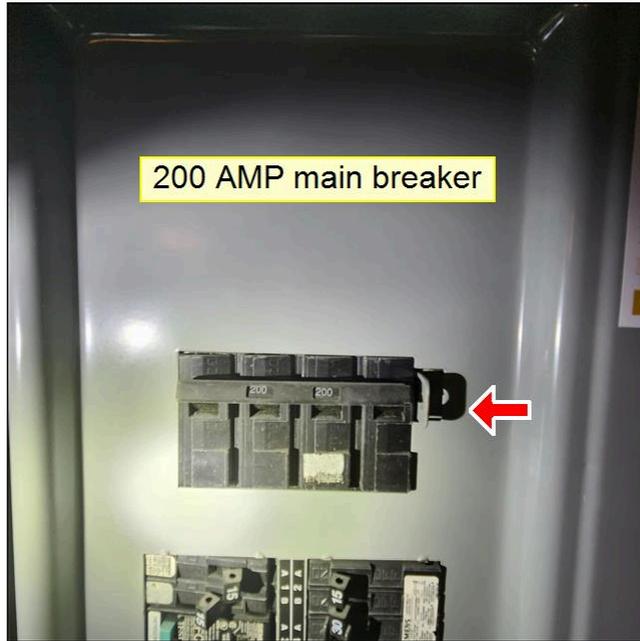
10.1 (Picture 1)

200 Amp main breaker. All copper wires noted through panel and house. Double tap noticed in panel. Double tap is when two wires are run to a single breaker. Recommend assessment by qualified electrician.

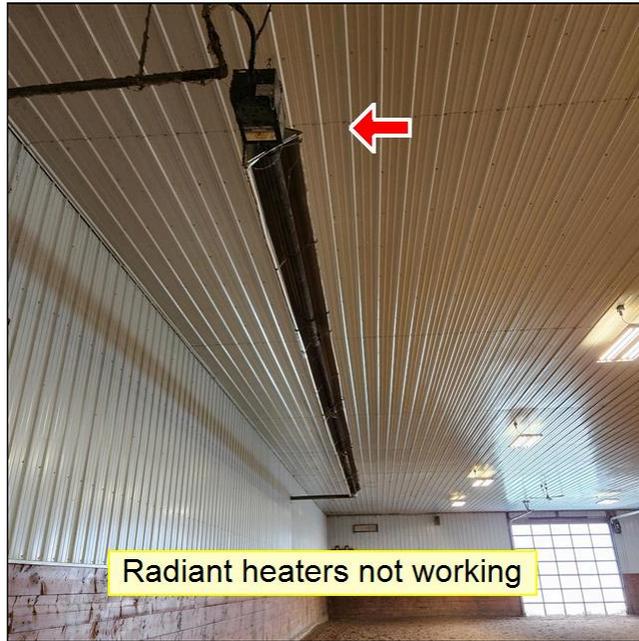
14.0 (Picture 1)

Tried functioning radiant heaters in riding arena. Both radiant heaters weren't in functioning order at the time of inspection. Recommend having units serviced or repaired by qualified plumber.

Heater replaced

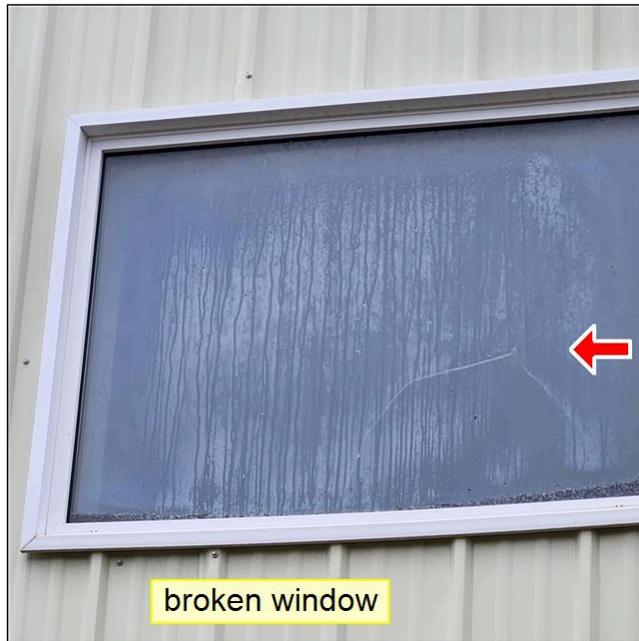
14.1 (Picture 1)

Noticed cracked windows and windows missing window seals (6 units) in riding arena. Recommend assessment of window units by a qualified window and door technician.

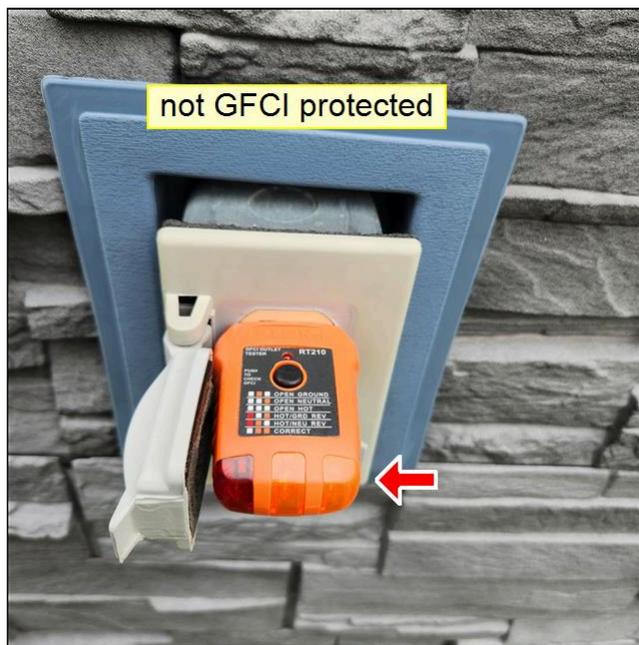
14.2 (Picture 1)

Noticed exterior plugs are not GFCI protected. Recommend having plugs upgraded by qualified electrician for personal safety.

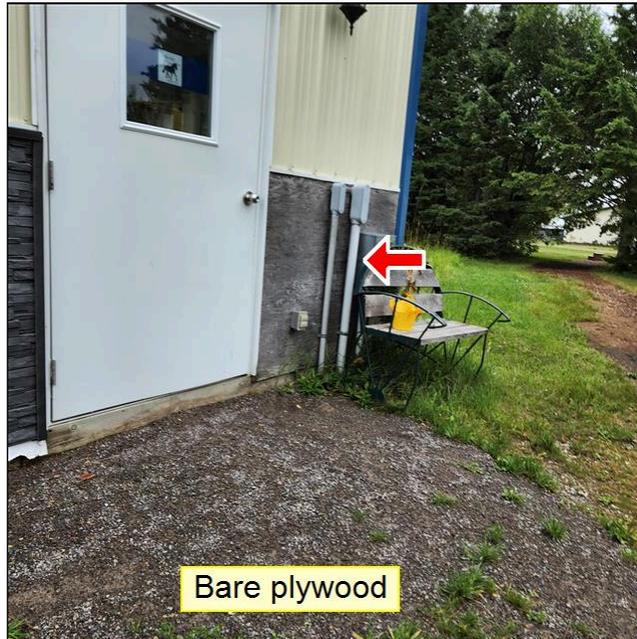
14.3 (1) Noticed bare plywood beside entry door. Recommend sealing or covering with exterior covering to reduce weathering of building material.

Matching Siding/covering installed

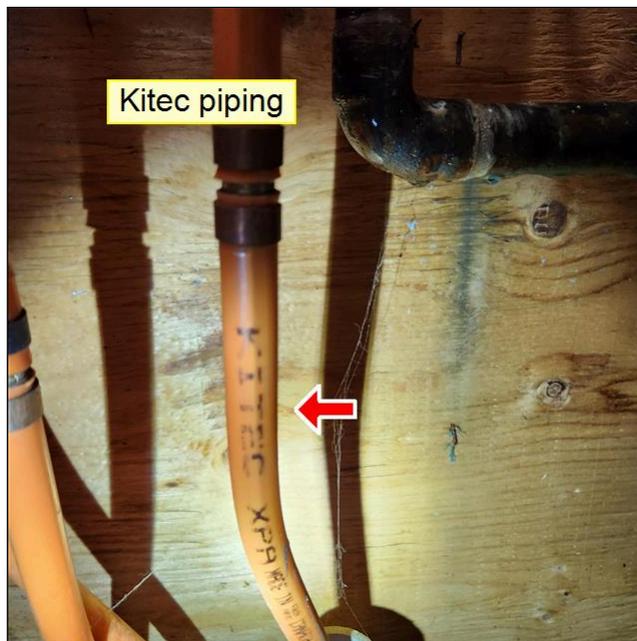
14.4 (Picture 1)

Stable in floor heating didn't turn on zoning valves/circulation pumps with thermo stats. Recommend having assessment and possible repair of components.

Kitec piping used for in floor used for in floor heating. Kitec piping sometimes has a reaction with crimped fittings which will show as white water staining at the crimp. Recommend assessing periodically to see if staining is starting to occur and if its observed having crimped ring replaced by plumber.

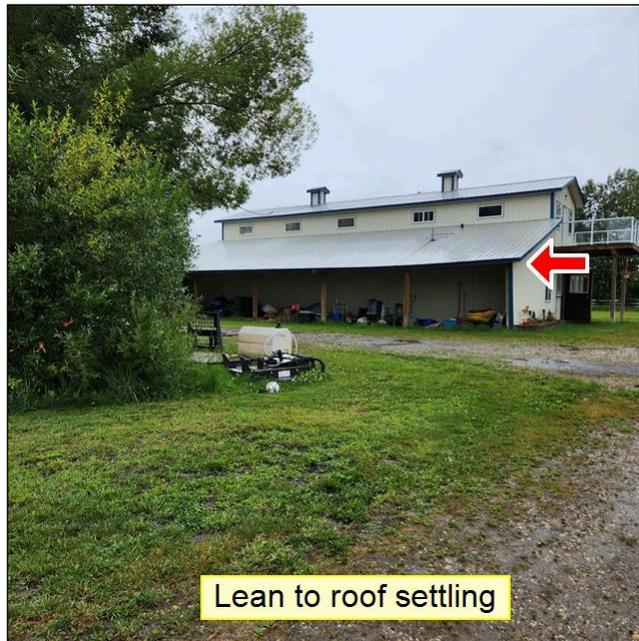
14.5 (Picture 1)

Lean to roof on stable appears to have a small sag in the middle. Posts may have settled a bit over time. The movement currently doesn't appear to cause for a concern. Just looks like it settled a bit different over time.

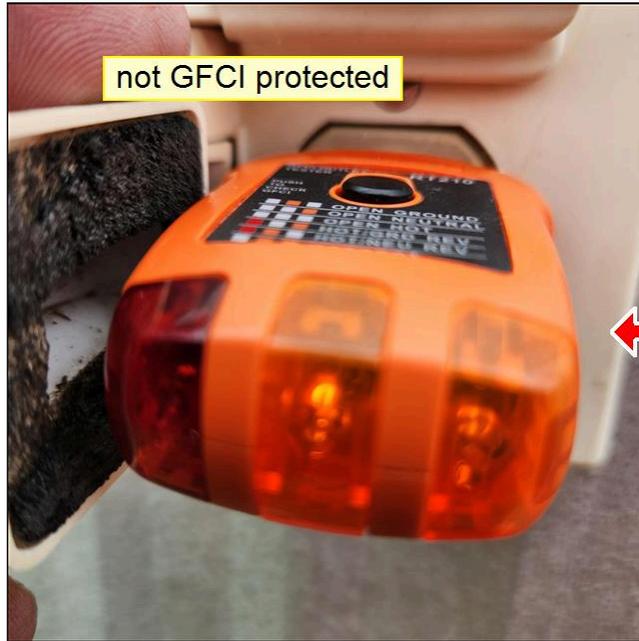
14.6 (Picture 1)

Exterior plugs on shop not GFCI protected. Recommend having plugs upgraded by qualified electrician for personal safety.

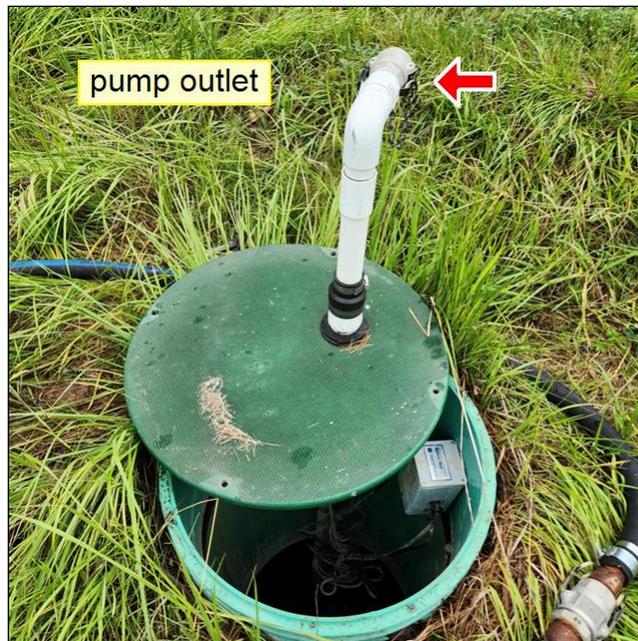
16.2.B (Picture 1)

Black water holding tank and grey water holding tank appear to be newer. Estimated less than 10 years. Black water holding tank appears to have a lot of solids in it at the time of inspection. Recommend having tanks sucked out and cleaned. Tanks are for containment with no field discharge present.

Tank emptied Sep/23
