ENHANCED PHASE I ENVIRONMENTAL SITE ASSESSMENT

**134 CRESCENT AVENUE
LOT 6, BLOCK 8, PLAN 7810085
PICTURE BUTTE, ALBERTA**

PROJECT NO. WA-24-081460

September 11th, 2024

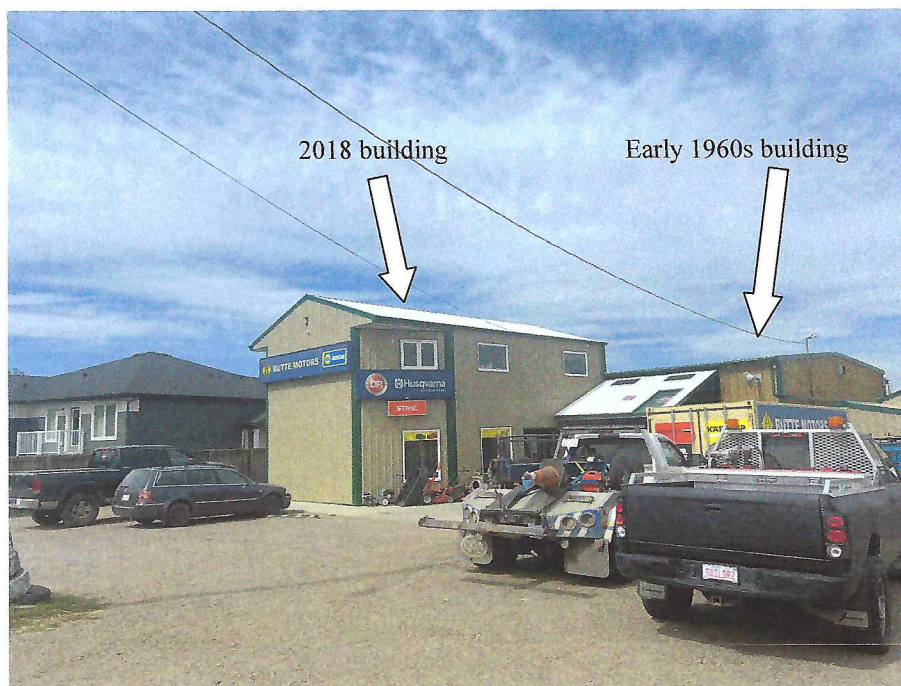
Photograph 1: View of subject site, looking northwest Crescent Avenue.

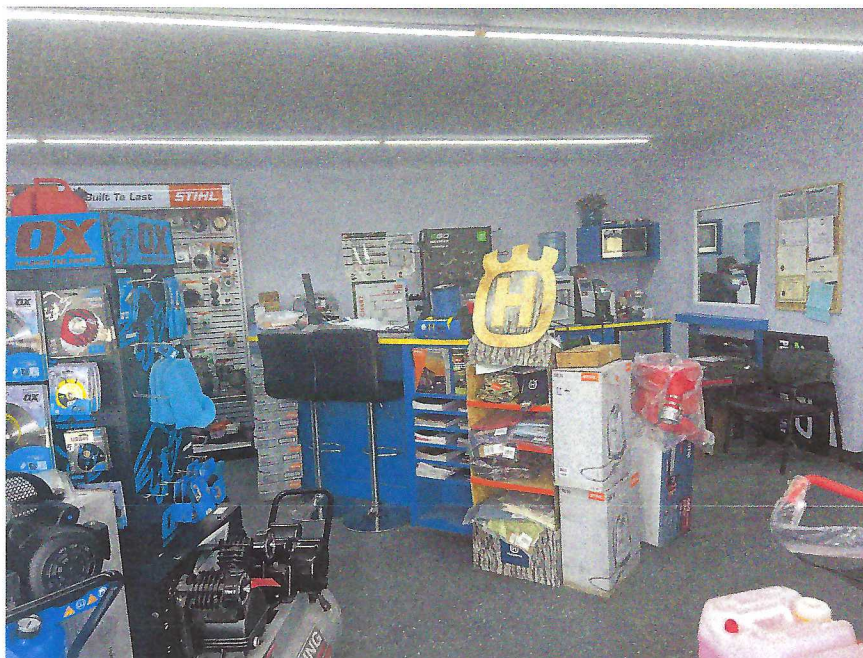
Photograph 2 – View retail area in 2018 building.

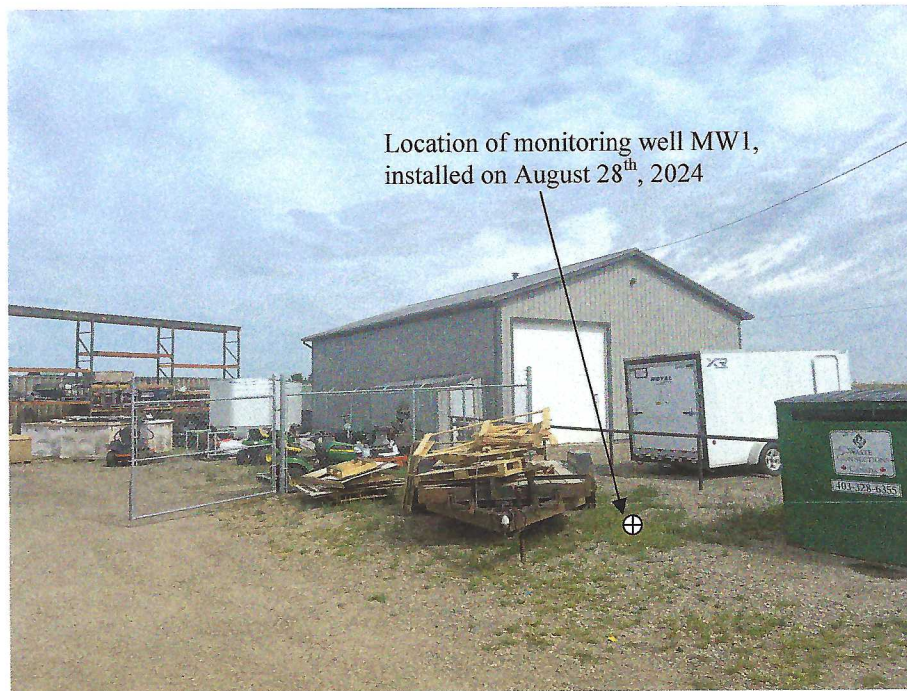
Due to the presence of former adjacent underground fuel storage tanks used to fuel service vehicles, one 50 mm diameter monitoring well was installed to confirm whether or not the soil and/or groundwater conditions at the site have been negatively impacted by subsurface petroleum hydrocarbons.

*Photograph 3 – View of former Lees Heating and Air Conditioning.
Note: USTs were located where the white trailer is parked.*

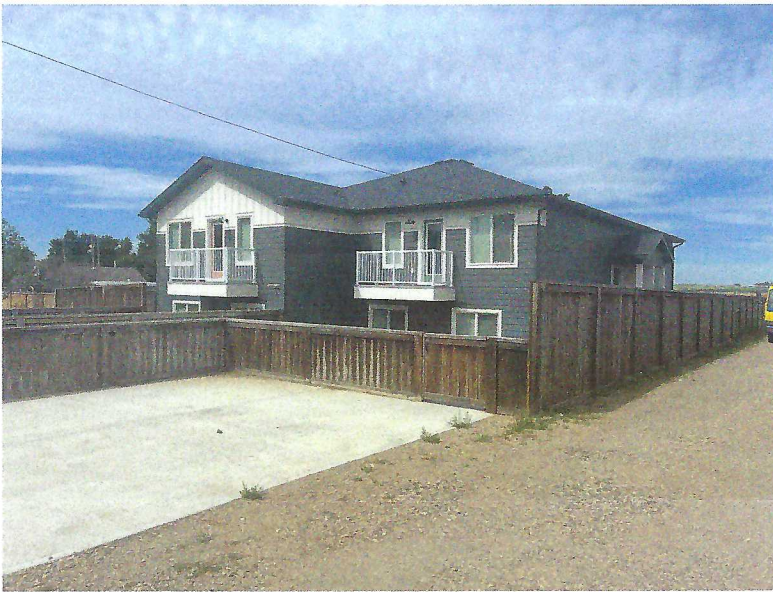
Photograph 4: Recently renovated adjacent property to the west

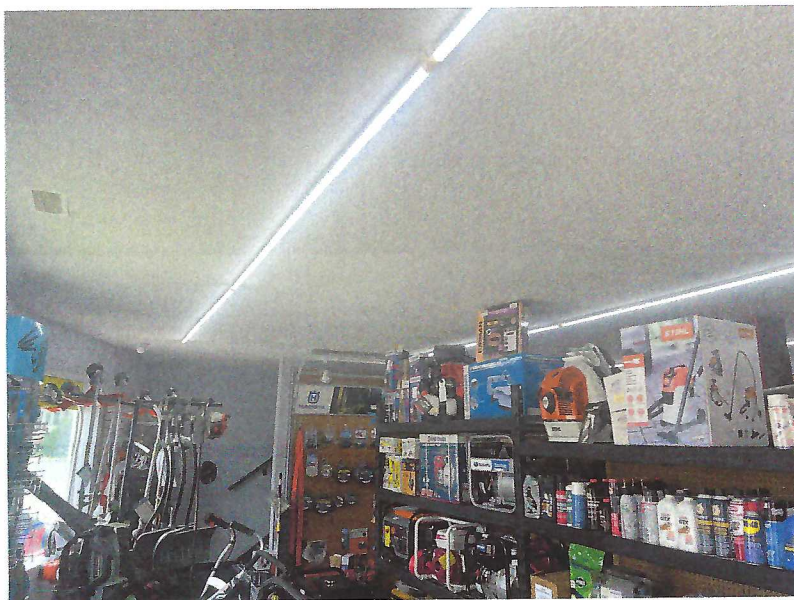
None observed or reported. A waste oil “tote” was observed at the rear of the building which has a double wall and serviced regularly by a recycling contractor. No evidence of fill or vent pipes indicating the possible presence of underground storage tanks was observed on site. Automotive lubricants and other products were observed to be stored according to industry standards. Domestic cleaning chemicals observed to be stored in an orderly fashion.

Photograph 5 – View of automotive products displayed in the main retail area.

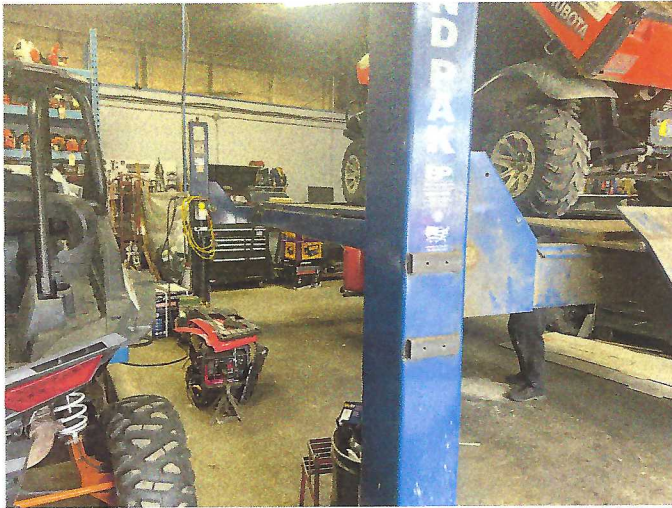
There were no hydraulic hoists or elevators observed at the subject property during the site reconnaissance. The automotive shop utilizes electrical free standing hoists for the business.

Photograph 6: View of electric free standing hoist located in the main shop areas.
