Phase I Environmental Site Assessment

NE 25-053-17W5M

**Prepared For:
G. Simmons Trucking Ltd.**

Project Reference:
4327- NE 25-053-17W5M

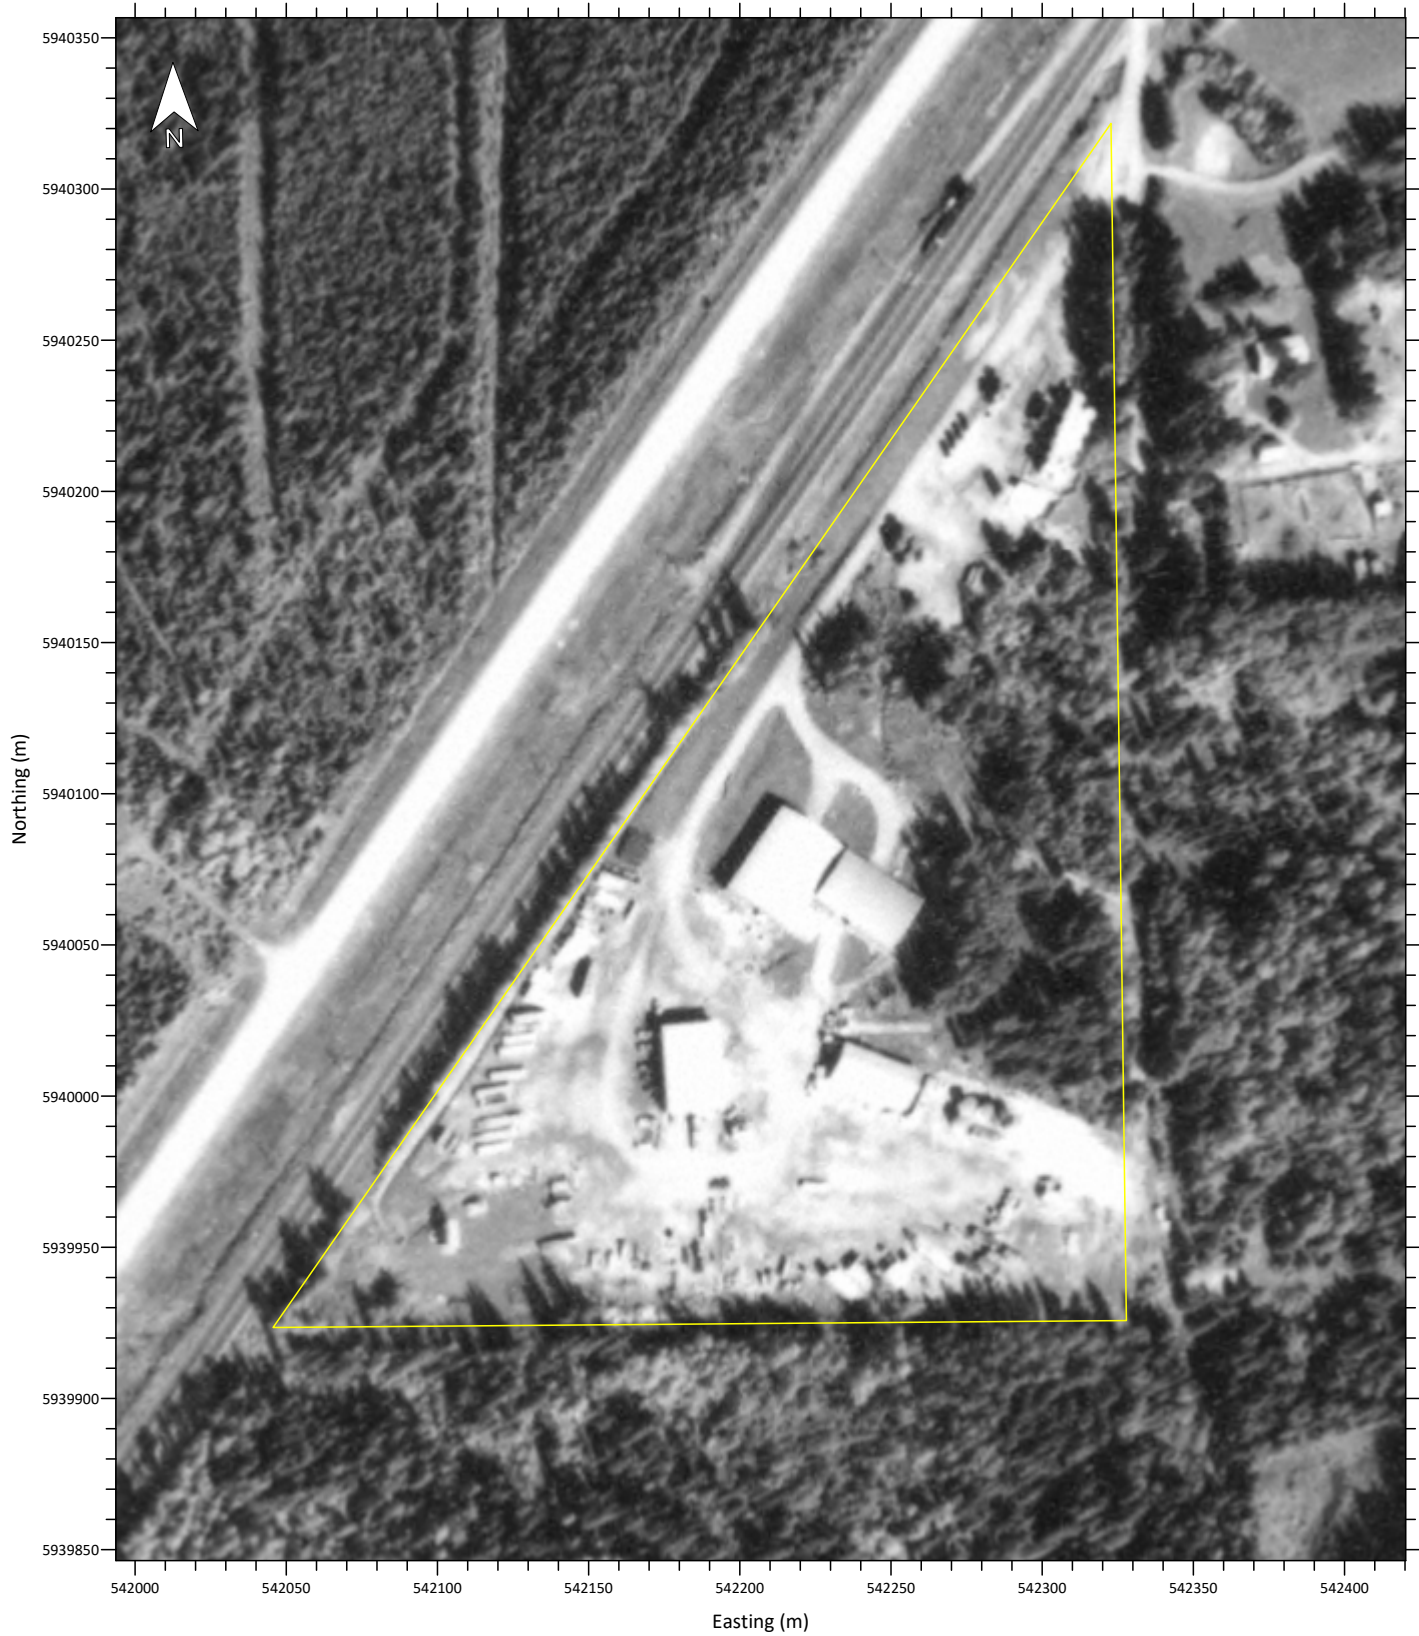
Figure 8	AS4062-098	1990	Enlarged to 1:2,500	The commercial property was expanded in size with additional structures and objects. Increased development was present on land northeast of site.	
Figure 9	TRSG9902-438	1999	Enlarged to 1:2,500	The land north and west of the subject property was cleared of trees. Above ground storage tanks were visible on the north tip clearing.	
Figure 10	AS5291-038	2004	Enlarged to 1:2,500	Several additional commercial structures were visible on the subject property.	
Figure 11	Google Earth	2012	Enlarged to 1:2,500	The commercial structures on the northern portion of the property were removed as were two structures on the main portion of the property.	
Figure 12	Google Earth	2020	Enlarged to 1:2,500	Same as previous air photo.	
Figure 13	Abadata	2022	Enlarged to 1:2,500	Same as previous air photo.

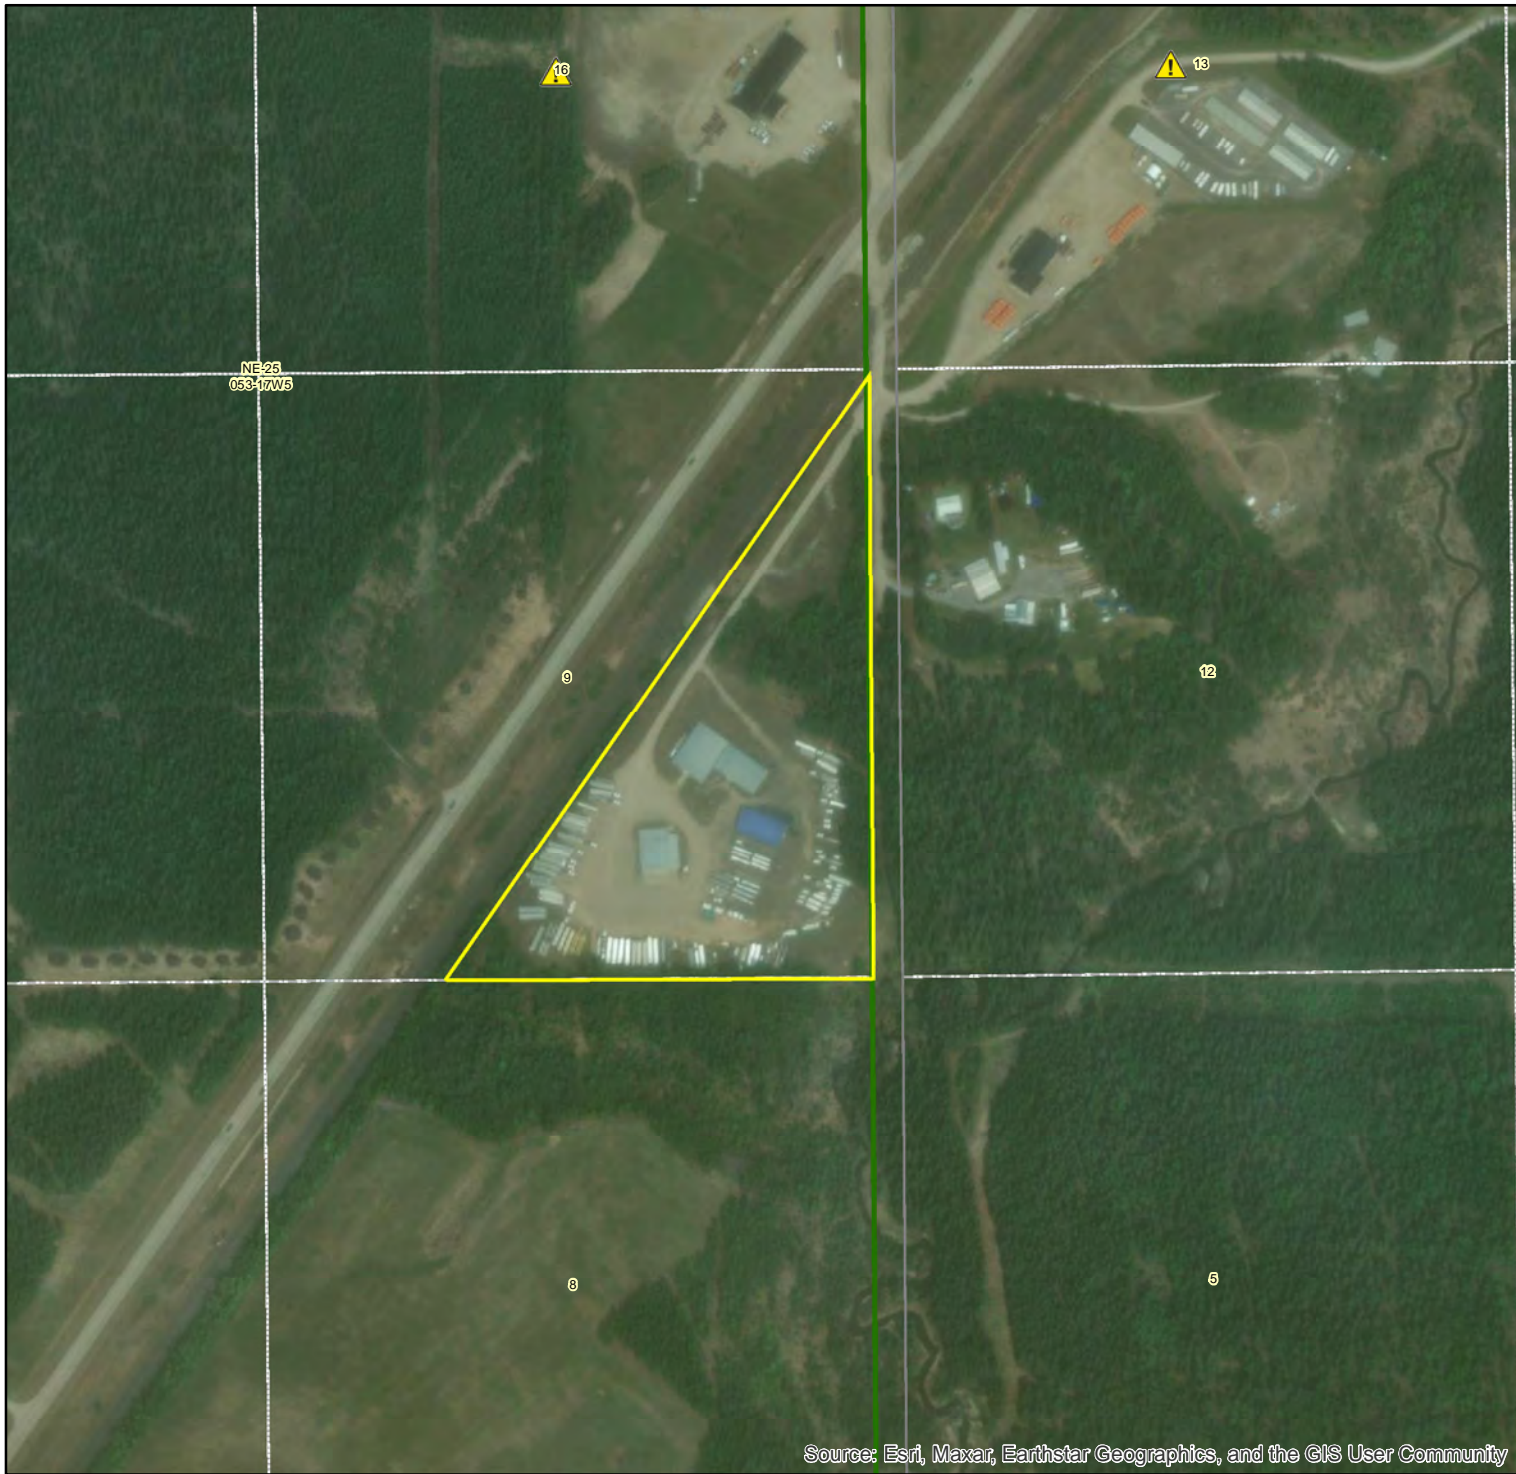
09-25-053-17W5M Spill & Complaint Search

16-25-053-17W5M (Dowell Schlumberger Canada Inc. – November, 1997). In 1997 approximately 15 m³ of diesel oil were spilled due to a valve leak at the tank farm. It was reported that 14.9 m³ were recovered.

13-30-053-16W5M (Northwestern Utilities Limited. –January, 1990). In 1990 a complaint was issued against Northwestern Utilities Ltd. regarding odours in the area. No further information was provided.

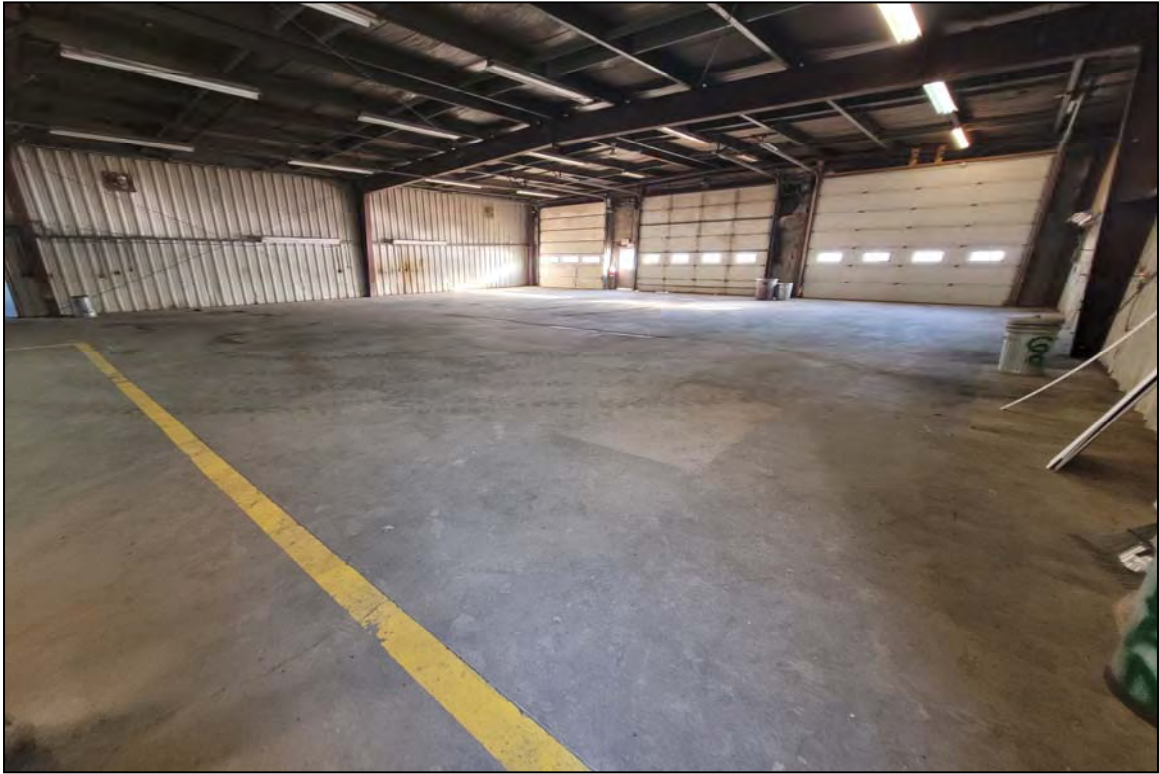
There were no underground storage tanks, with the exception of the septic system, on the subject property. Sumps were observed in main building and appeared to be in good condition.

Photograph 5: Looking at the bay in the main building (Oct-25-23).

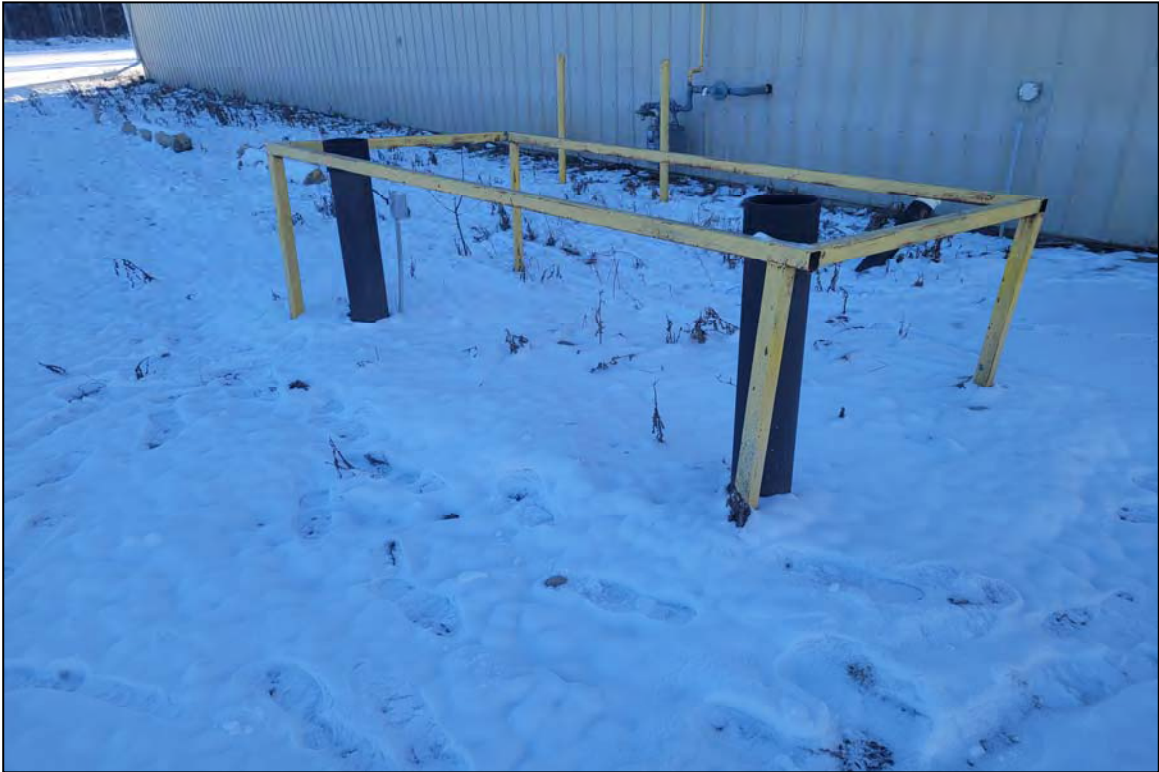
There is an underground septic system located onsite.

Photograph 9: Looking at septic system vents (Oct-25-23).

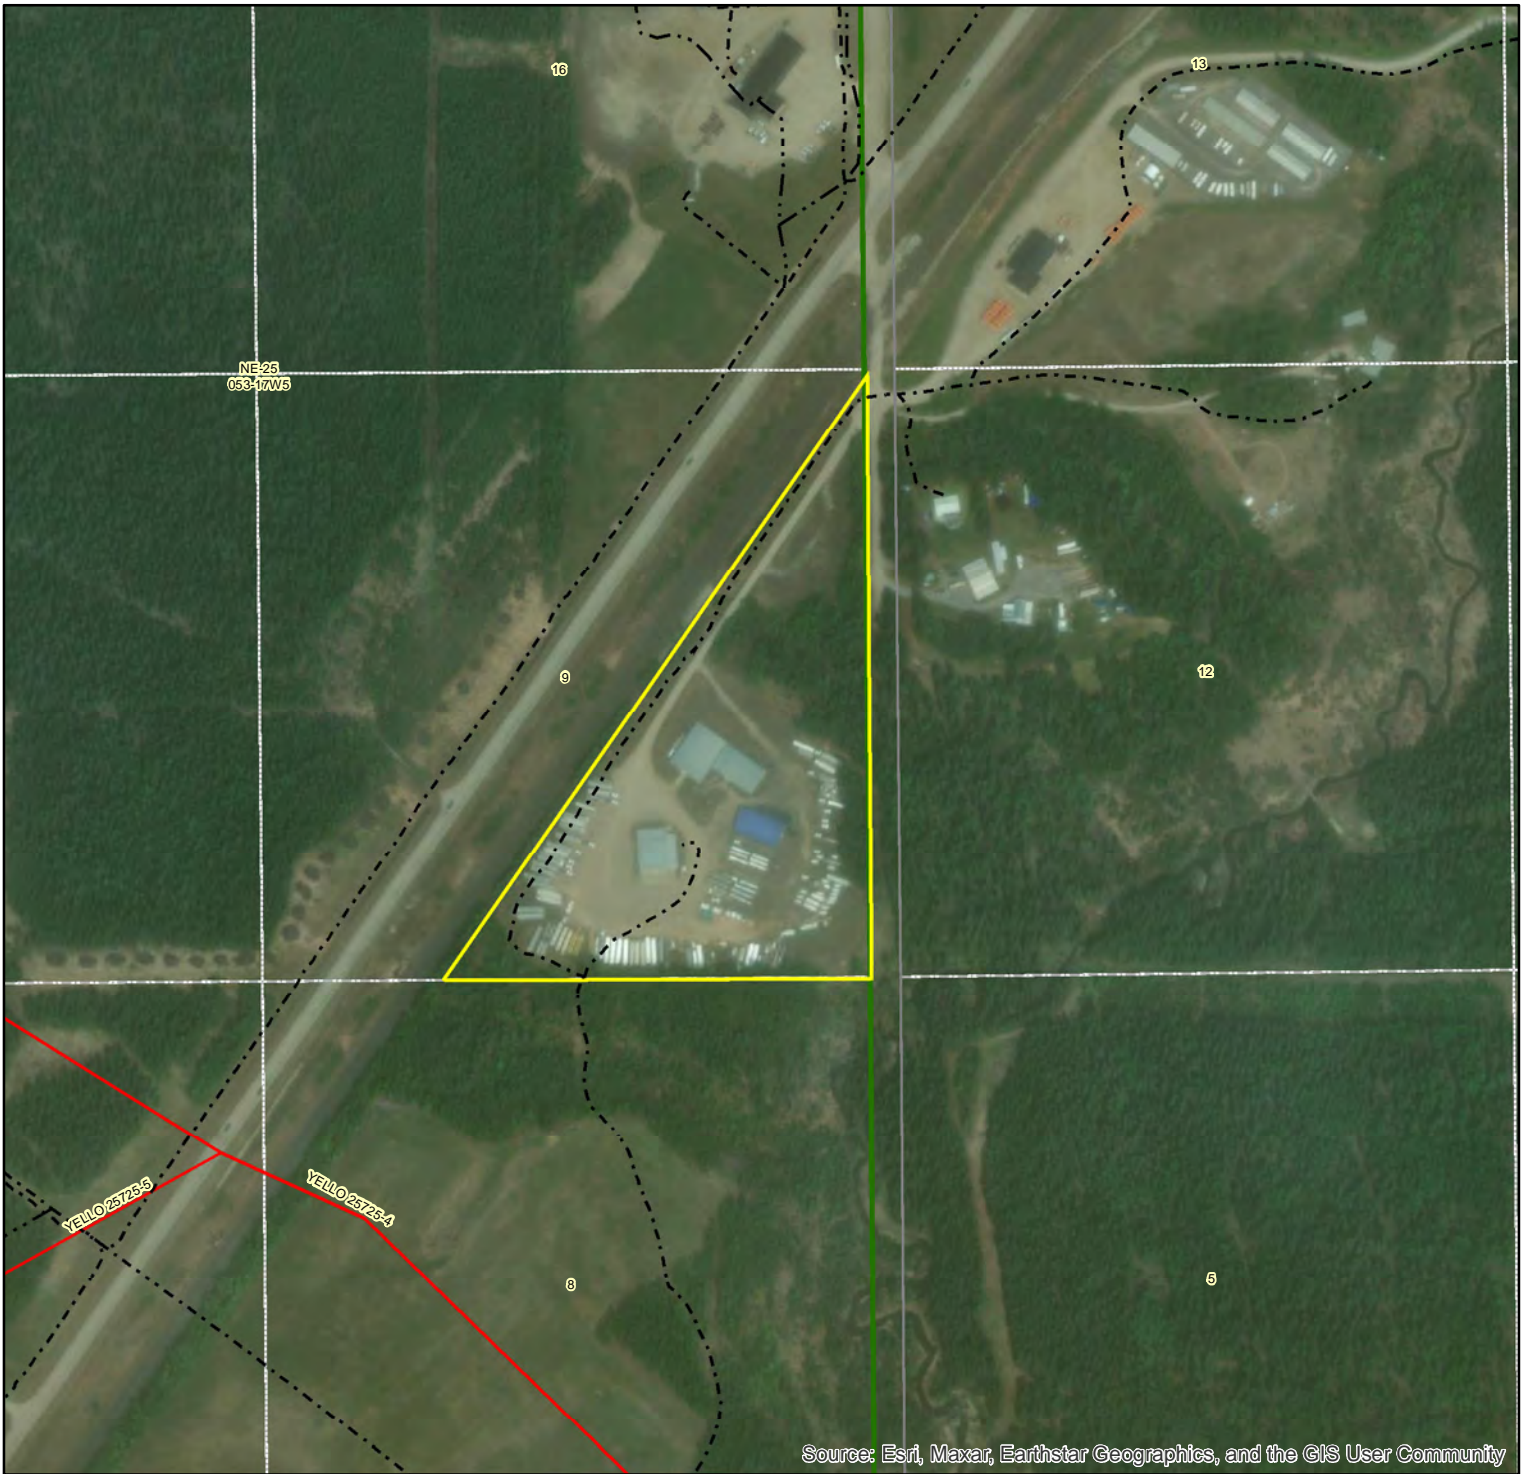
09-25-053-17W5M Pipeline Information

There are two Yellow Gas Co-Op Ltd. (Yellowhead) low pressure natural gas pipelines that traverse the property (Appendix I).
