# Phase I Environmental Site Assessment

*6340 - 47 Street, Tofield, Alberta*

CA0039477.6578

August 2024

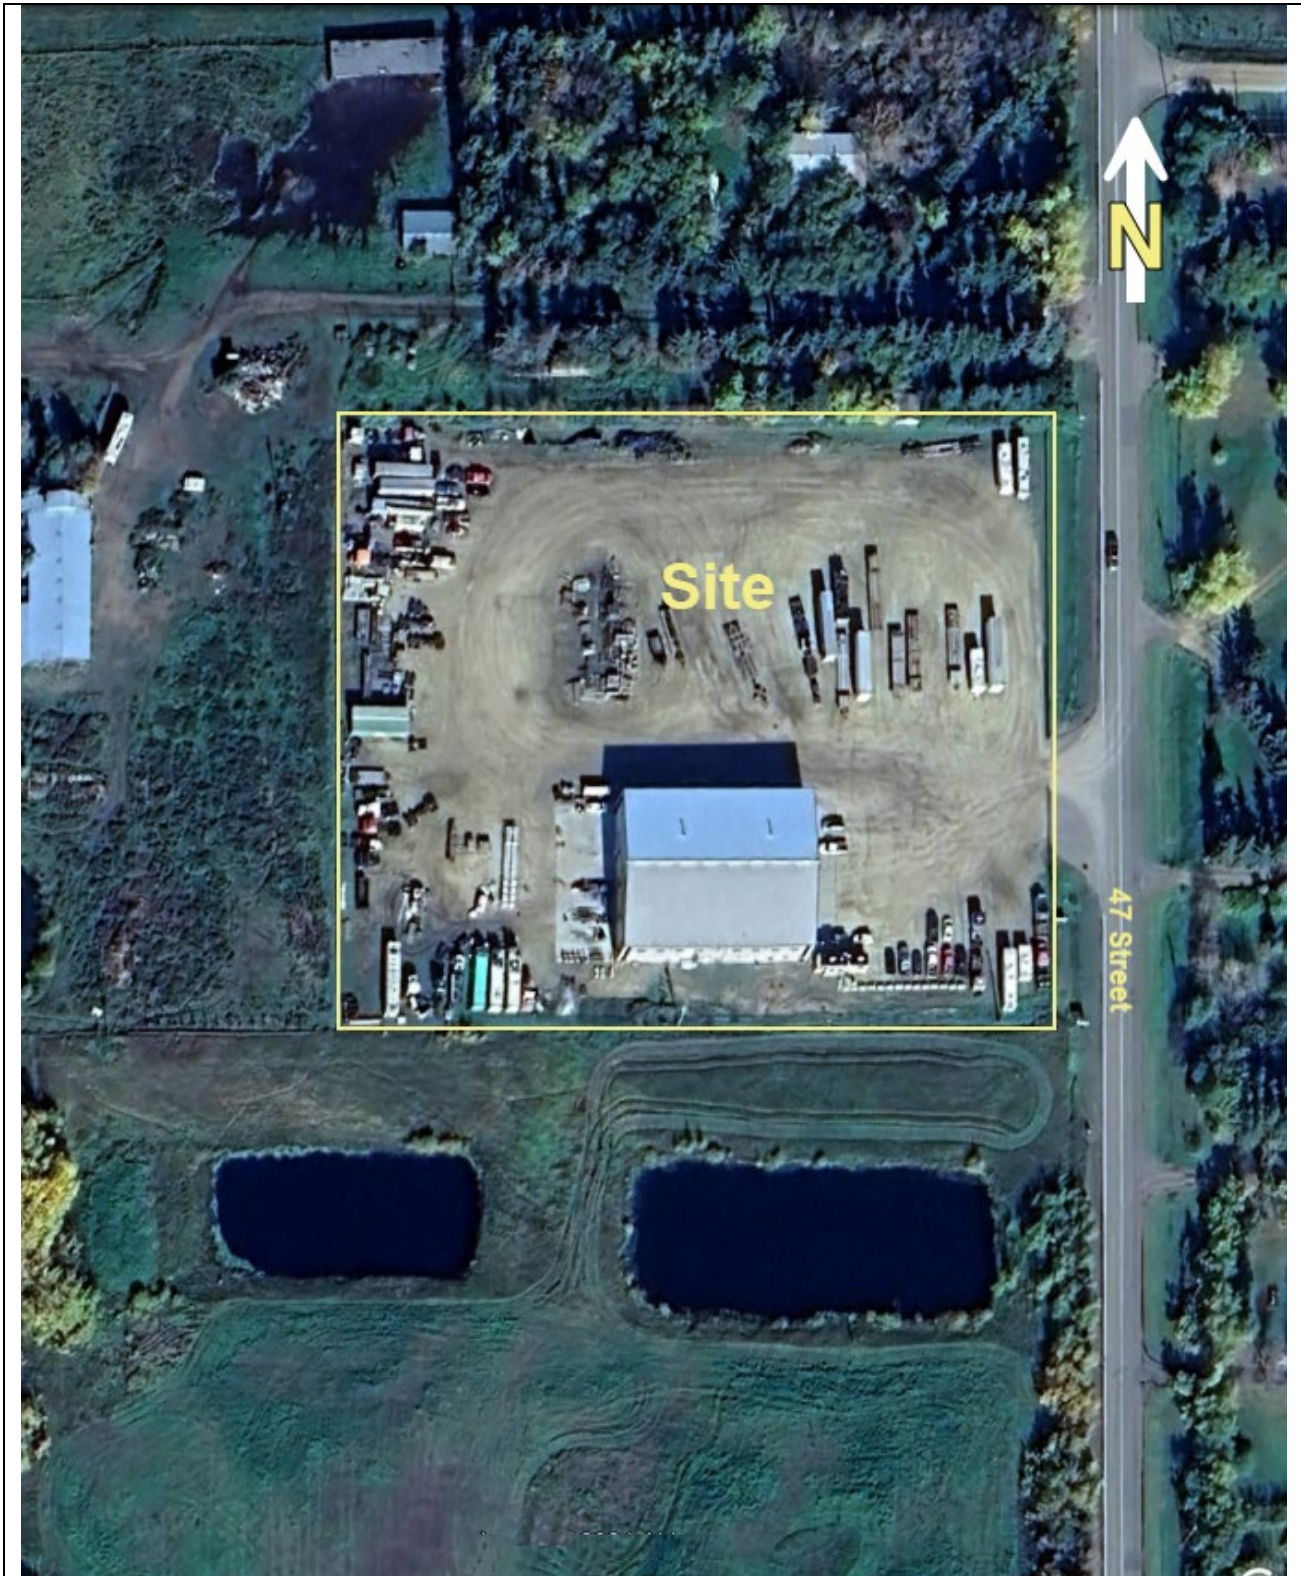
Figure 1: Site Location and Surrounding Properties  
Figure 2: Site APECs

As discussed in Section 2.2, the regional groundwater is anticipated to flow southeast. The Site and surrounding lands are illustrated on Figure 1. A summary of observations regarding surrounding land use is provided below.

Source: Google Earth® 2023 Satellite Image

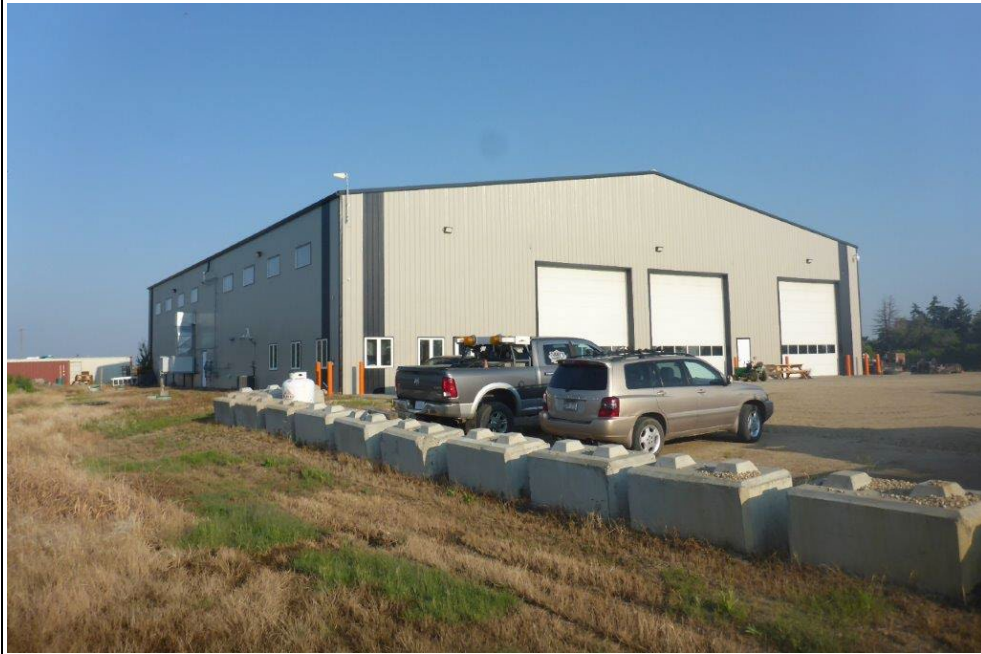
The approximately 1.94 hectares Site is zoned Urban Reserve (UR) by the Town of Tofield and is accessed from 47 Street/Highway 834 which borders the east side of the property. There is one approximately 1,330 square metres (m<sup>2</sup>) building on the southern side of the property (Photographs 1 to 9, Appendix D). This building, constructed in 2017, is a truck shop with approximately 93 m<sup>2</sup> of office space in the southeast corner. The office space includes bathrooms, a lunchroom, and a mechanical room. A mezzanine is located above the offices. There are three drive-through shop bays equipped with roll-up overhead doors. The northernmost bay is utilized to wash trucks and other equipment. A fourth bay is located on the southern side of the shop, adjacent to the western side of the offices and is accessed via an overhead roll-up door on the western side of the building.

**Photograph 1:**  
The Site building as viewed from the southeast.

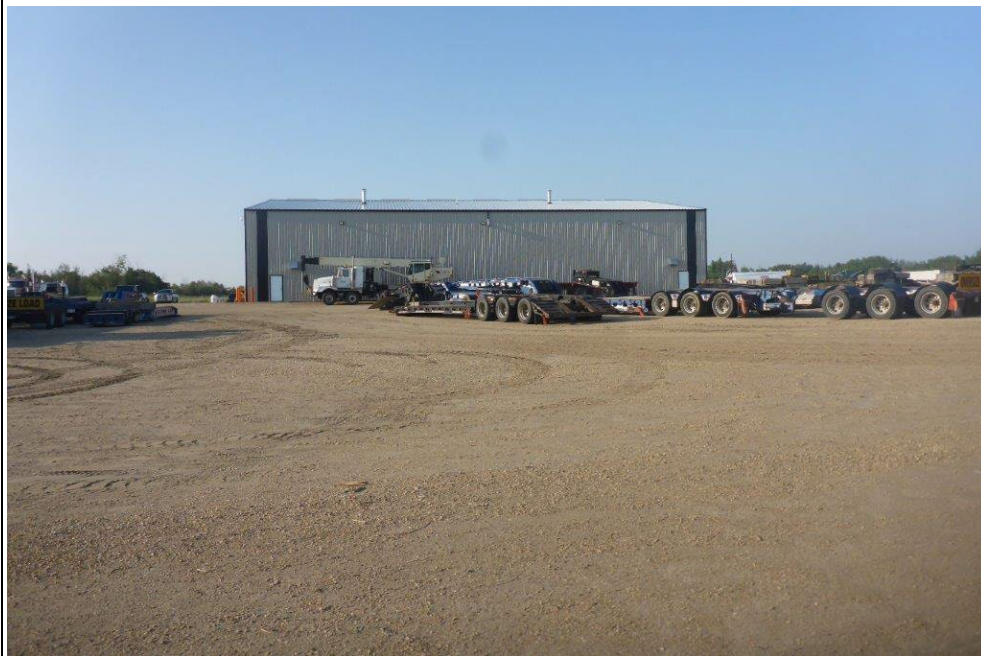
**Photograph 2:**  
The Site as viewed from the north.

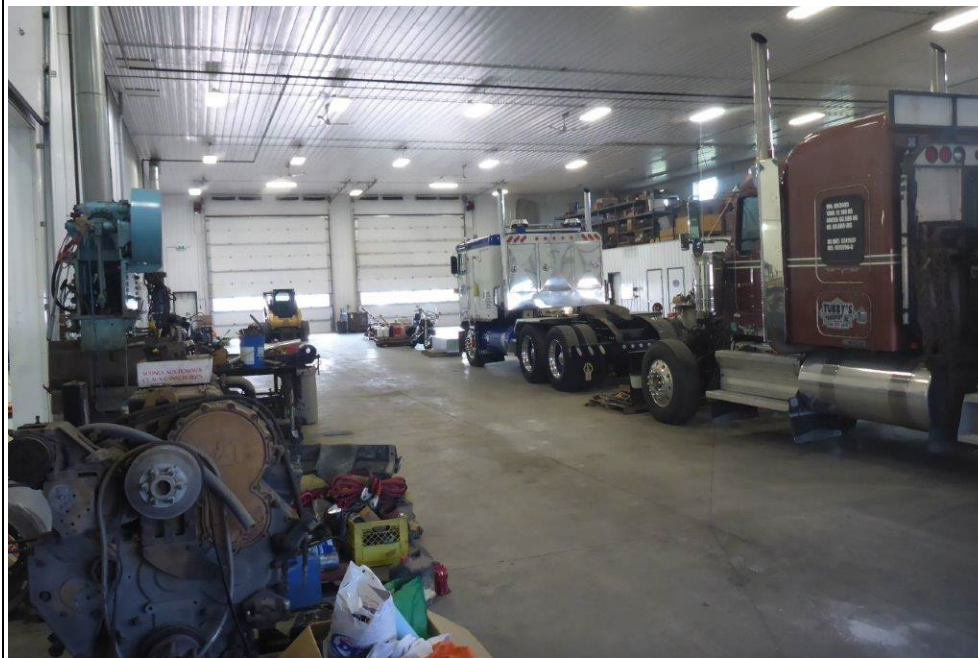
**Photograph 4:**  
Shop interior.

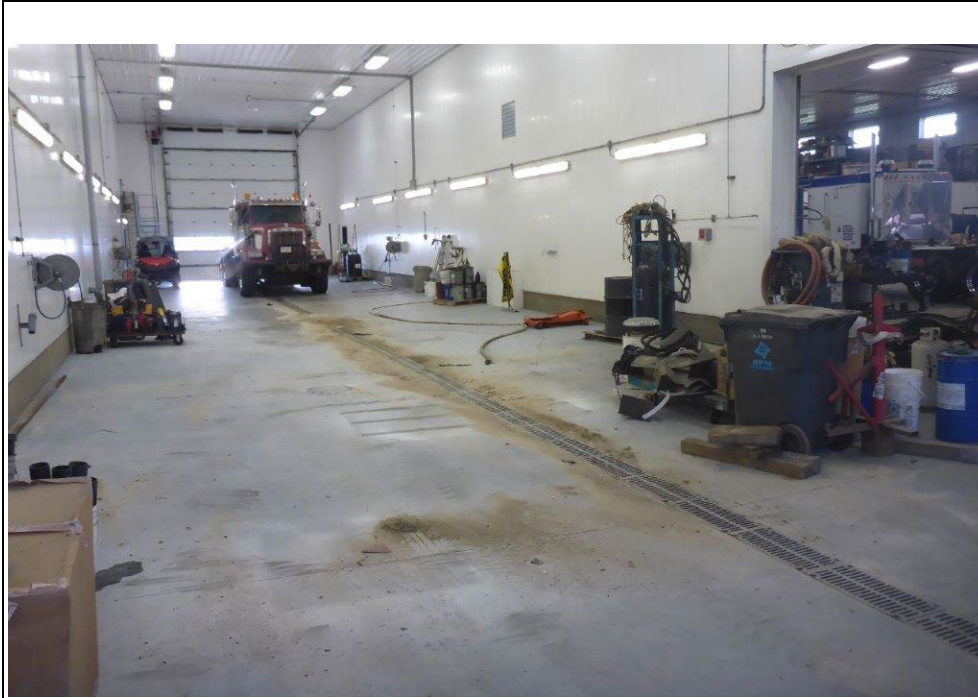
**Photograph 5:**  
Wash bay in the northernmost portion of the shop.

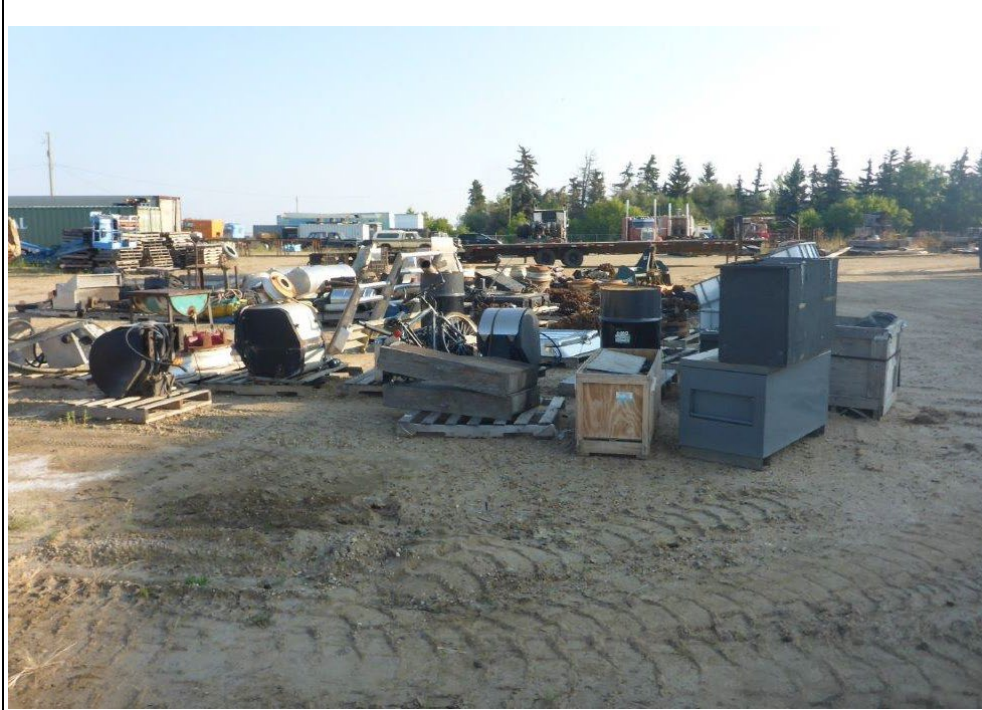
The Site is surrounded by a vegetated open drainage ditch (Photographs 6 and 7, Appendix D). According to the Site Representative, occasionally the drainage system becomes overwhelmed and requires assistance to remove standing water from the southwest corner of the Site and into the municipal surface water drainage ditch and culverts to the south of the Site. This includes a sump equipped with a submersible pump and a fire hose to discharge water to the south of the property (Photographs 8 and 35, Appendix D). The submersible pump is gasoline powered and portable fuel containers were observed on the wooden rig mats (Photograph 8, Appendix D). As a best practice, the pump and fuel containers should be provided with secondary containment or spill protection.

**Photograph 7:**  
Equipment storage on  
the western portion of  
the Site.

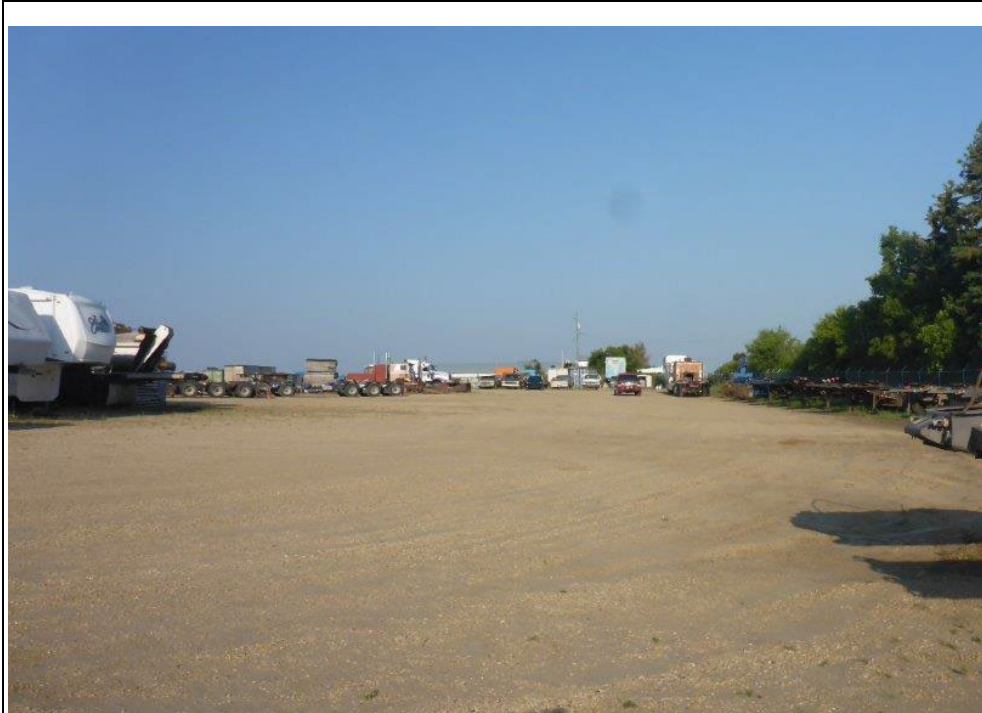
**Photograph 8:**  
Northern portion of  
Site.

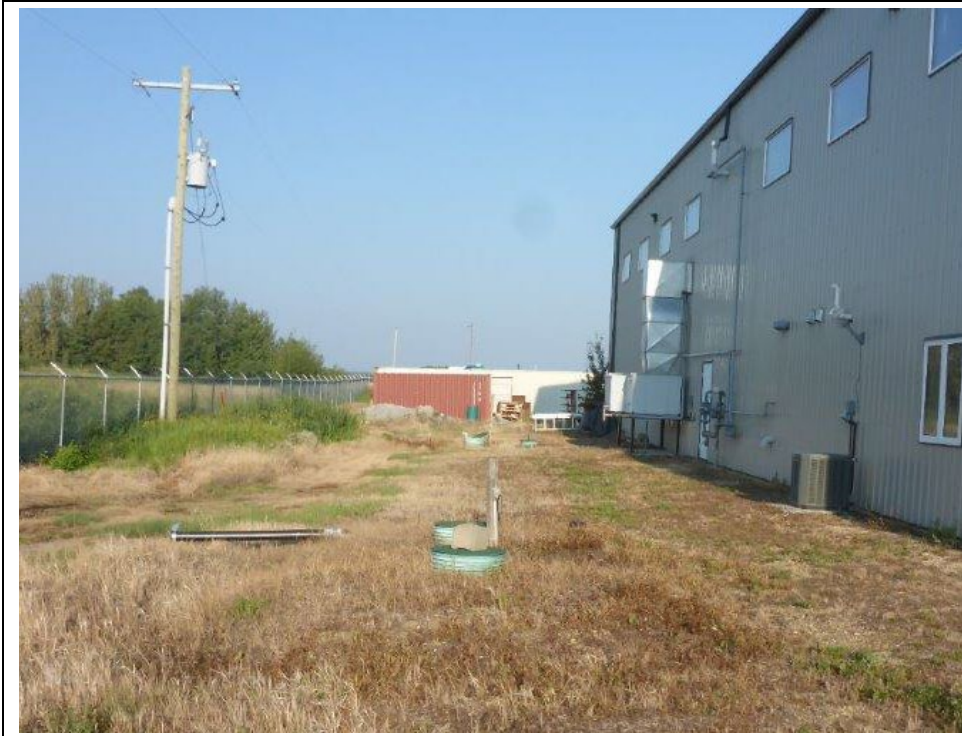
**Photograph 9:**  
Southern portion of the Site showing infrastructure associated with a well (foreground) and septic tank (background). An approximately 15,000 L underground storage tank located in this area collects rainwater from the building roof for use in the wash bay.

Potable water for the Site is obtained from a well located to the south of the building (Photograph 9, Appendix D). An open well was observed on the north side of the Site (Photograph 10, Appendix D). The Site Representative indicated that this well was present prior to their purchase of the Site and has not been used since their occupancy. There was no evidence (protective risers/casings, piping, or pumps) of other wells identified on the Site at the time of the viewing. The Site Representative was not aware of environmental or geotechnical monitoring well investigations completed on-site.

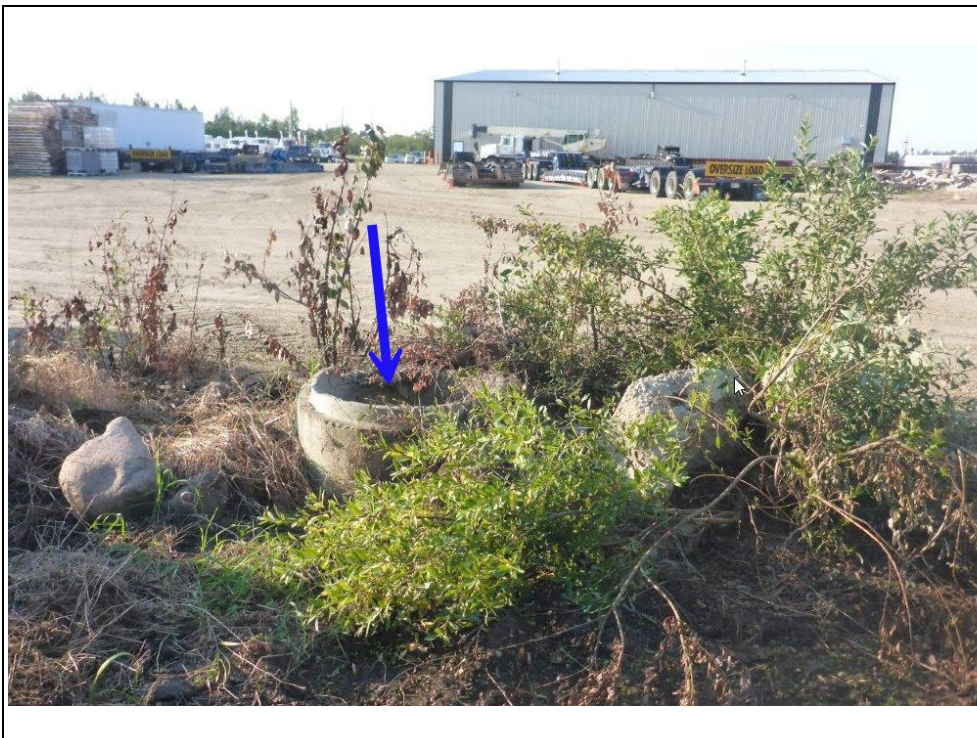
**Photograph 10:**  
The Site Representative indicated that this well, located near the north side of the Site, is not being used.

An open well was observed on the north side of the Site and, according to the Site Representative has not been used since their occupancy. Any wells identified on the Site and not intended for further use should be abandoned in accordance with *Alberta Regulation 205/98* which outlines requirements for disinfecting and sealing of wells.

The well present on the north side of the Site was observed at this time (in 2015). WSP recommended that any groundwater wells identified on the Site and not intended for future use should be reclaimed in accordance with *Alberta Regulation 205/98* which outlines requirements for disinfecting and sealing of wells as part of the reclamation.

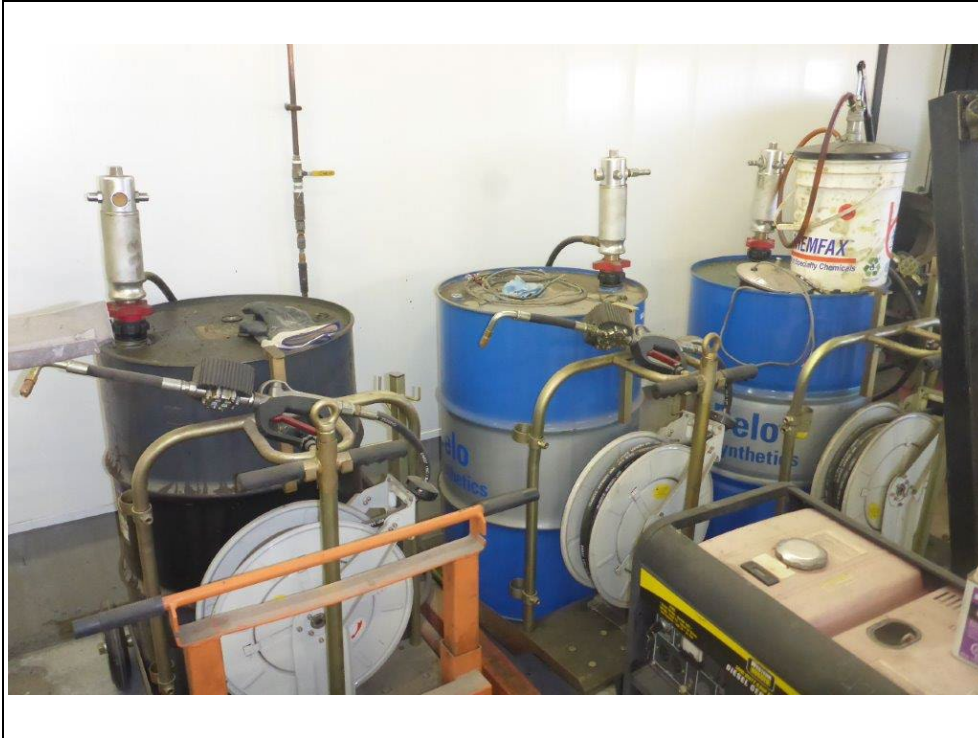
**Photograph 11:**  
Drums of lubricant used for servicing vehicles stored inside the shop.

Industrial chemicals used for the maintenance and operation of the transport trailers and equipment were observed inside the shop in containers ranging in capacity from less than 1 litre (L) to 205 L (Photographs 11 to 13, Appendix D). Chemicals observed on Site include lubricants, coolants, paints, solvents, de-icing fluid, sealants, fuel treatment, brake fluid, detergents, degreasers and roofing tar. Most of the chemicals on the Site consisted of lubricants. WSP observed four 205 L drums, 10 20-L containers and approximately 20 5-L containers of oil inside the shop. Five 20 L containers of motor oil were observed on the northwest corner of the Site. A 205 L drum of water-based degreaser and a 205 L drum of rig wash were also observed inside a shop. At the time of the visual inspection, many of the chemicals were being sorted for an upcoming auction and were temporarily being stored directly on the concrete floor. No staining or other evidence of spills or leaks was observed on the concrete floor or ground surface in the vicinity of the chemicals stored on the Site.

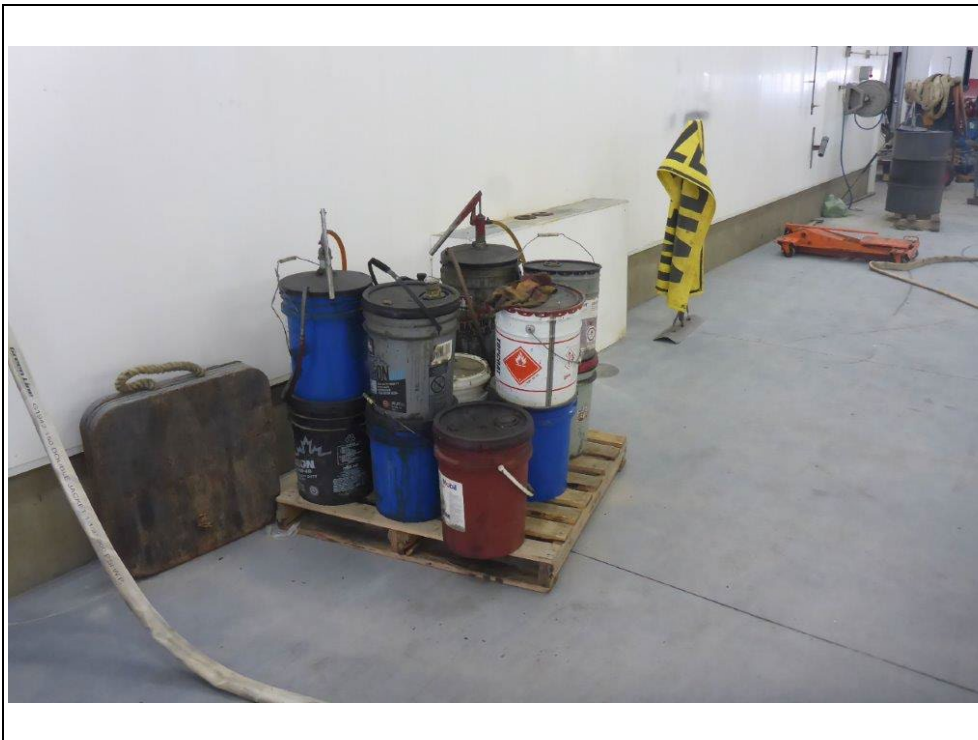
**Photograph 12:**  
Oils and solvent stored inside the shop in containers having capacities of 20 L.

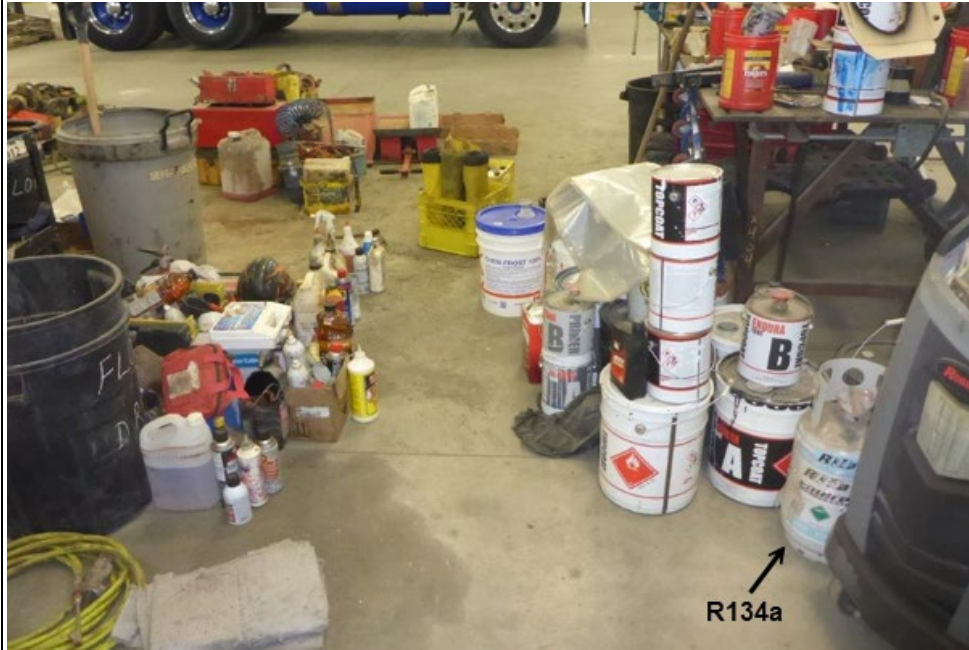
**Photograph 13:** Various containers of oil, solvent, and paint stored on the floor on the south side of the shop. Chemicals were being staged as part of cleanup activities in preparation for an upcoming auction. A canister of R134a is partially visible on the right.

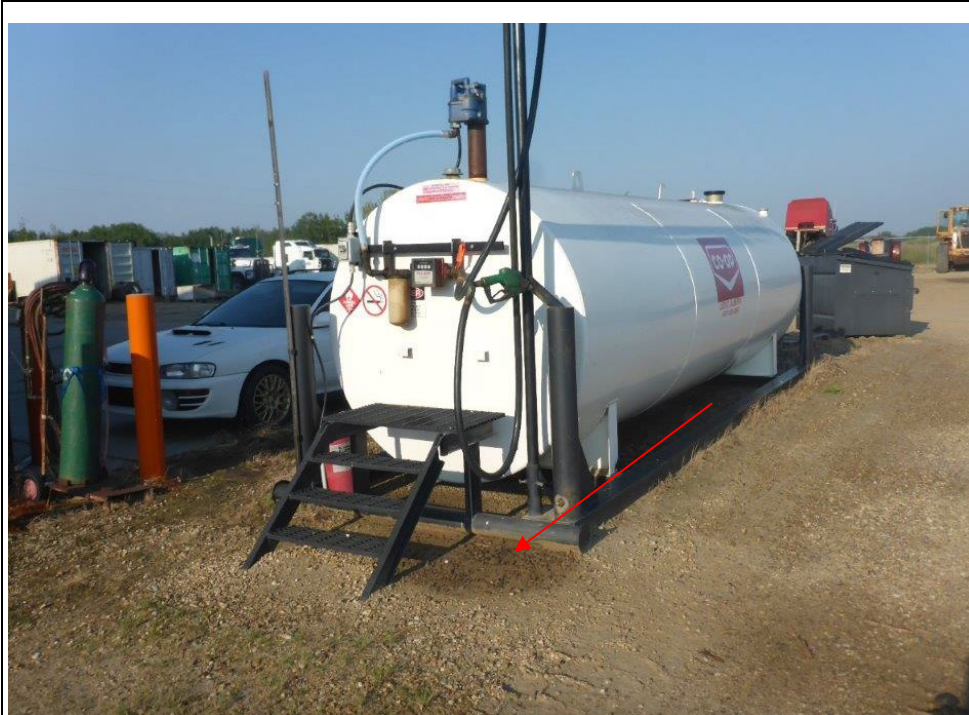
Two ASTs were observed on the Site. The largest AST, having a capacity of 13,000 L, is a double-walled steel tank that contains diesel fuel (Photograph 14, Appendix D). An approximately 1 m<sup>2</sup> stain was observed on the ground surface near the fill point of this AST. ASCA had no records for this AST. The National Fire Code (Alberta Edition) outlines the requirements for registering ASTs containing flammable or combustible liquids and having capacities of 2,500 L or more. A 1,140 L bench tank inside the shop is used for the storage of lubricant (Photograph 15, Appendix D). According to the affixed label, this is a single walled steel tank that was manufactured in 2024. No staining was observed on the concrete floor in the vicinity of the bench tank. An empty 300 L slip tank was observed on the concrete apron on the west side of the building. The Site Representative indicated that this tank is only intended for vehicles travelling to work locations and it is not used on the Site. No other ASTs were observed on the Site. No evidence of USTs was observed by WSP at the time of the Site visit.

**Photograph 14:** This 13,000 L double-walled steel AST is located adjacent to the northwest corner of the Site and contains diesel fuel. An approximately 1 m<sup>2</sup> stain is visible near the fill point beside this AST.

The stained soils in the vicinity of the diesel fuel AST should be removed following ground disturbance protocols and disposed at a facility approved to accept this material.

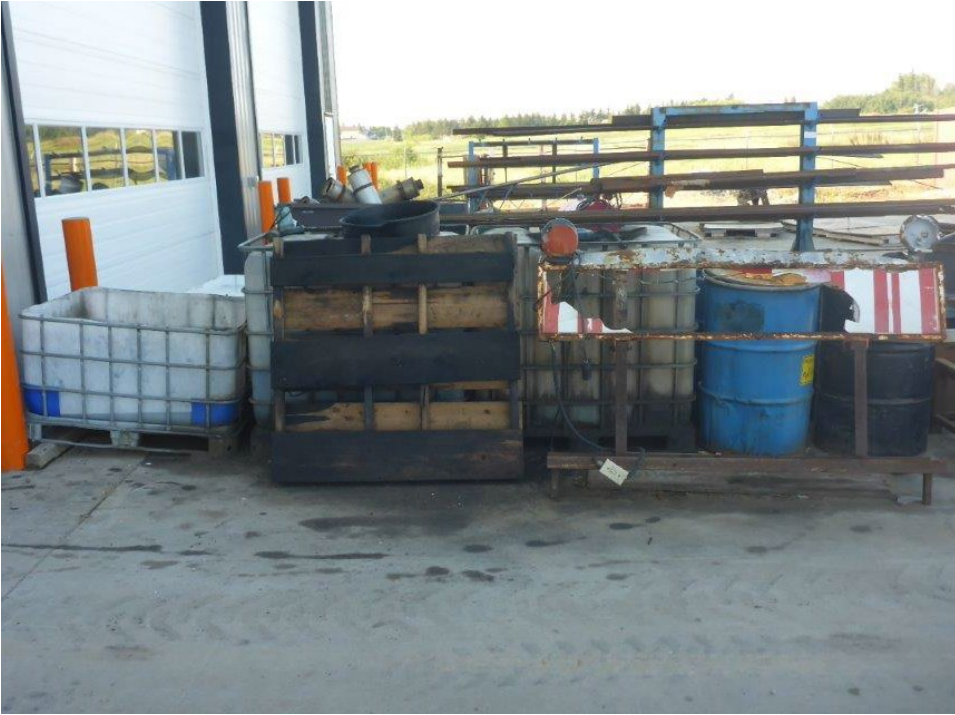
Waste oil generated from vehicle maintenance on the Site is collected in two 1,000 L intermediate bulk containers (IBCs) located on the concrete apron adjacent to the west side of the building (Photographs 15 and 16, Appendix D). Spent oil filters, oily rags, and empty oil containers are collected in steel drums located beside the IBCs. Approximately 10 m<sup>2</sup> of staining was observed on the concrete pad in this area. However, the concrete pad appeared to be in good condition with no cracking or other damage that could act as conduits for released liquids to migrate beneath the slab. The waste oil, oily rags, and spent oil filters are recycled or disposed through Pat's Off-Road Transport.

An approximately 10 m<sup>2</sup> of staining was observed on the concrete pad in area of the waste oil IBCs and drums of oily wastes. However, the concrete pad appeared to be in good condition with no cracking or other damage that could act as conduits for released liquids to migrate beneath the slab. Smaller stains, generally less than 1 m<sup>2</sup> and associated with vehicle drippings or minor spillages were observed on the concrete floor inside the shop and on the gravel-surfaced yard.

**Photograph 15:**  
Waste oil generated from vehicle maintenance is collected in two IBCs located on the concrete pad outside the west side of the building. Drums used for the collection of oily rags, spent oil filters and emptied oil containers were also present in this area. Staining was visible on the concrete pad in this area.

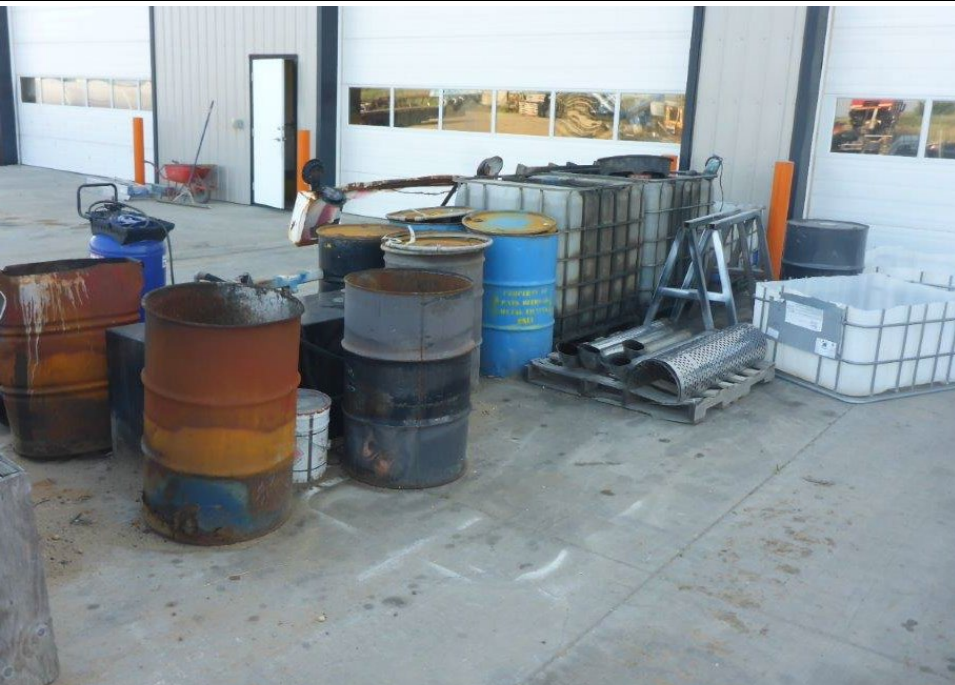
Metal wastes are collected in bins and are transported to metal recycling facilities by the Site occupants. Paper wastes, primarily generated by the office, are burned in a barrel on the concrete apron adjacent to the west side of the building. The ash from the burn barrel is transferred to a bin for eventual off-Site disposal. The Site Representative indicated that the property was being cleaned up for an auction and materials deemed as unfit to be sold or kept were being collected in bins for eventual disposal. The remaining solid wastes generated on the Site are collected in a bin and picked up by the Town of Tofield twice weekly for disposal.

**Photograph 16:**  
The waste oil IBCs and drums used for the collection of oily rags, spent oil filters and emptied oil containers. One of the drums in the foreground contained ash from burned paper wastes.
