Home Inspection Report

38201 JONES ROAD (house)

Mission, BC V0M1H0

Inspected on Tue, Apr 23 2024 at 12:00

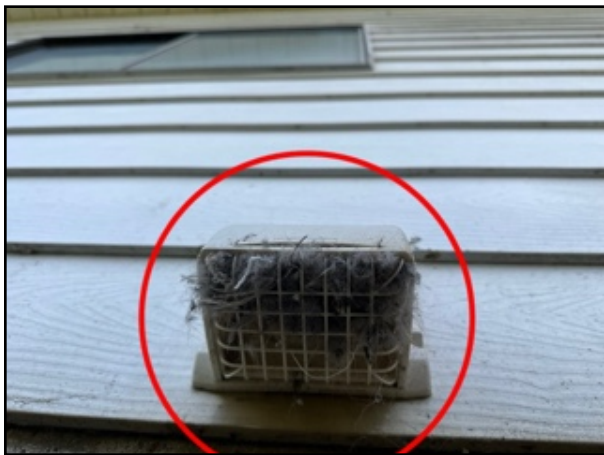
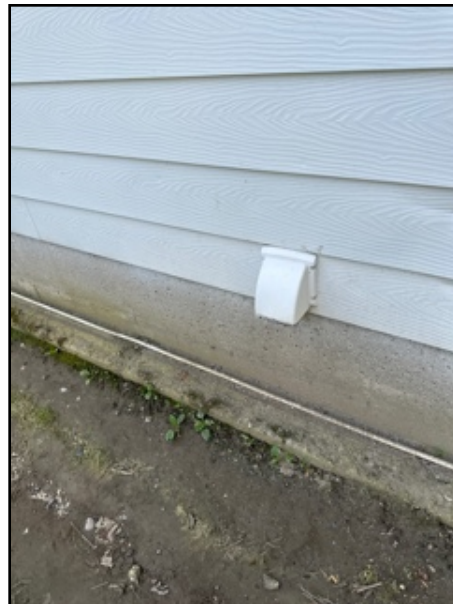
Routine maintenance includes keeping exterior air intake vent and dryer vents cleaned.

Located on the outside and around of the house.

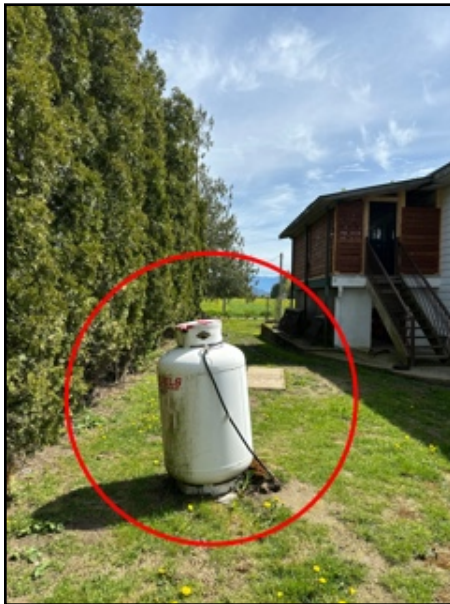
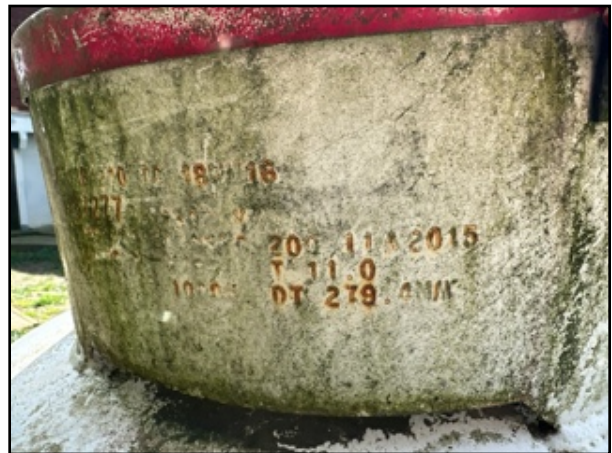
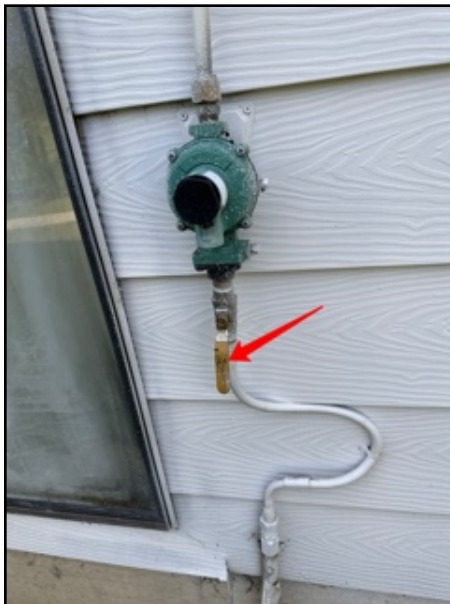
Propane tank reservoirs need to be recertified following their manufacturing date every 5-10 yrs.

For added safety, consider securing this tanks to the ground for seismic stability.

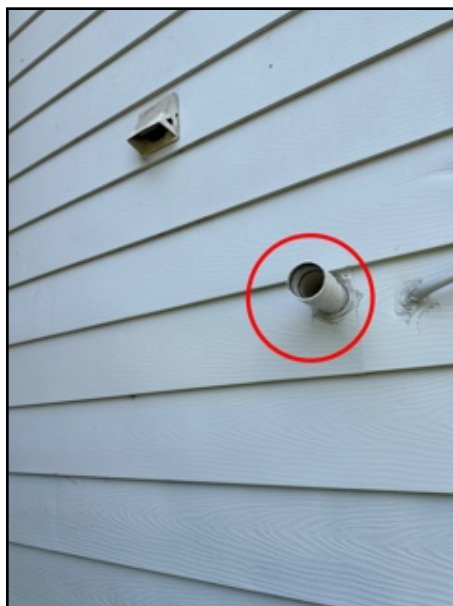
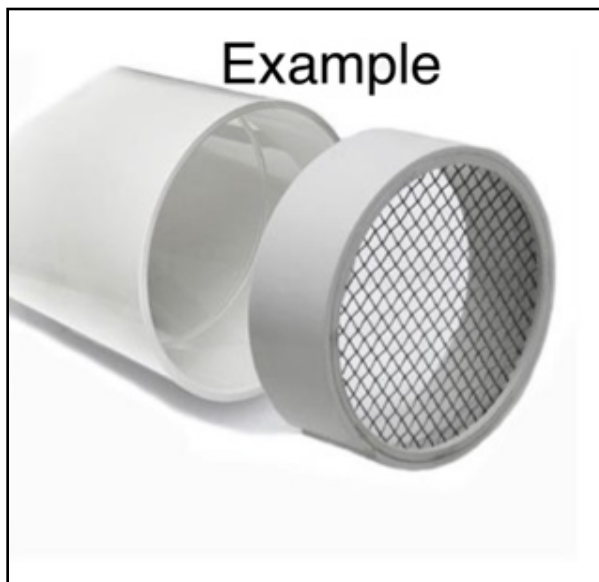
i **Comment 15:**
Install a vent screen cover on furnace exhaust pipe to prevent vermin entry.

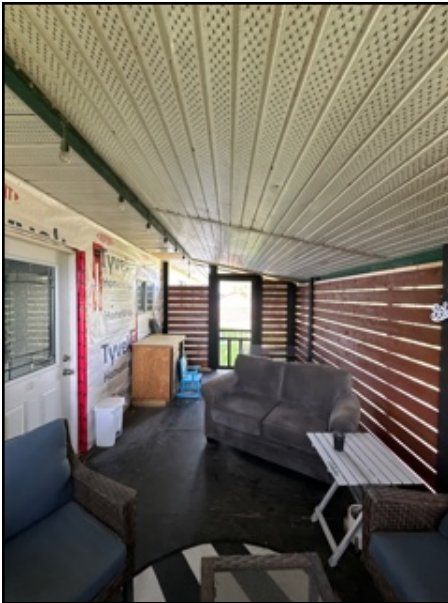
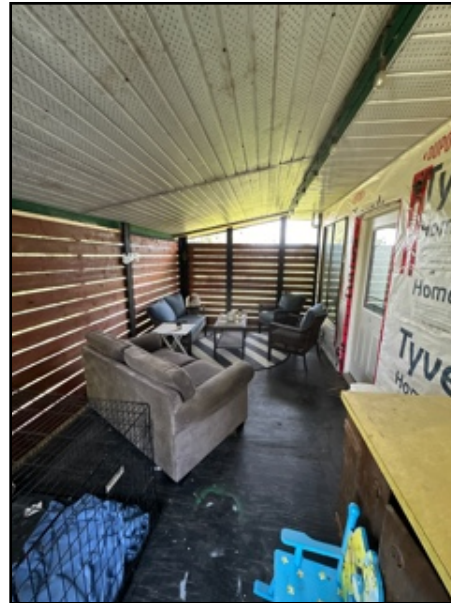
Comment 16:
Deck observations.

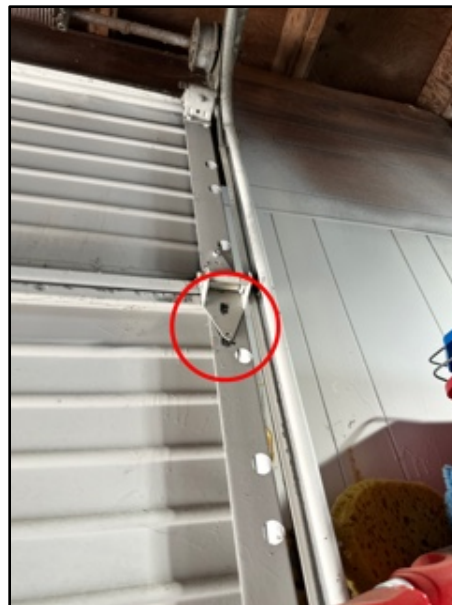
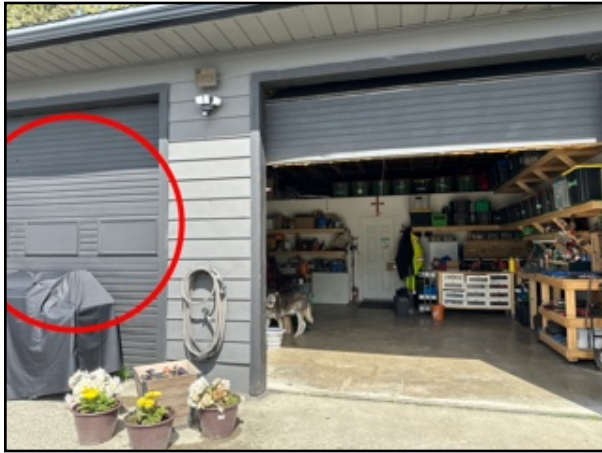
Denting noted on door panels. Loose rollers are also noted which need repairs.

West door is not able to open due to broken rollers. Anticipate repairs.

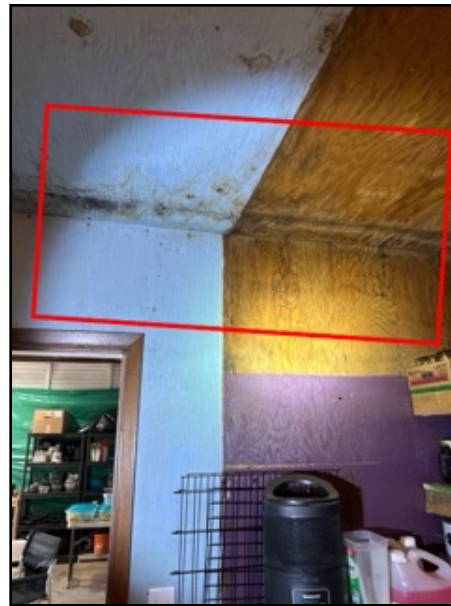
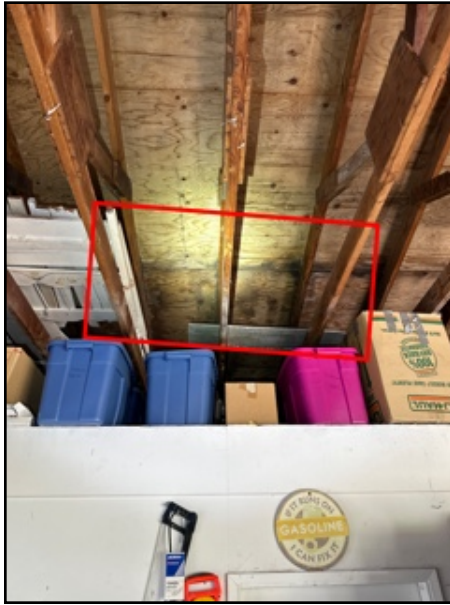
There is water staining observed on the addition garage sheathing at several locations. I cannot confirm if this is still an active leak. Further evaluation is needed by a roofing contractor to ensure that this is not due to an active leak.

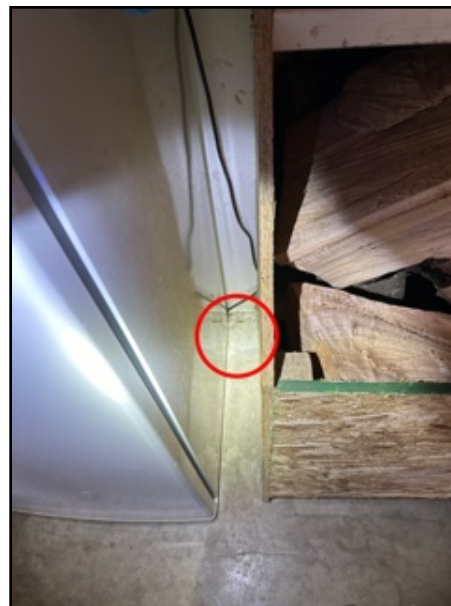
There are rodent droppings observed in the garage. Set traps as a precautionary measure and seal all gaps and penetrations from the exterior. Alternatively, consult a pest exterminator for remediation.

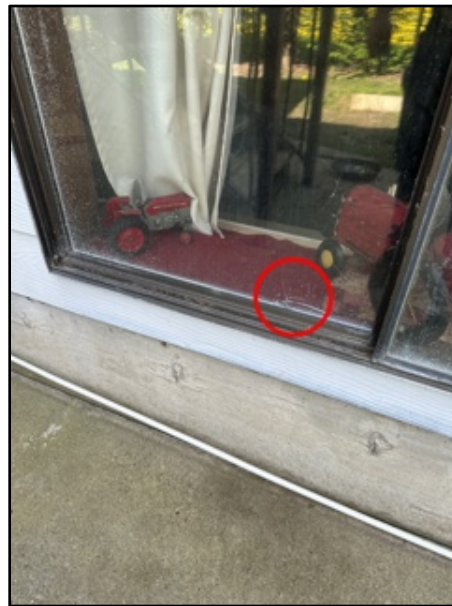
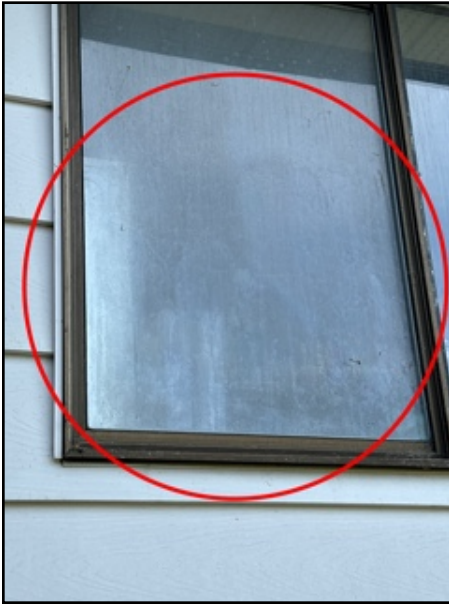
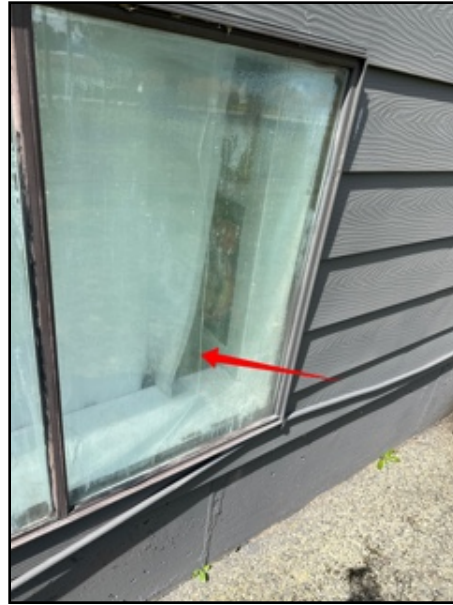
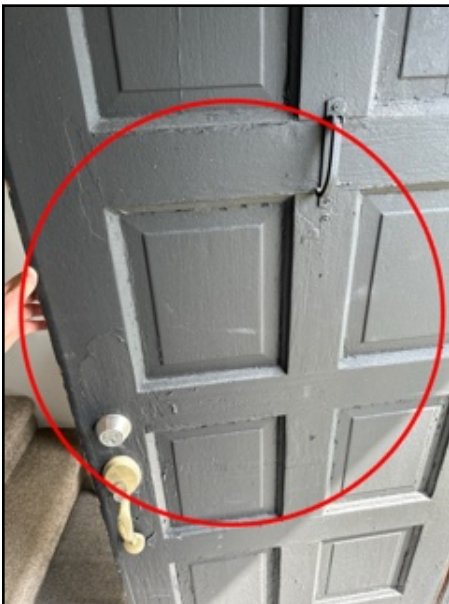
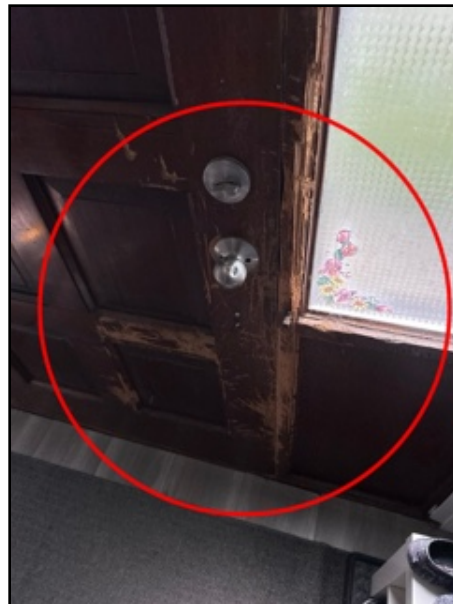
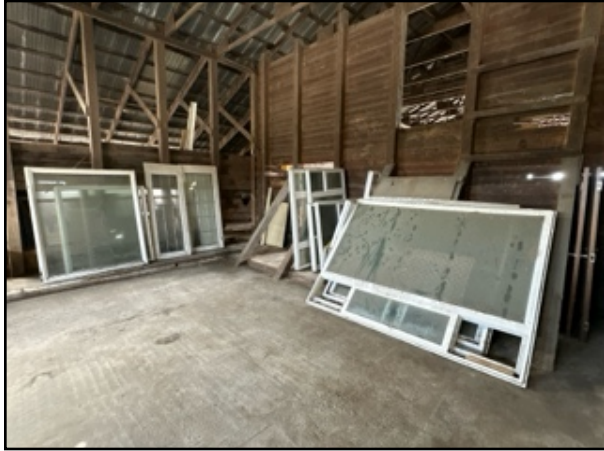
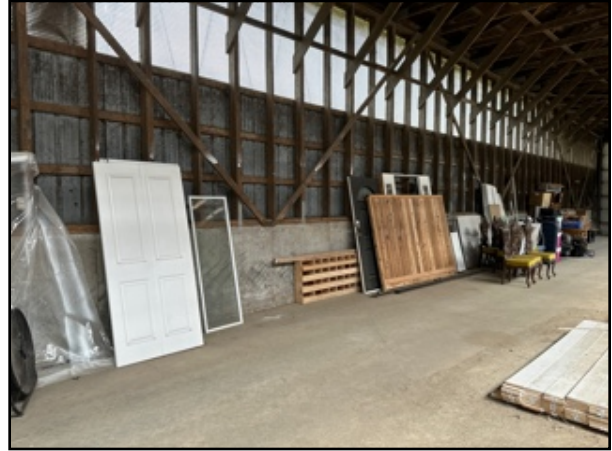
The windows around the home have failed seals, cracking, and mechanical damage observed. The front door is also damaged.

Materials for replacements were observed in the barn. Anticipate repairs and replacements.

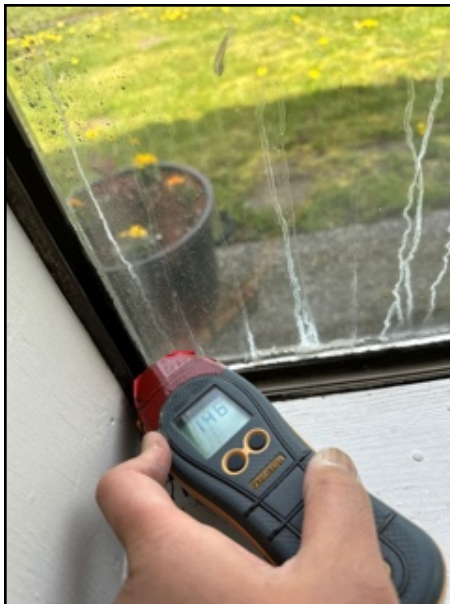
Figure 25-1

Comment 25:
Moisture test for leaky windows at all areas resulted in dry meter reading.

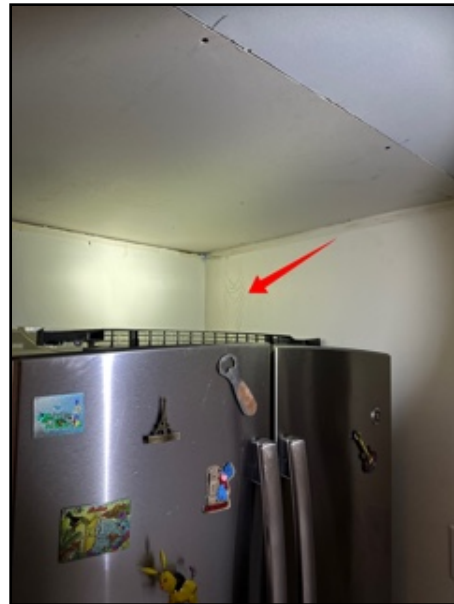
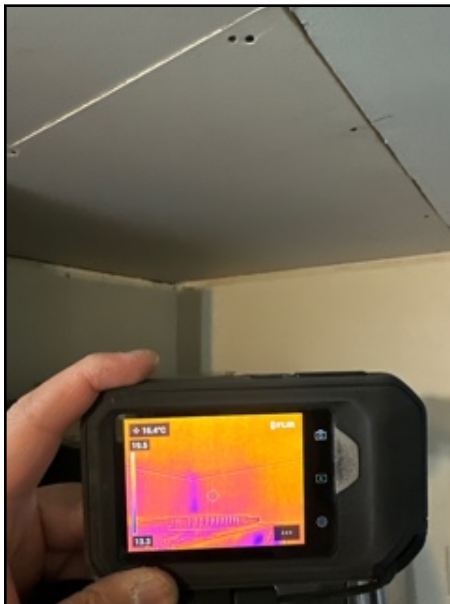
No moisture levels recorded on water damaged drywall in the basement kitchen. It is recommended to contact current owner on further information on possible repairs made.

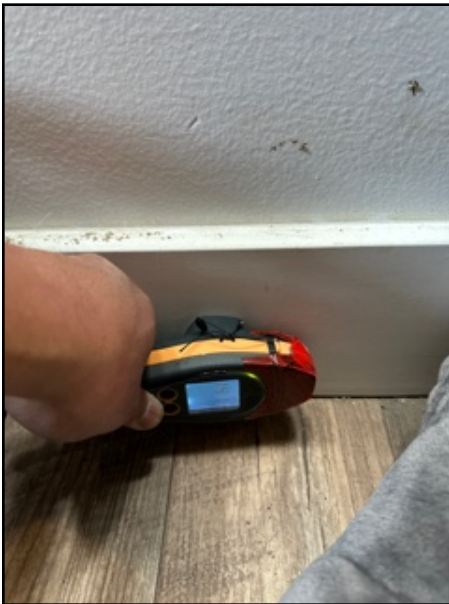
Figure 29-1

Comment 29:
Sample testing for moisture around basement was negative for moisture.

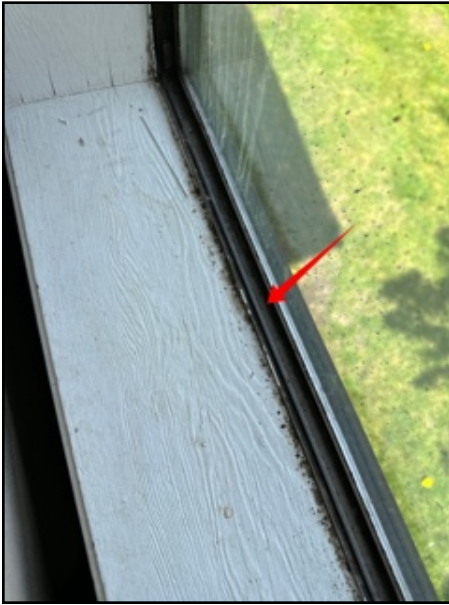
Figure 30-1

Comment 30:
Organic growth around the windows is a sign of high humidity and moisture. Running exhaust fans while showering and cooking is advised. Clean organic growth off windows and control moisture in home. Further evaluation is needed if organic growth returns.

Ensure to also open window blinds to allow for air circulation in this space.

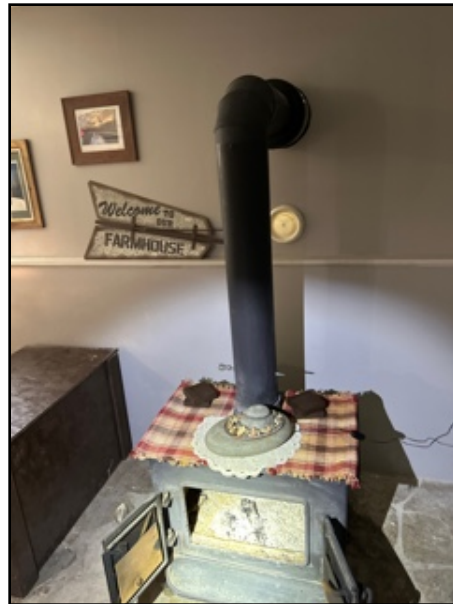
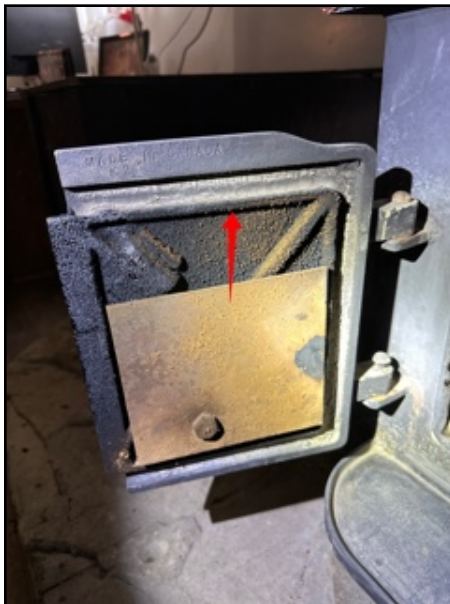
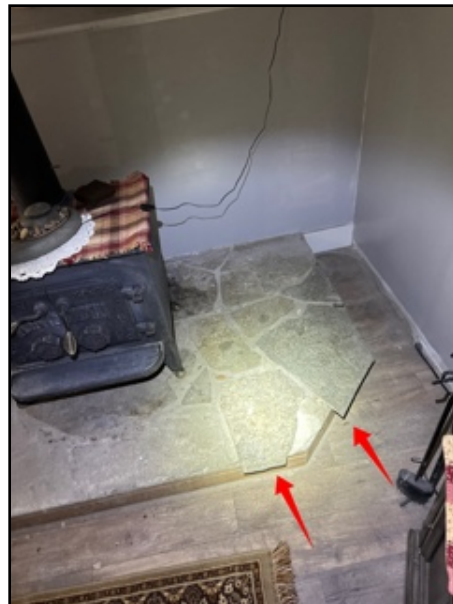
Damaged tiles for the stove hearth will need to be repaired. The door is also missing a seal.

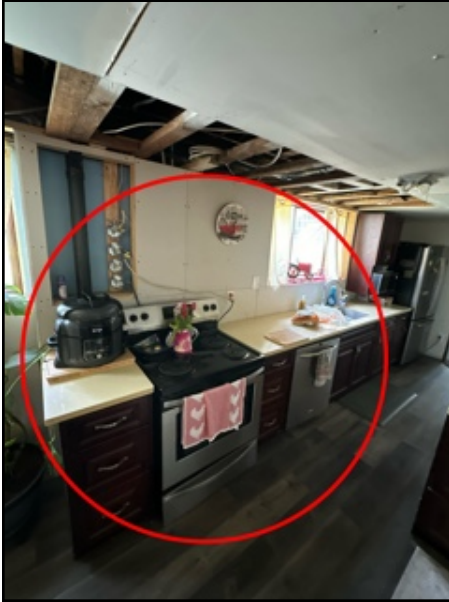
Figure 34-1

Basement kitchen appliances were not tested due to them not being hooked up. This was a limitation to the inspection.

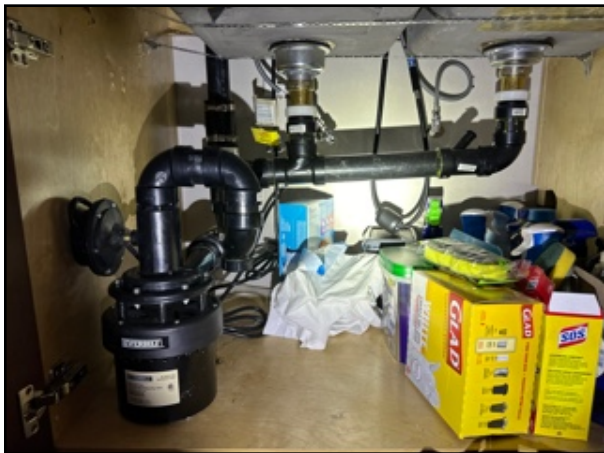
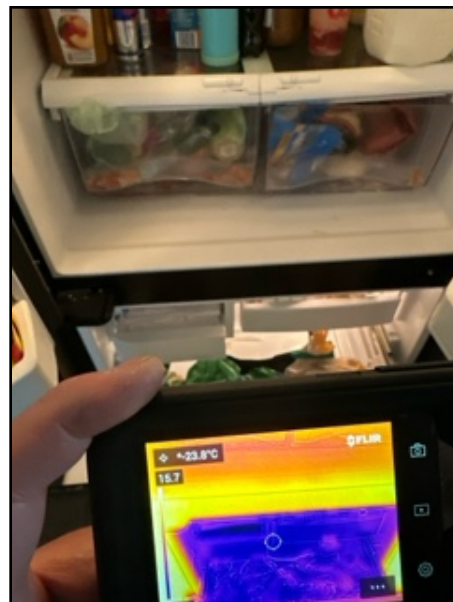
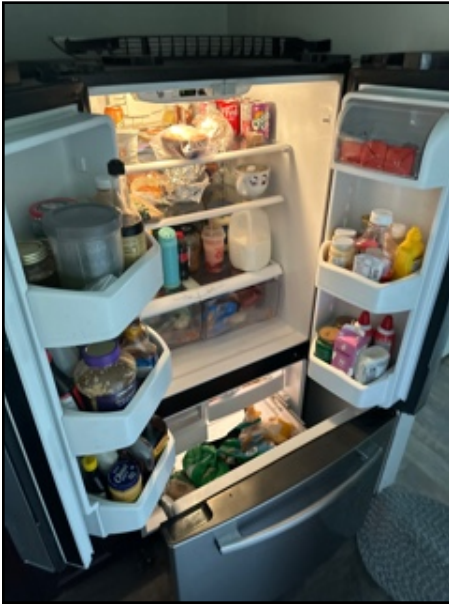
Basement kitchen appliances that were currently functioning is only the fridge. Overall serviceable condition.

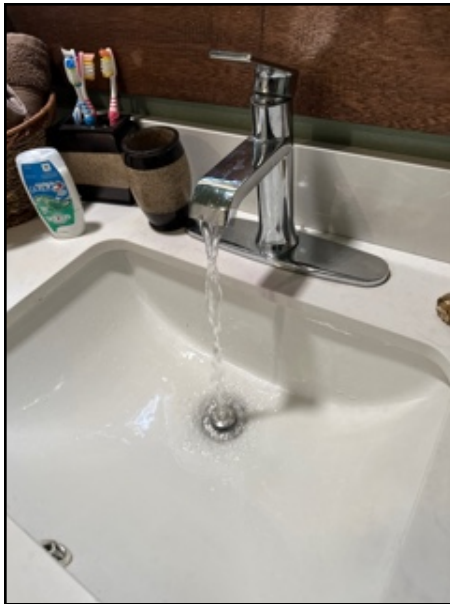
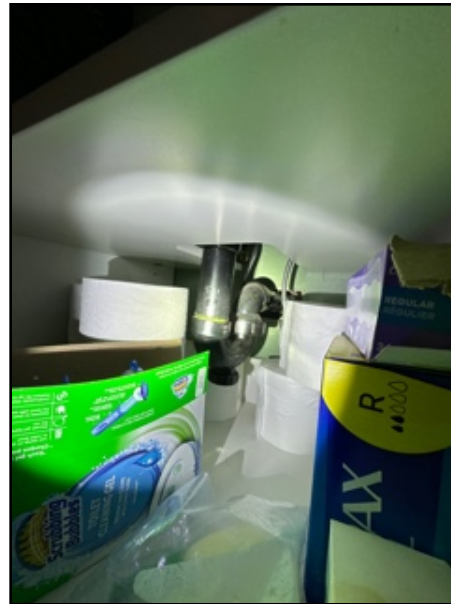
Basement bathroom observations.

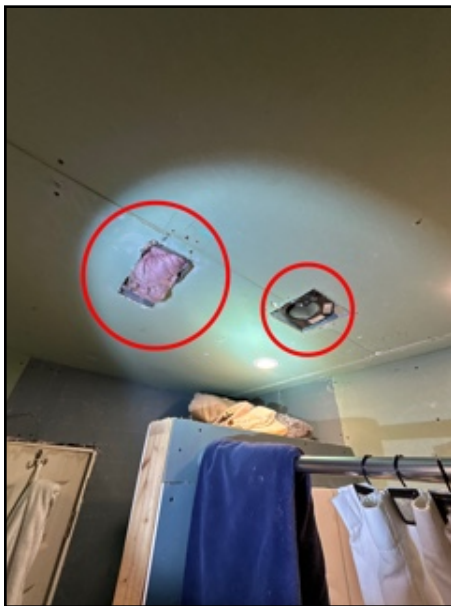
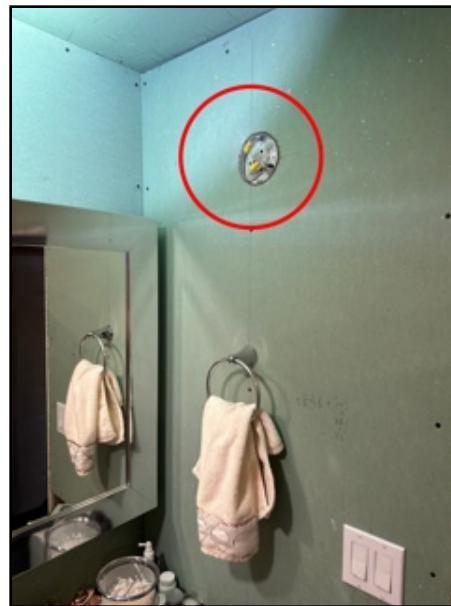
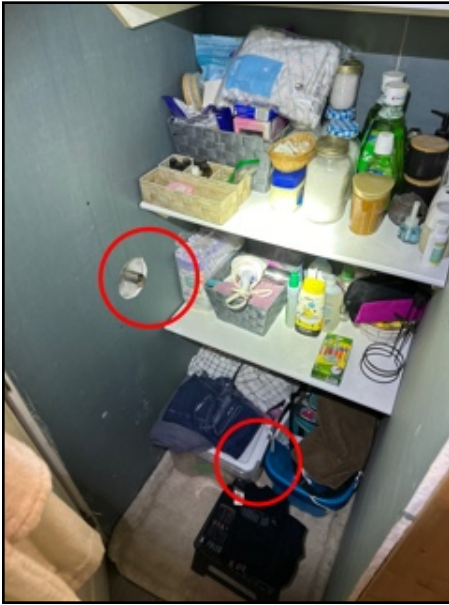
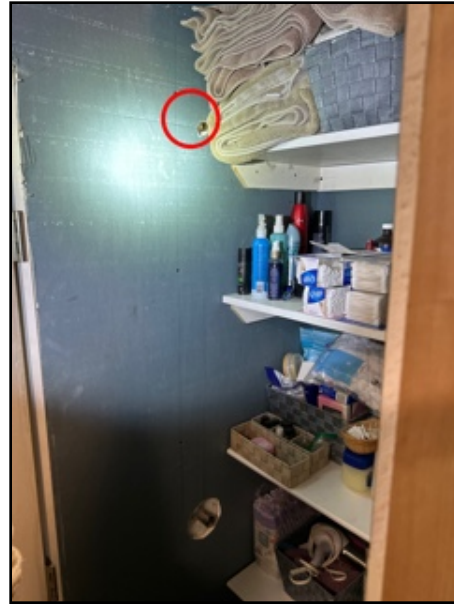
The heat register has been covered with insulation, the bathroom fan is missing a cover, and the shower stall is unfinished. Anticipate repairs.

Drywall also requires finishing and paint.

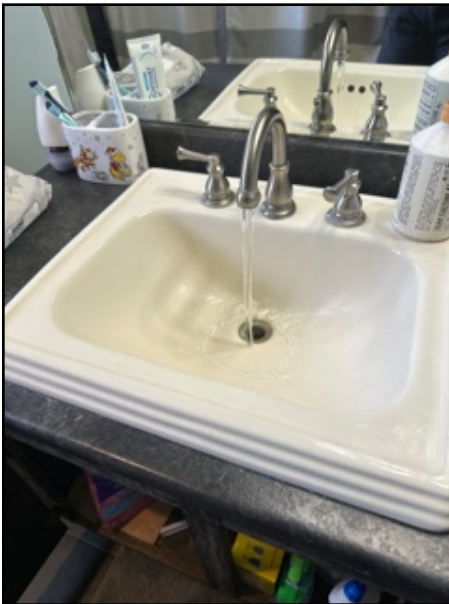
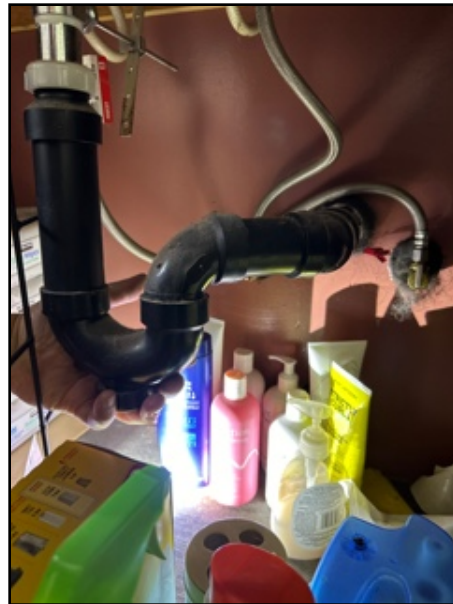
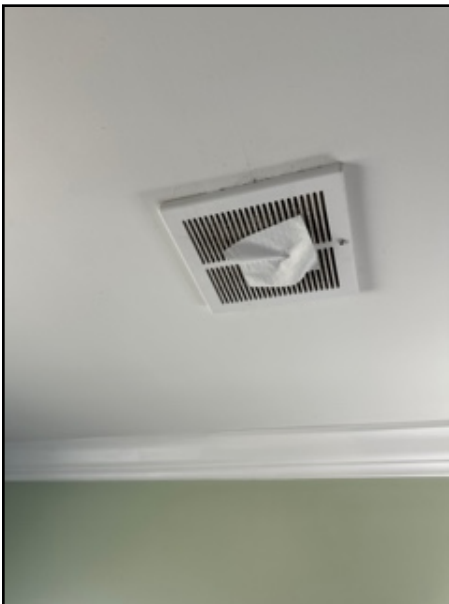
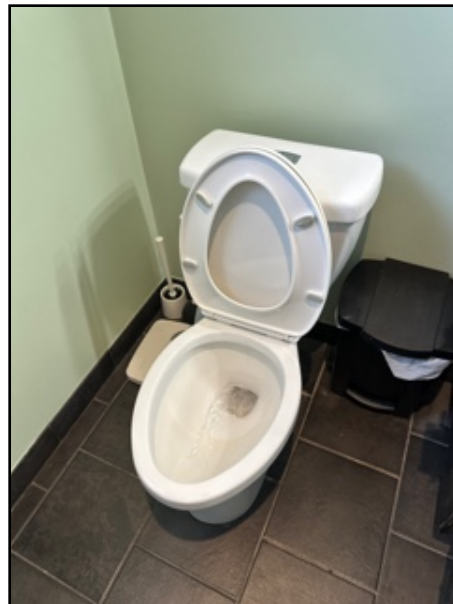
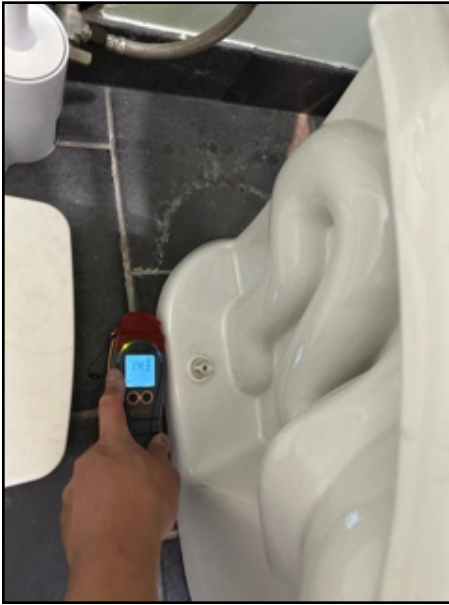
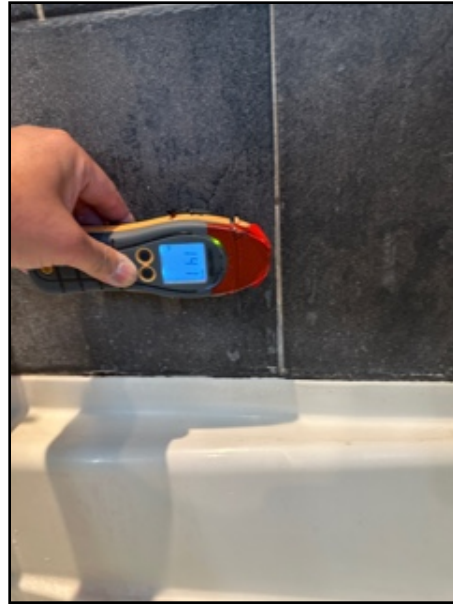
Comment 42:
Second floor bathroom observations.

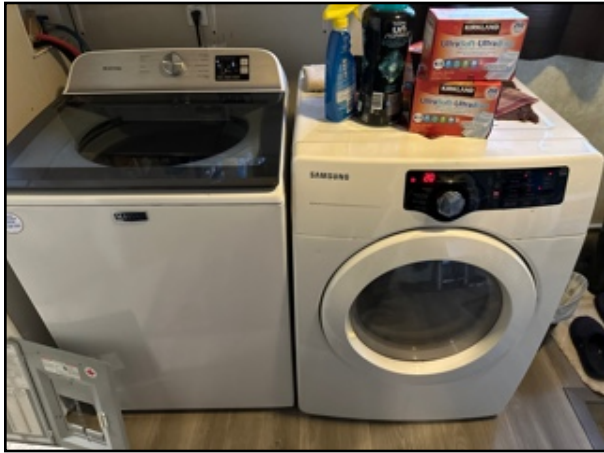
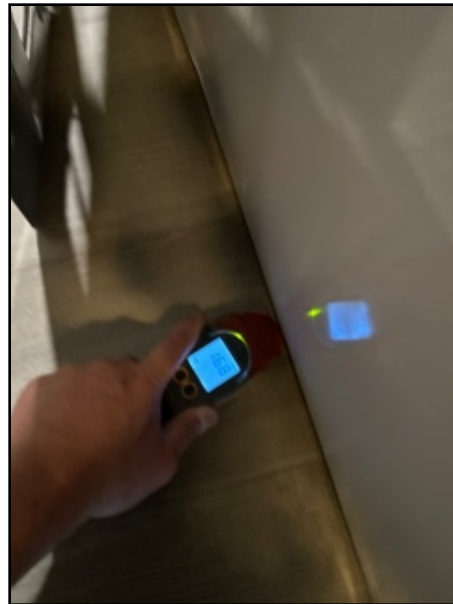
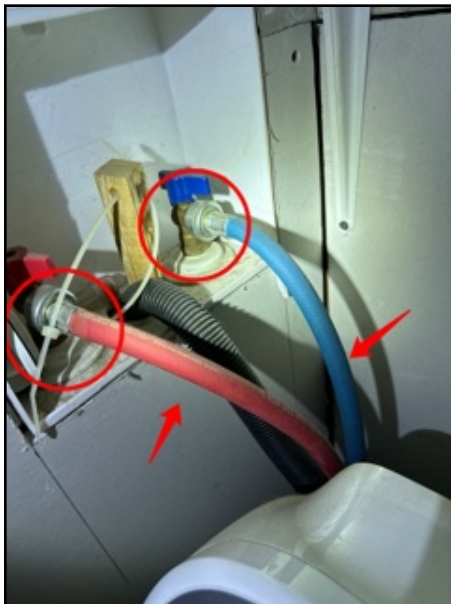
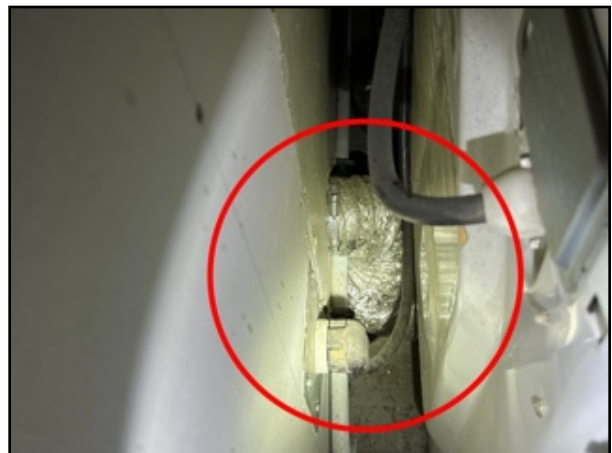
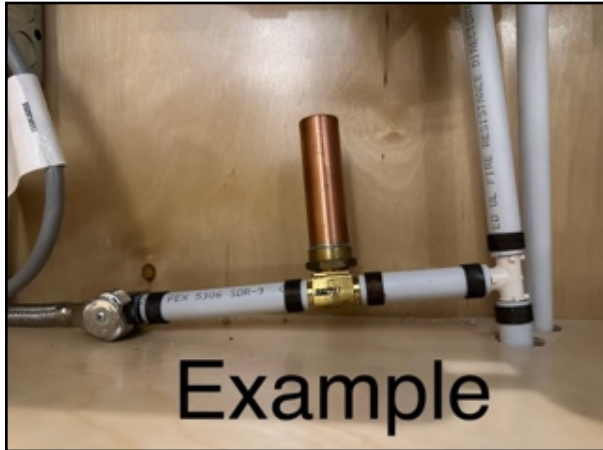
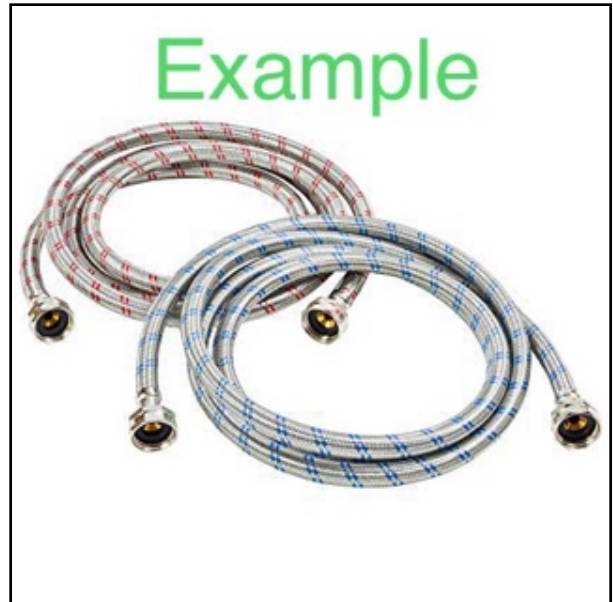
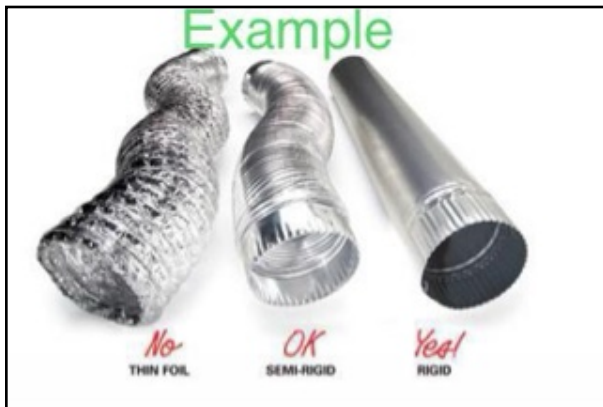
We recommend replacing rubber hot and cold hoses on wash machine with steel braided hoses to prevent risk of leaking over the long term. Water hammer arrestors are also missing for the washer supplies. Upgrade dryer ducting to more suitable material.

Monitor washer and dryer upon move-in for leaks or other deficiencies that could occur after the inspection.

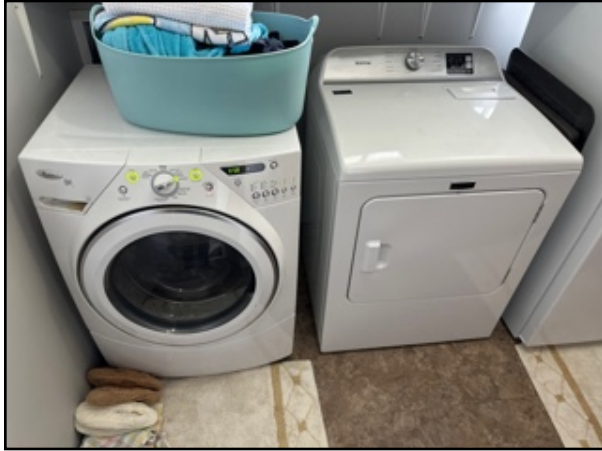
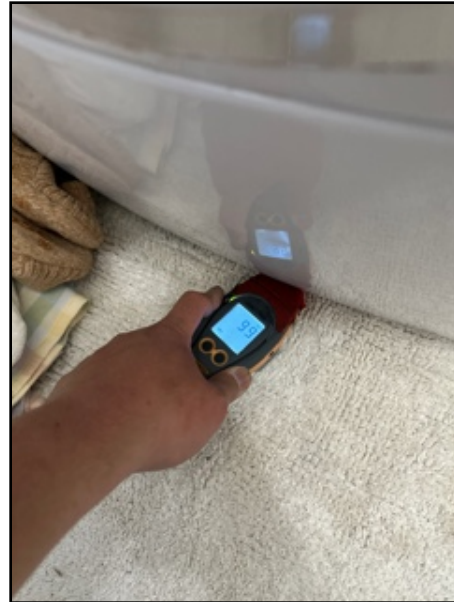
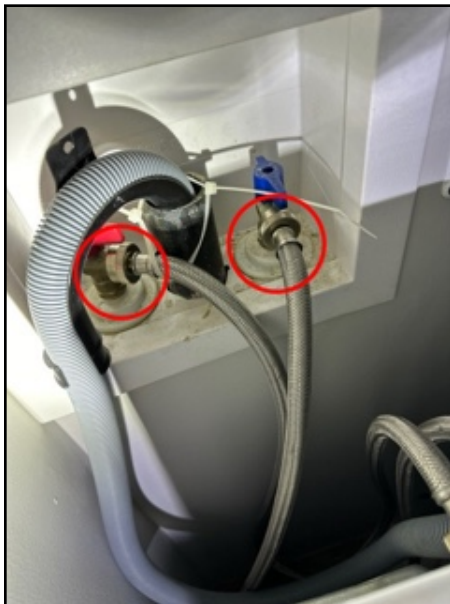
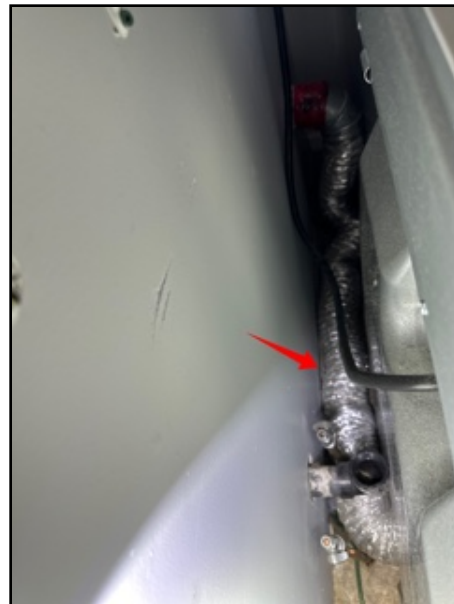
Water hammer arrestors are missing for the washer supplies. Dryer ducting should be upgraded with more suitable material.

Washing machines and clothes dryers should be monitored during the your first usage. Stainless steel water supply pipes should be installed on washing machine. Dryer vents should be properly connected and lint trap and vent pipe cleaned before use. We cannot always confirm what happens at the end of an inspection until you take possession. This is general home maintenance and good housekeeper.

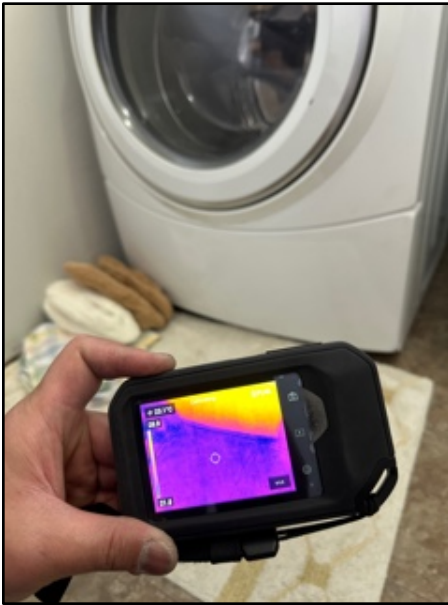
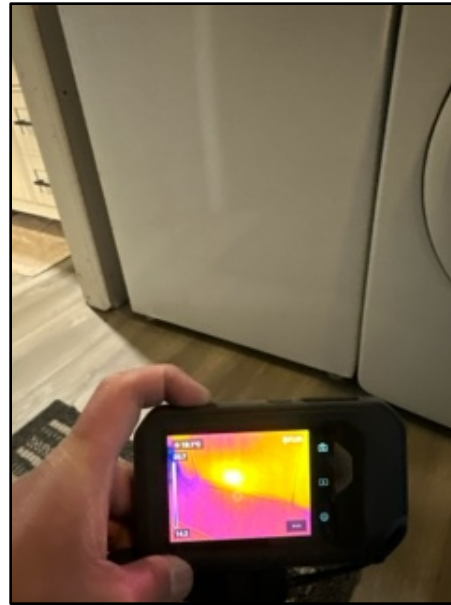
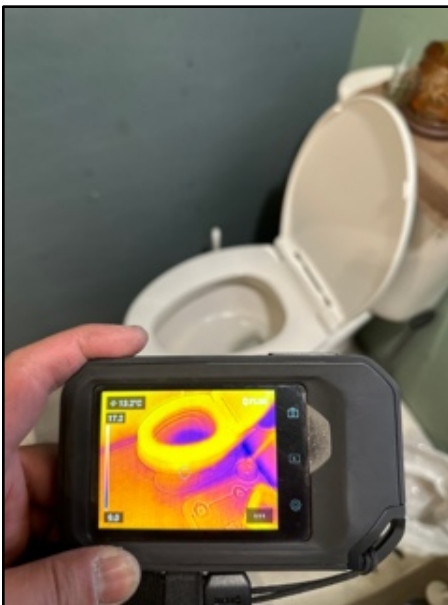
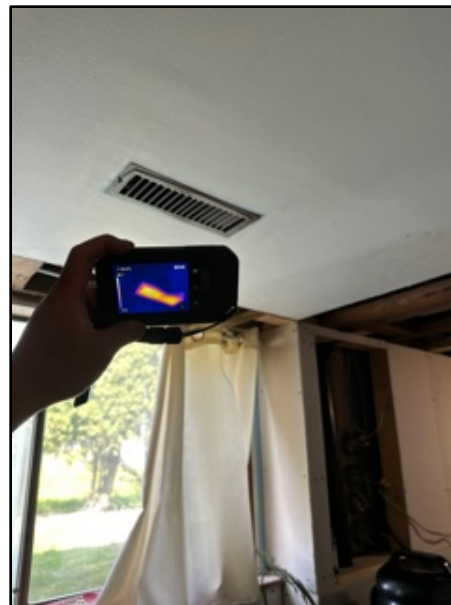
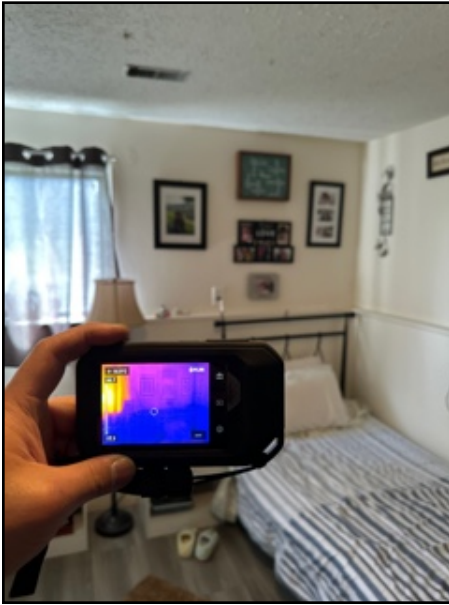
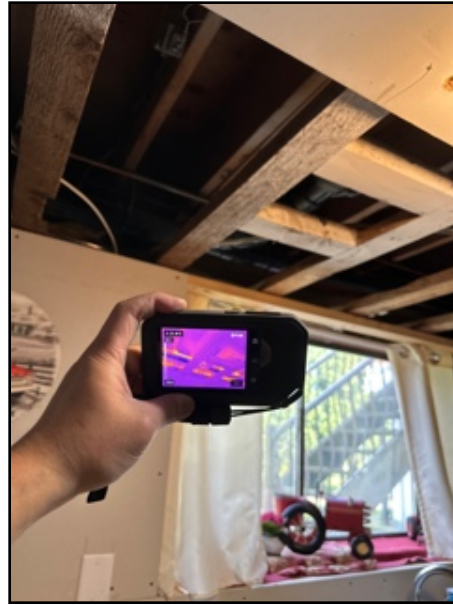
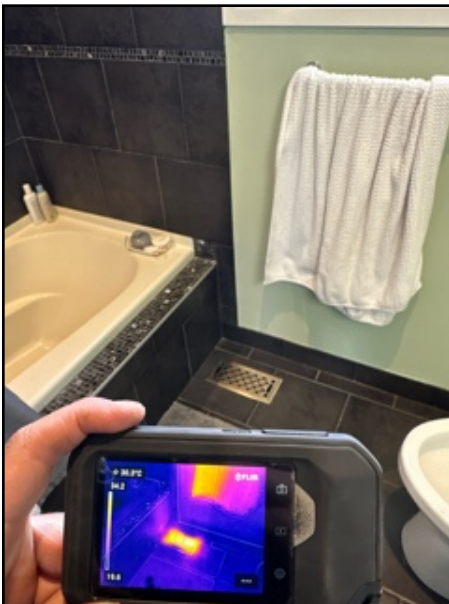
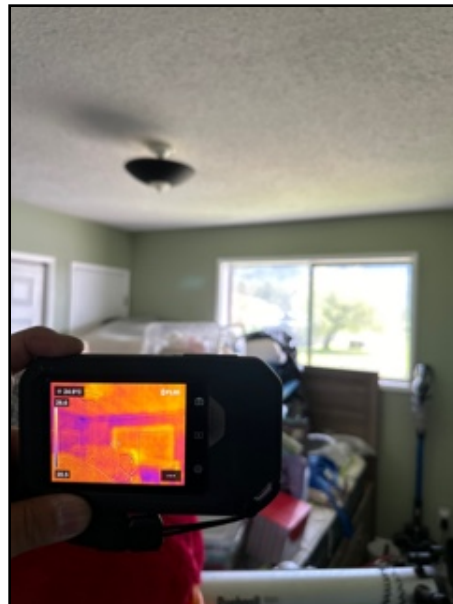
Thermal scan has been completed at the end of this inspection on the windows, heating, ceilings, walls, and plumbing areas (bathrooms, kitchen, laundry). No leaks observed at time of inspection.

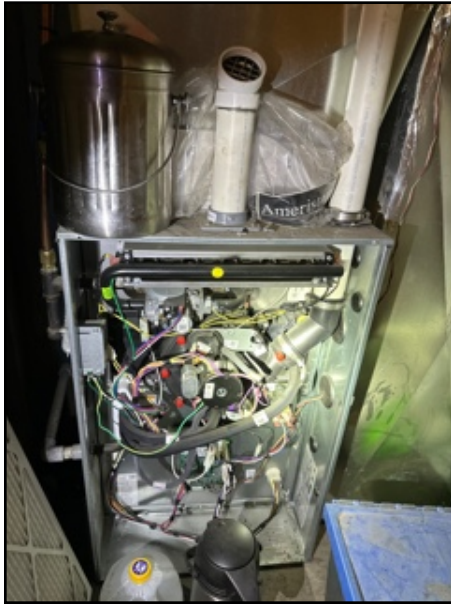
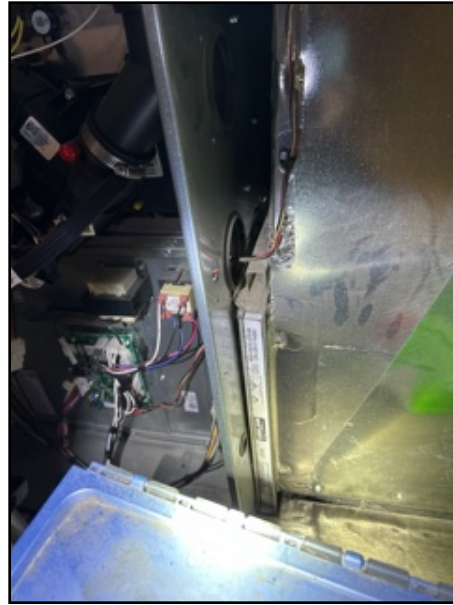
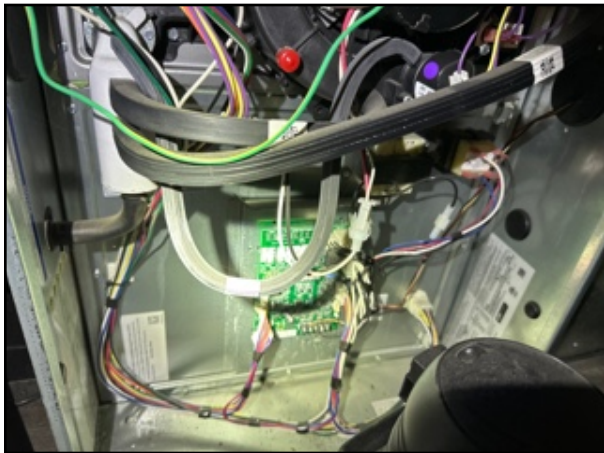
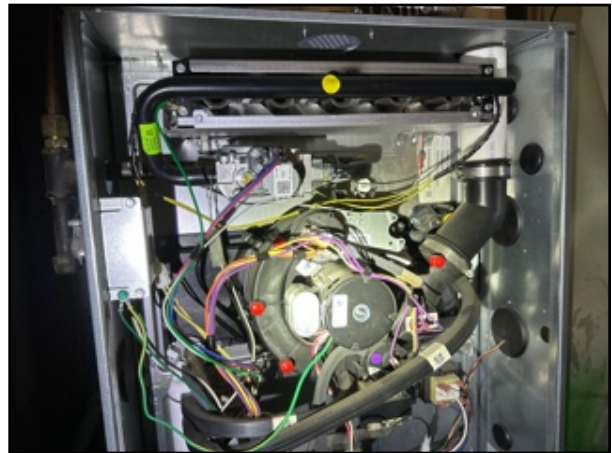
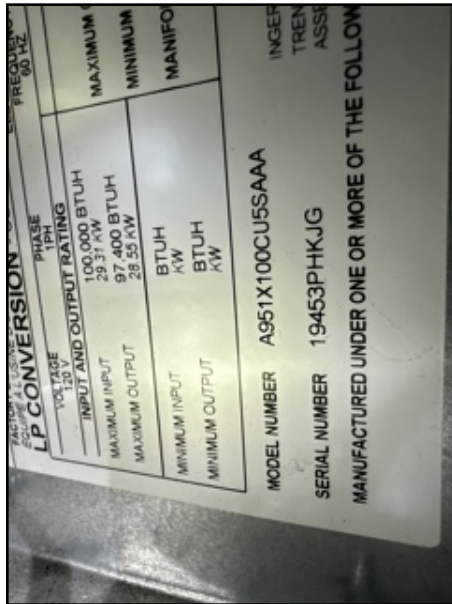
Comment 48:
Furnace observations. Age 2019 (5 years old). Filter Size 16x25x1. Replace immediately then, every 3 months in heating season.

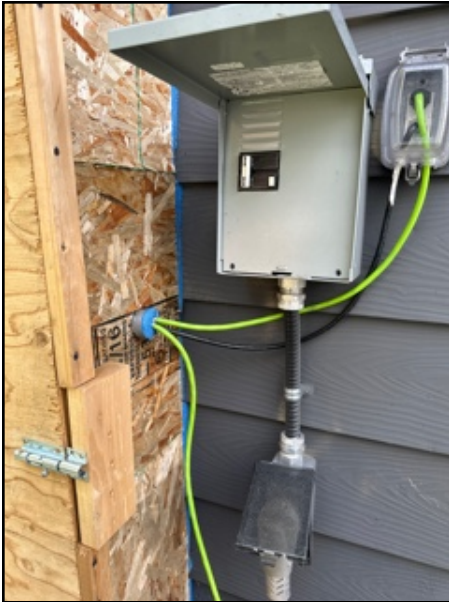
Figure 50-1

Comment 50:
50 amp GFCI protected outlet noted on the west side for an RV hook up.

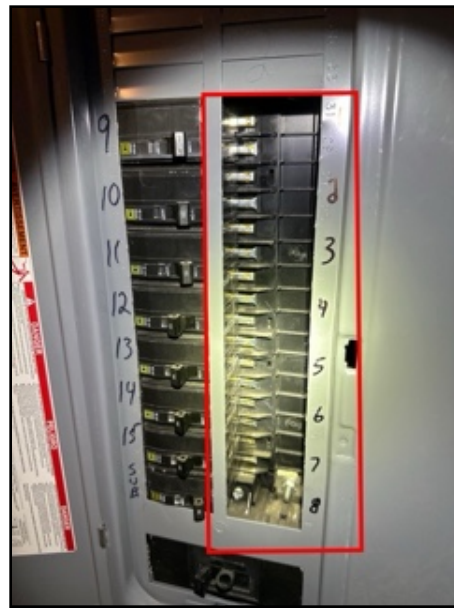
Figure 51-2

Knockout cover is missing in the main electrical panel. This is needed to prevent someone from sticking their fingers or a tool inside the panel and being electrocuted. Have knockout cover installed.

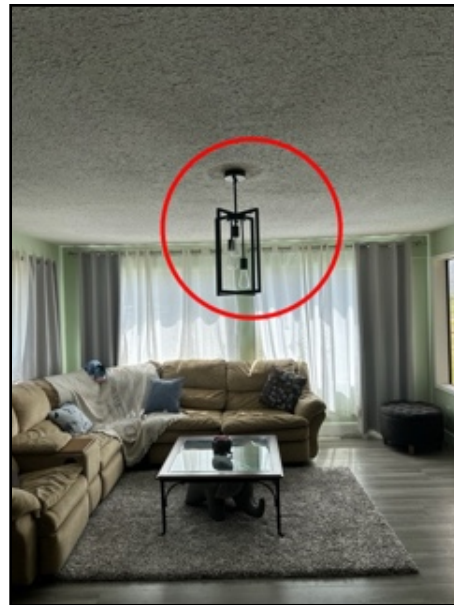
Figure 52-2

Possible lightbulb burnt out/missing or incorrect three way switch installation. Have further assessed by an electrician for troubleshooting and repairs.

Incorrect three way switch installation is noted in the second floor hallway. This is potentially due to incorrect wiring installation. This light fixture should be able to turn on at either location. Have further assessed by an electrician for repairs.

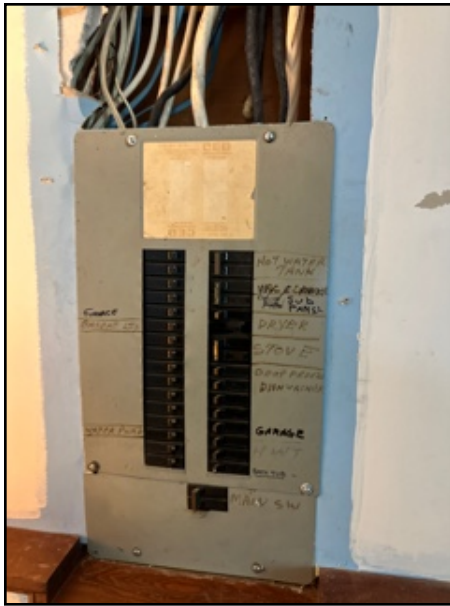
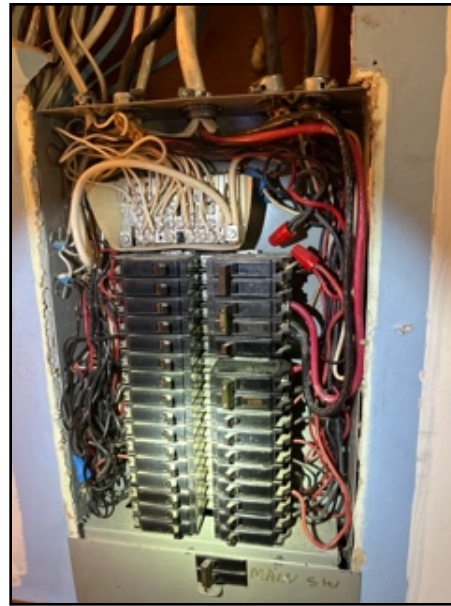
Sub panel located in basement powered from the main panel.
90 amp disconnect with copper branch wiring.

Breakers need to be labelled to identify which circuits they operate.

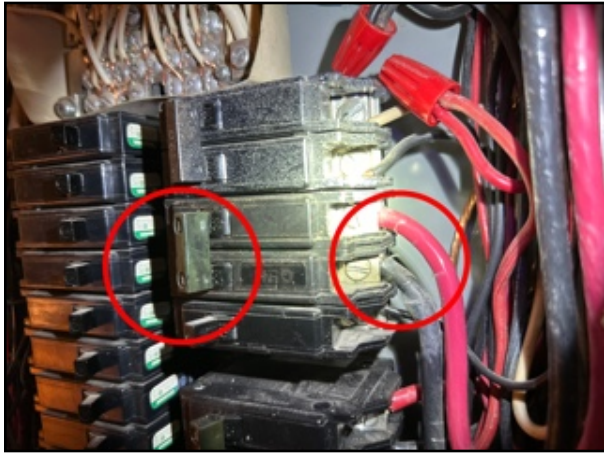
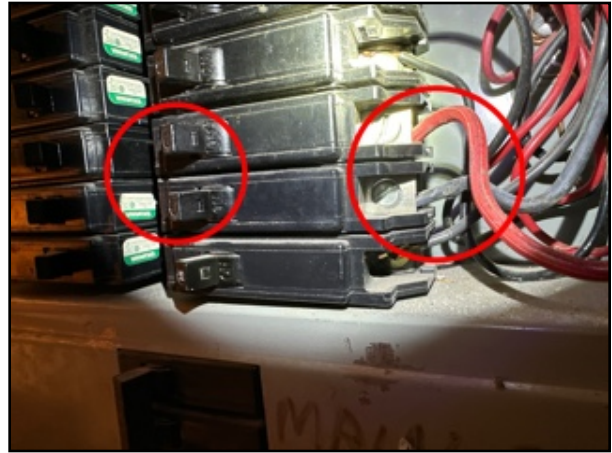
Incorrect size wire observed for the 100 amp and 40 amp breaker in the basement sub panel. Further evaluation is needed by an electrician for repairs. This is a safety concern that needs repairs to prevent a fire hazard.

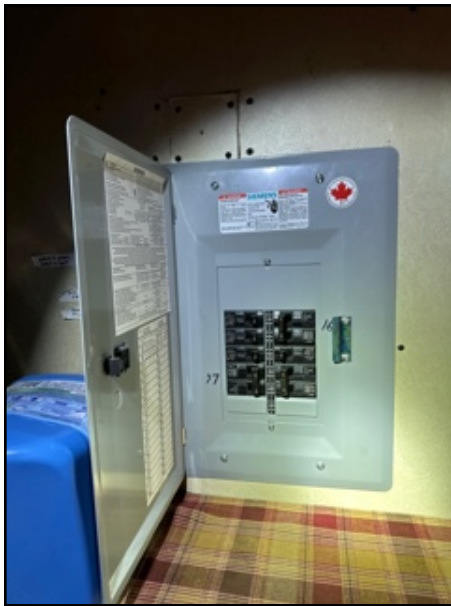
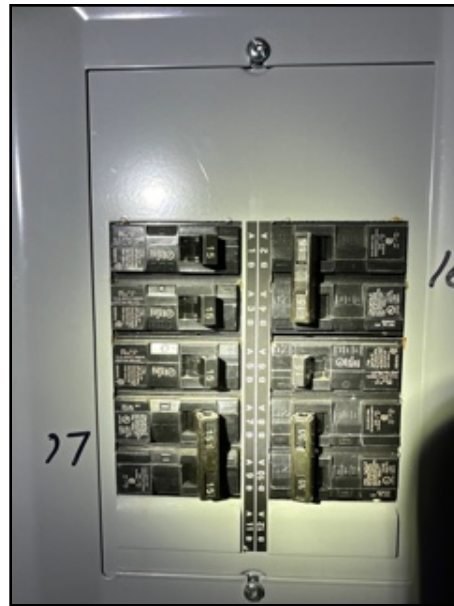
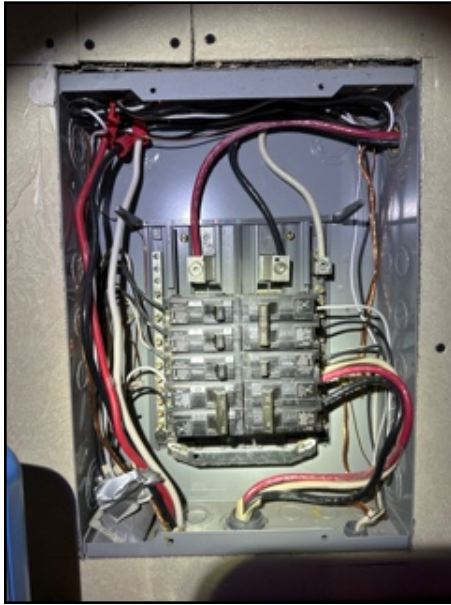
Sub panel located in basement laundry room powered from basement sub panel. 100 amp disconnect with copper branch wiring.
