Home Inspection Report

38201 JONES ROAD (house)

Mission, BC V0M1H0

Inspected on Tue, Apr 23 2024 at 12:00

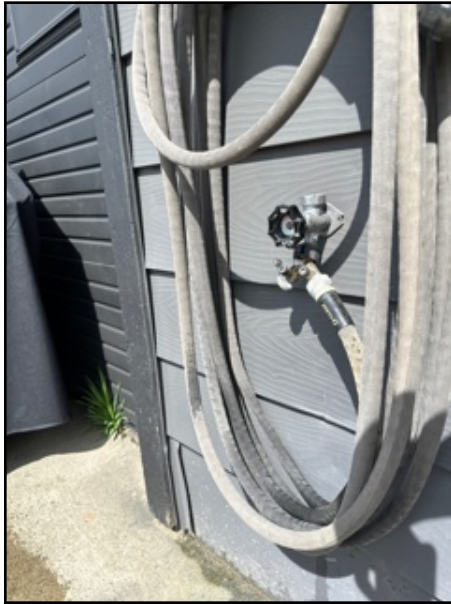
Figure 57-1

Comment 57:
Frost free hose bib observations.

Ensure to disconnect hose bibs during the winter time to prevent the possibility of freezing and potential damage to the tap.

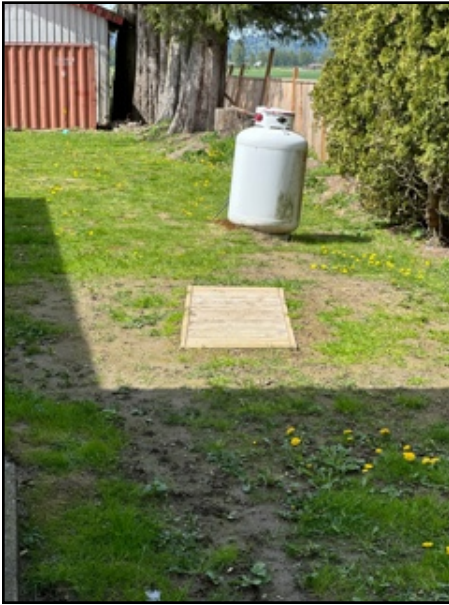
Figure 58-1

Comment 58:
Septic and related equipment is not included with a home inspection. It is outside of our scope of practice and we are not licensed to do so. I recommend having it inspected by an accredited professional for defects.

Well pump system and all related equipment for the well and water testing are outside of the scope of this inspection. We recommend it be performed by a third-party company.

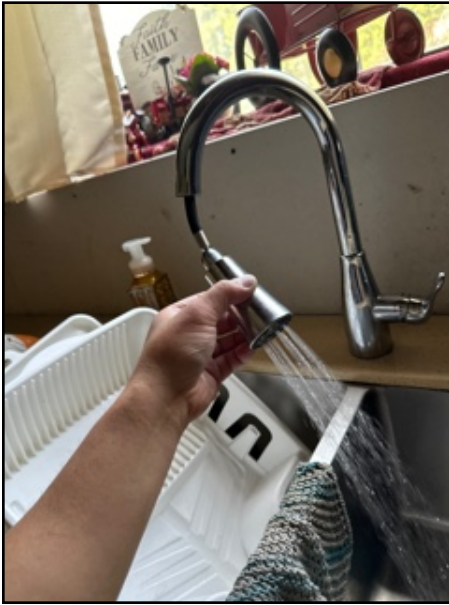
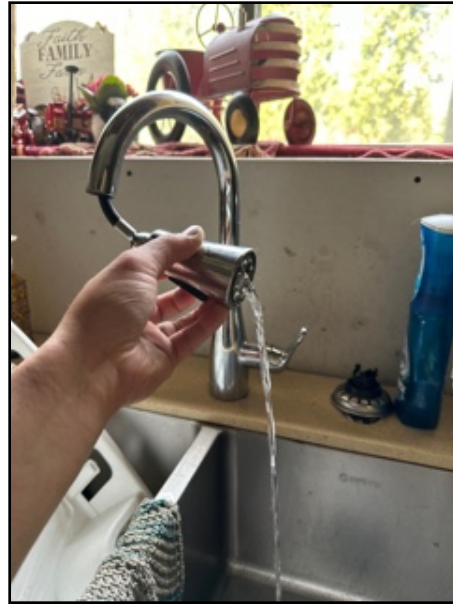
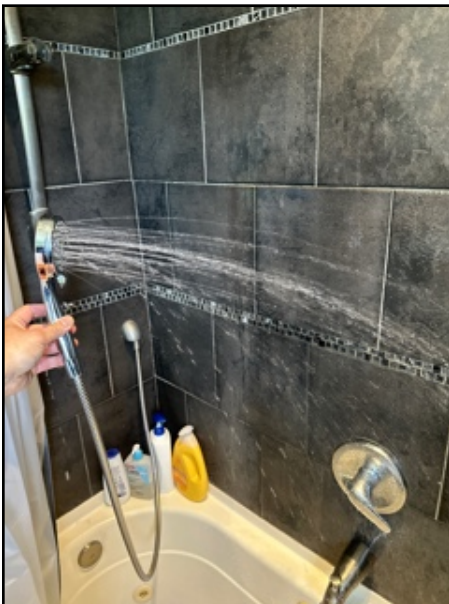
Water pressure for the house at several locations are low. This could be due to a supply issue. Further evaluation is needed by a plumber for troubleshooting and repairs.

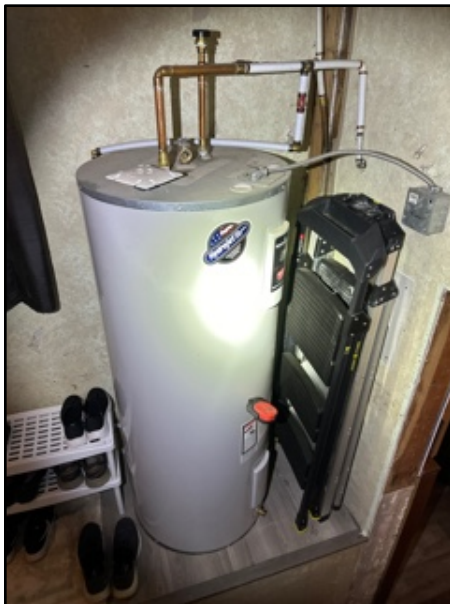
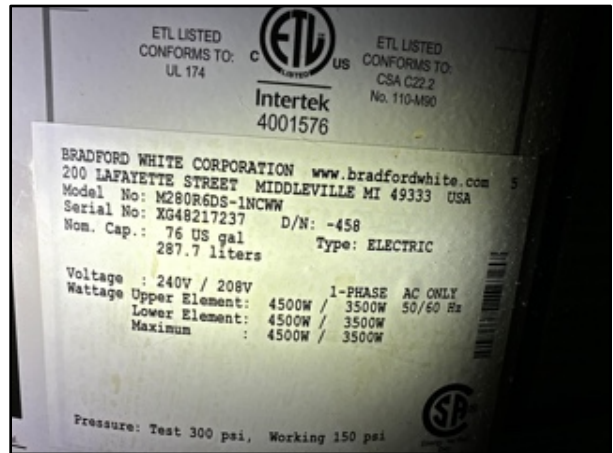
Water heater observations. Age 2021 (3 years old), average life span is around 10-12.

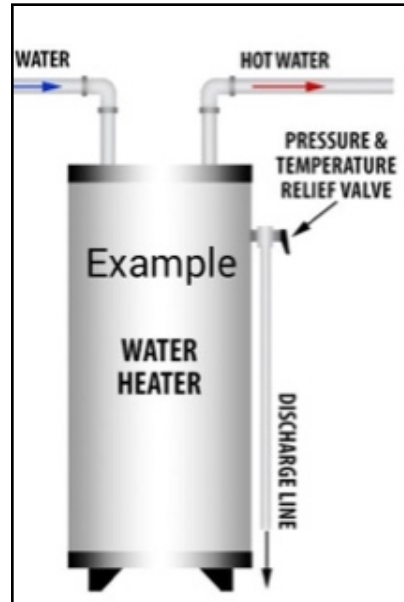
Figure 63-2

Temperature pressure relief valve downspout is missing on this hot water heater. This downspout will prevent high temperature water from discharging horizontally in this area. It is recommended that they be installed on hot water heaters.

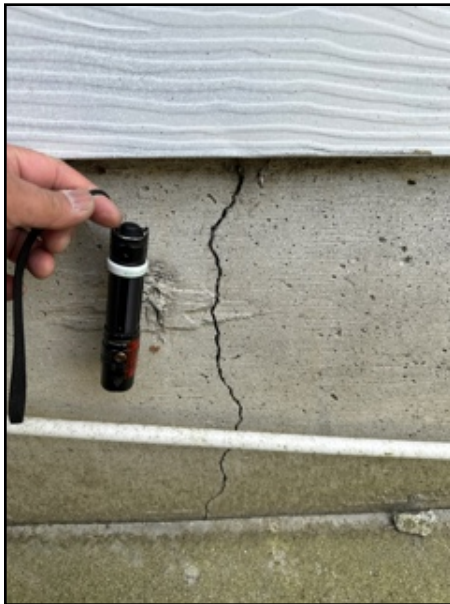
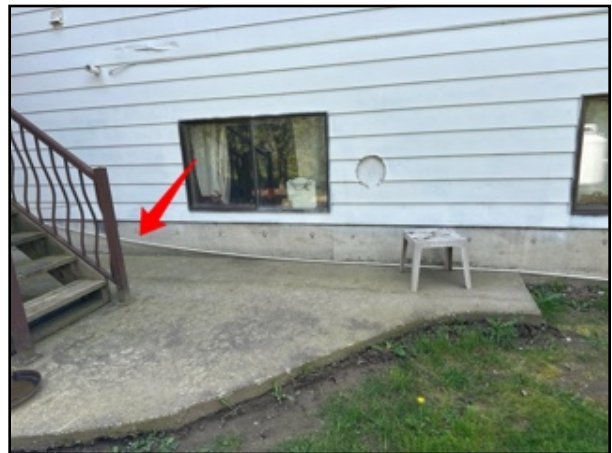
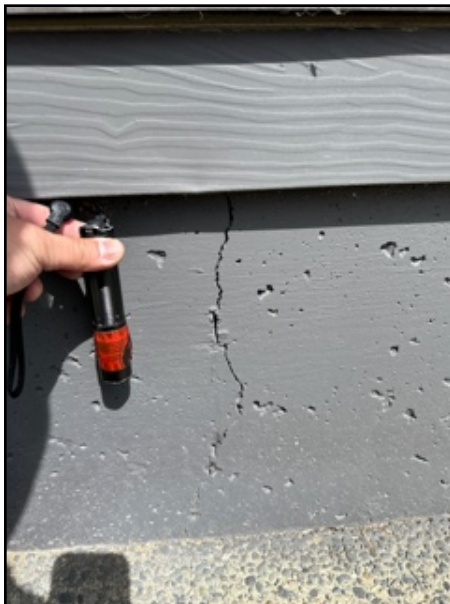
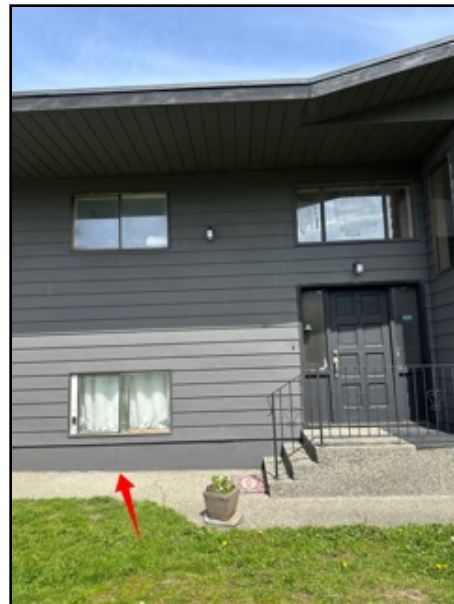
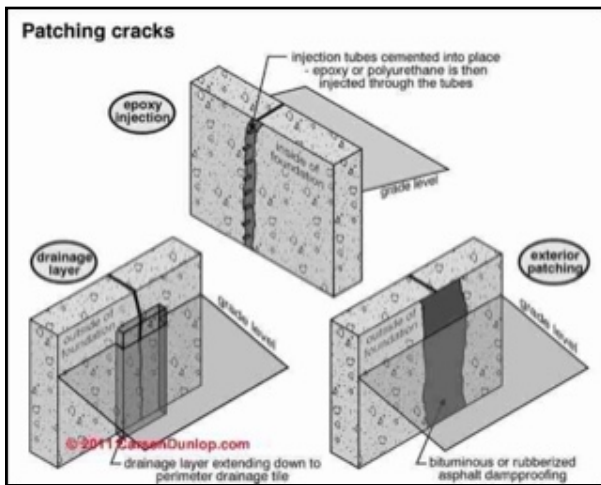
Comment 65:
Cracks in concrete foundation can be a result of the concrete shrinking during the drying process. Although foundation wall shrinkage cracks are very common it is recommended that all cracks be repaired to prevent the possibility of water ingress.

This can be repaired by a concrete foundation repair contractor if desired to be proactive.

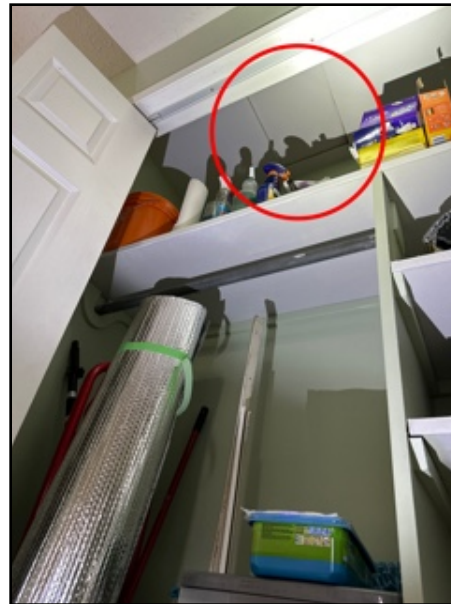
Figure 66-2

I recommend improving the opening and removing shelving that is blocking the hatch for easier access. This is needed in order to inspect the condition of the attic space. This was a limitation to the inspection.

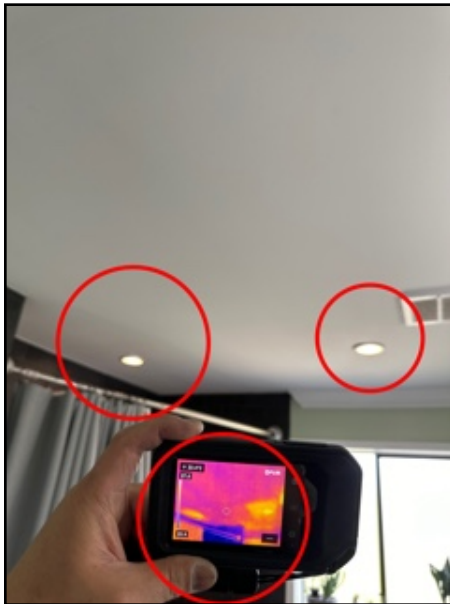
Figure 67-1

Ceiling scans on second floor bathroom shows signs of missing or insufficient insulation. Consider repairs for thermal efficiency.

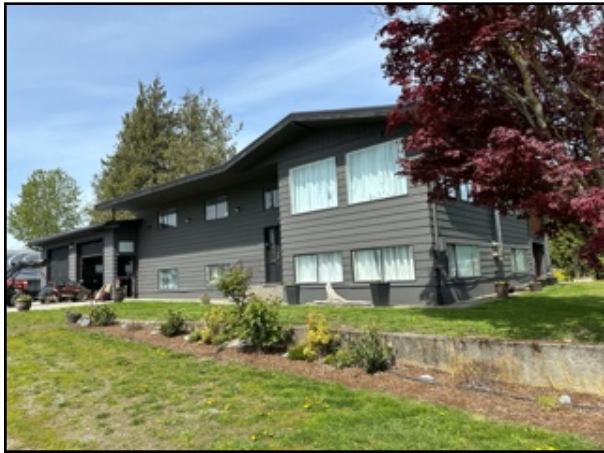
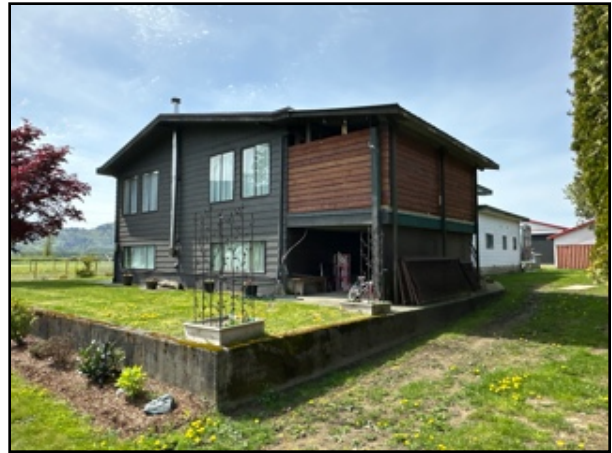
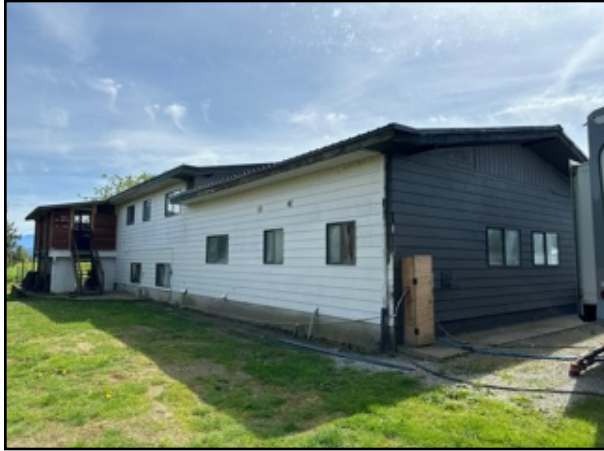
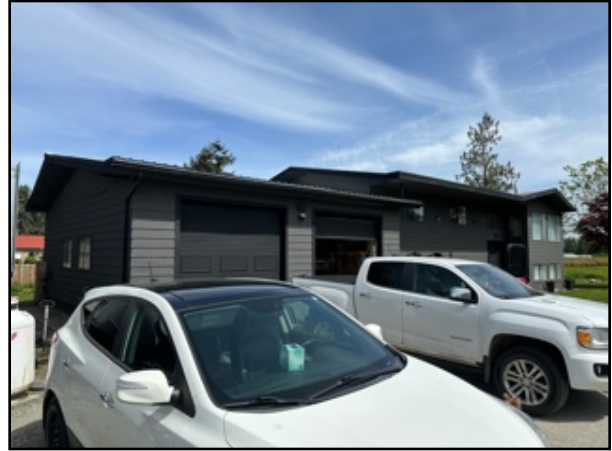
Comment 68:
Exterior observations.

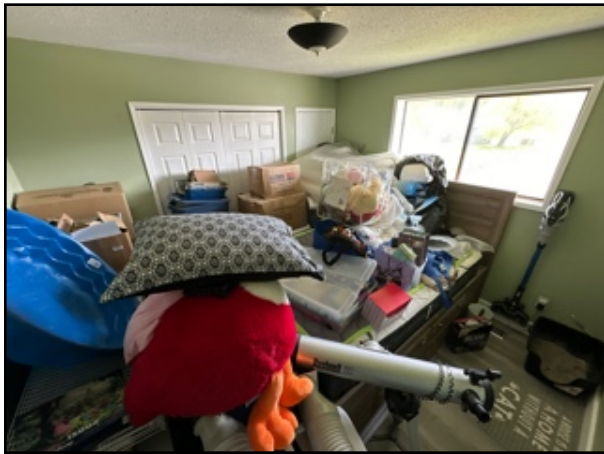
Figure 69-1

Comment 69:
Interior observations.
