Home Inspection Report

38201 JONES ROAD (mobile home)

Mission, BC V0M1H0

Inspected on Tue, Apr 23 2024 at 08:45

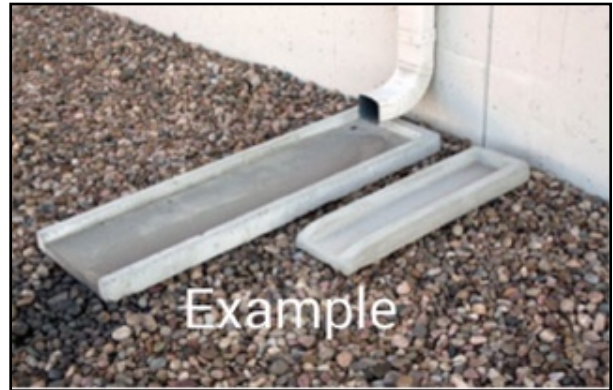
Figure 1-2

Underground portions of drains are not visible or tested in this home inspection. For a further review of this hidden system, consult a plumber on scope options available.

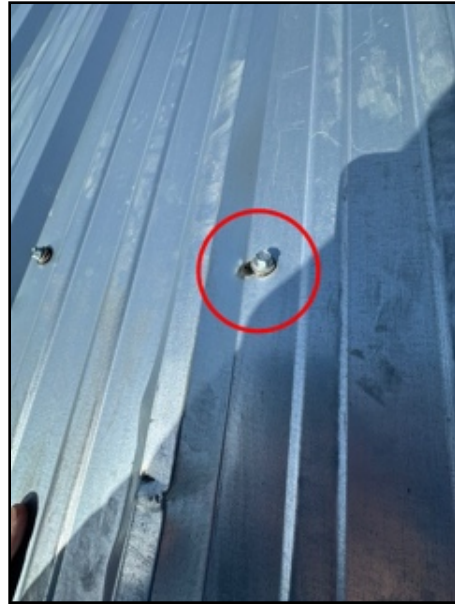
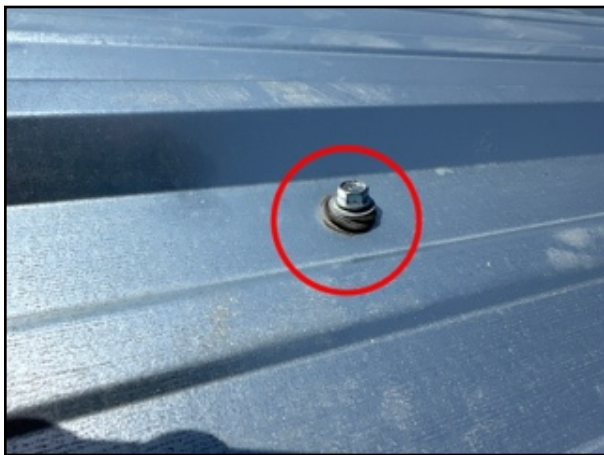
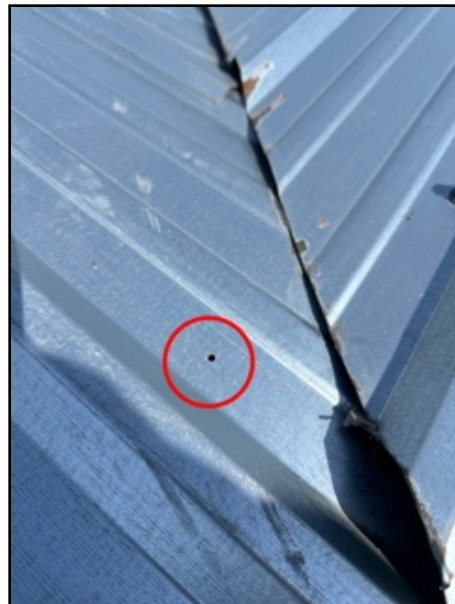
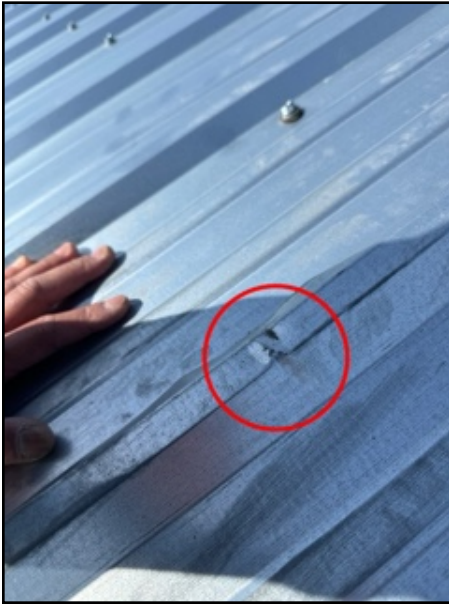
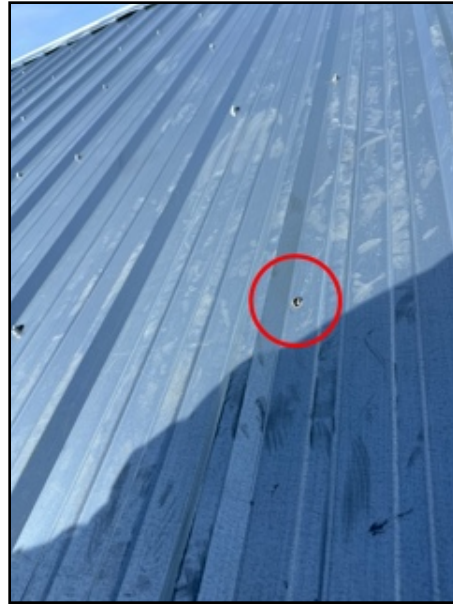
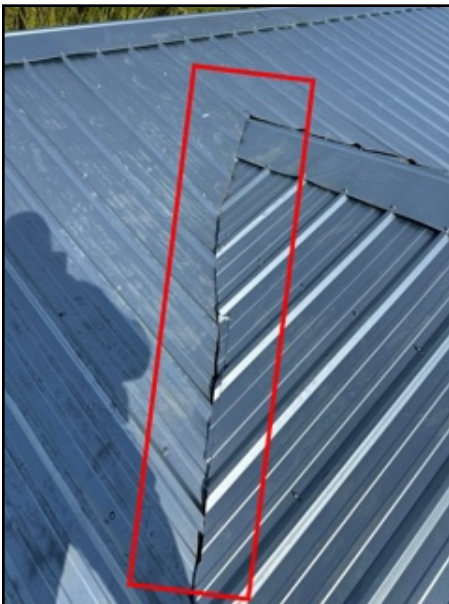
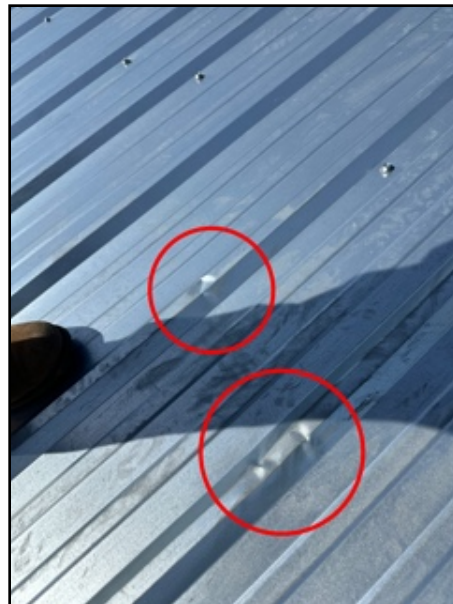
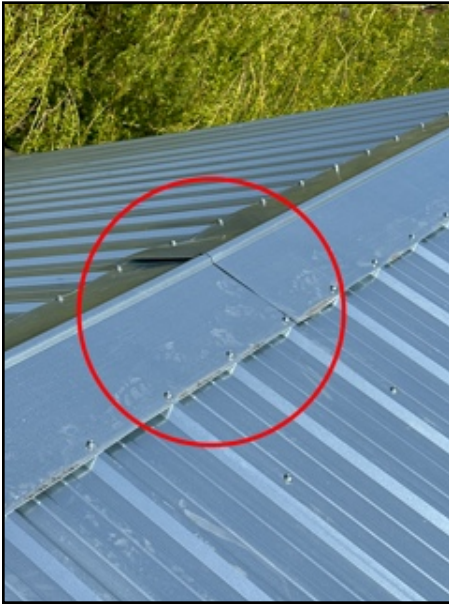
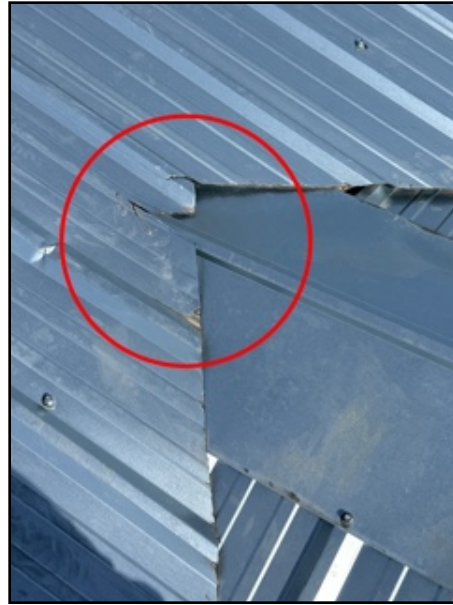
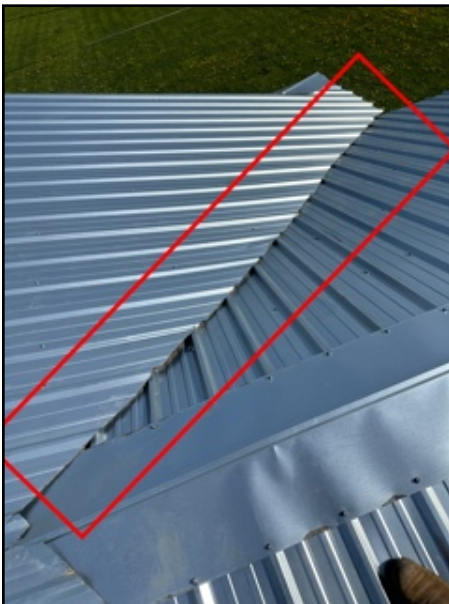
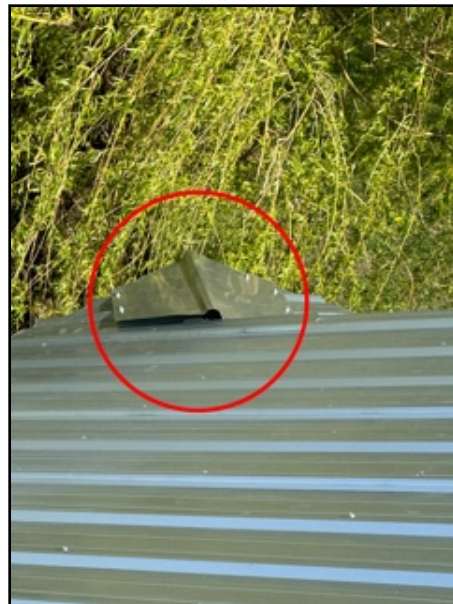
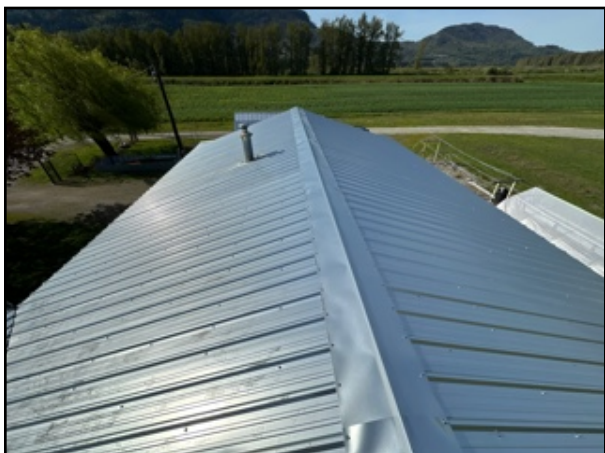
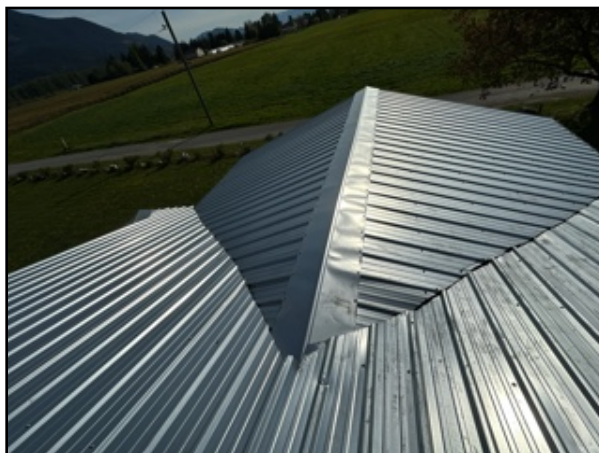
1) Poor installation is noted for this metal roof. Incorrect ridge cap detail is observed on the corners. Poor installation of fasteners are evident from the canted fasteners and warped gaskets. There are holes, mechanical damage, and denting observed at several locations. Poor flashing detail is also noted on the valleys. This roof does not appear to be installed by a professional roofing contractor and has a high risk of failure and leaking.

There are no visible plumbing vents observed on the roof. Plumbing vents may have been covered with the new roof from existing.

I recommend further evaluation by an accredited roofing contractor for a thorough assessment of the current installation and condition of this roof. Anticipate major repairs or replacements.

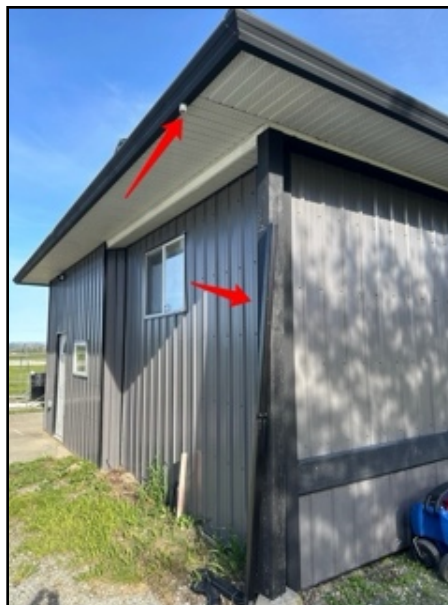
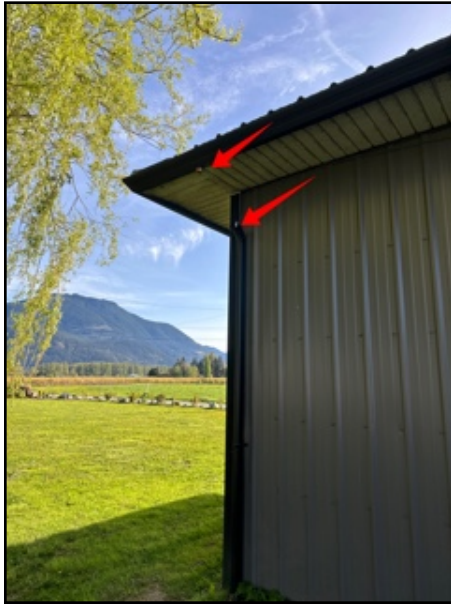
Figure 3-2

2) Downspouts need to be connected to the gutters for proper drainage. Anticipate repairs by a gutter technician.

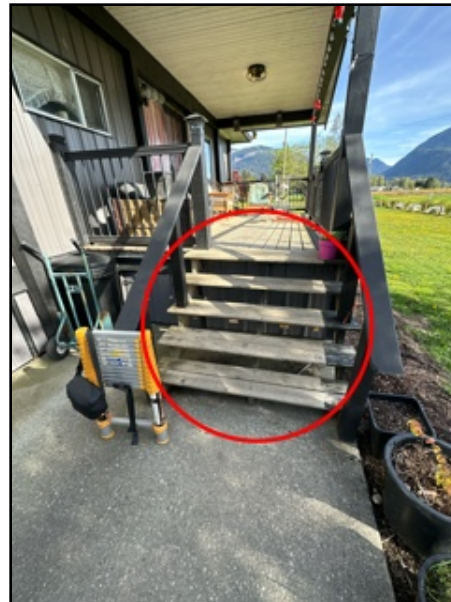
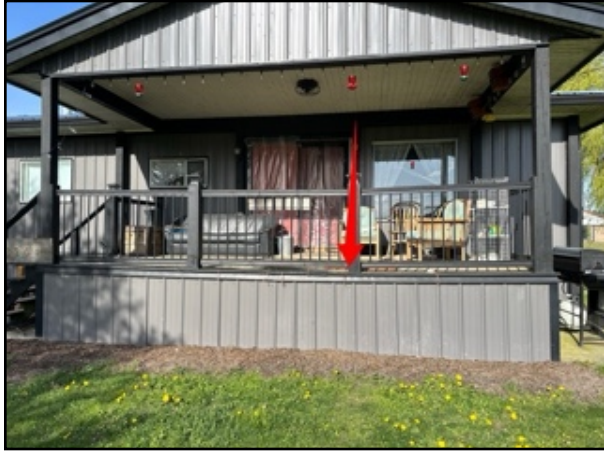
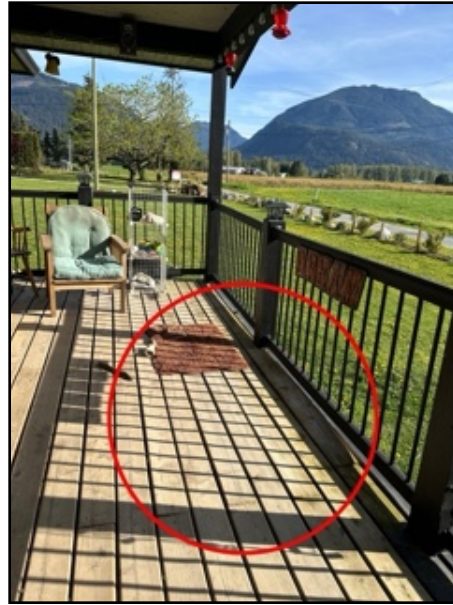
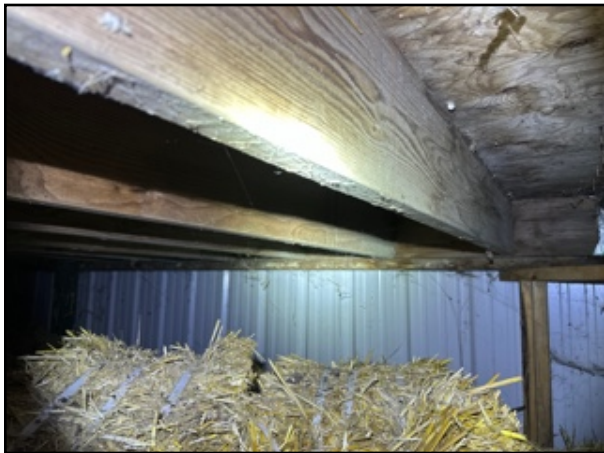
Figure 7-2

3) Incorrect configuration noted for the deck stairs. The stair treads are also deflecting and are leaning which is a fall hazard. This is a safety concern that needs repairs or replacements.

The middle edge section of the deck has settled and has bulging observed to the flooring on this area. This could be due to a structural concern to the deck. This is a safety concern that needs further evaluation by a general contractor or carpenter. Have assessed for structural integrity and repairs for safety. From the crawlspace, this deck appears to be missing a post and beam structure and is a poor installation. Anticipate improvements or replacements.

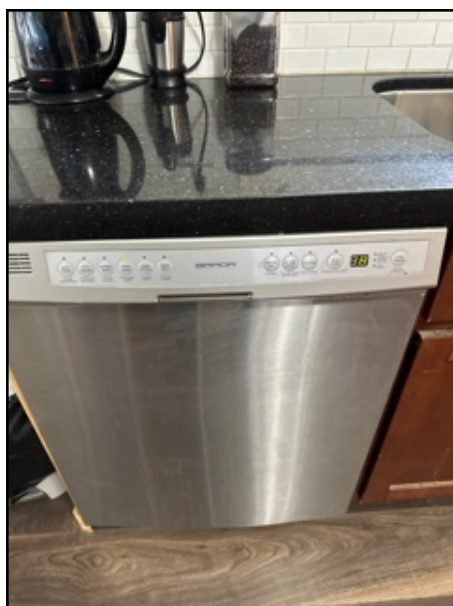
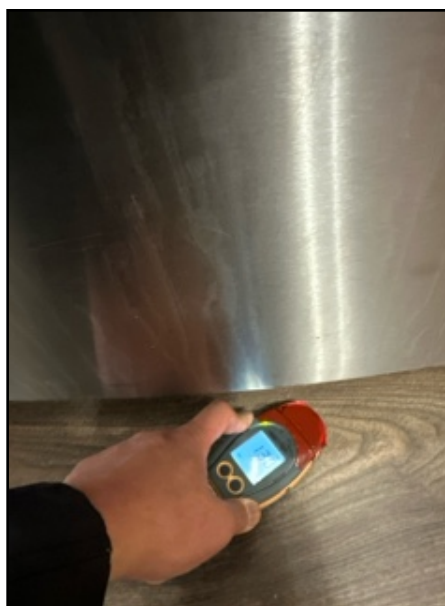
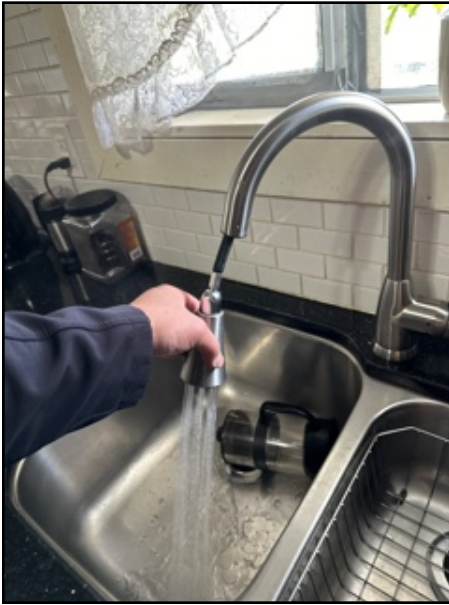
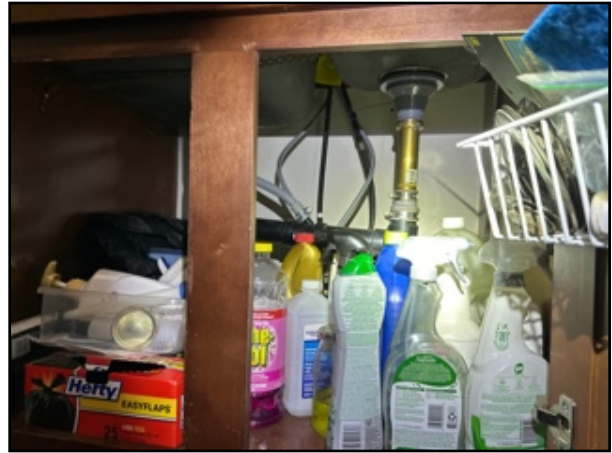
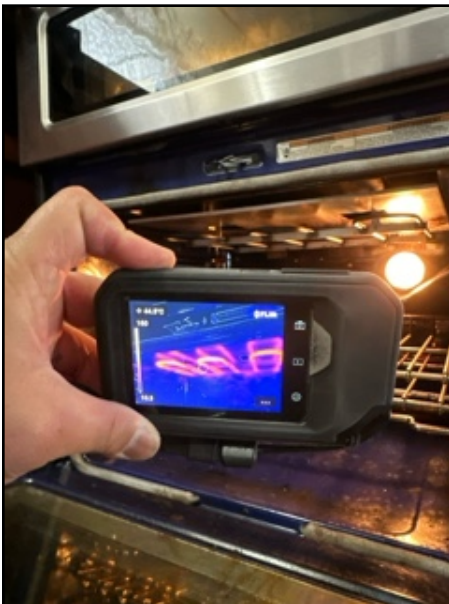
Figure 17-1

Verification photos of appliances currently working during the inspection. All appliances in the home should be monitored for unforeseeable leaks while they are in use for the first time upon possession.

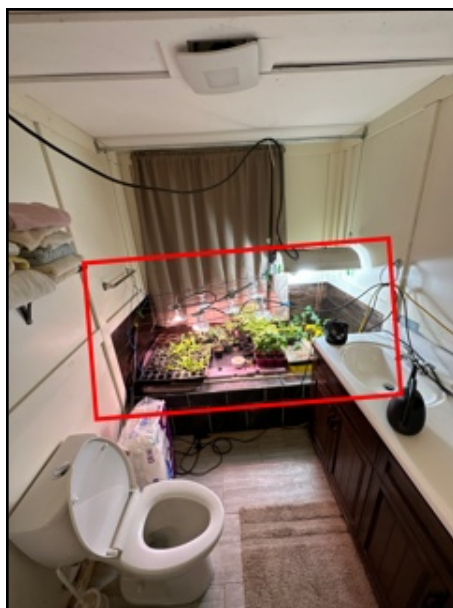
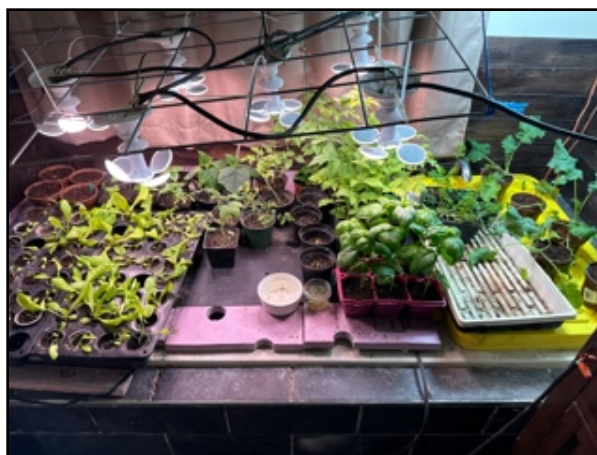
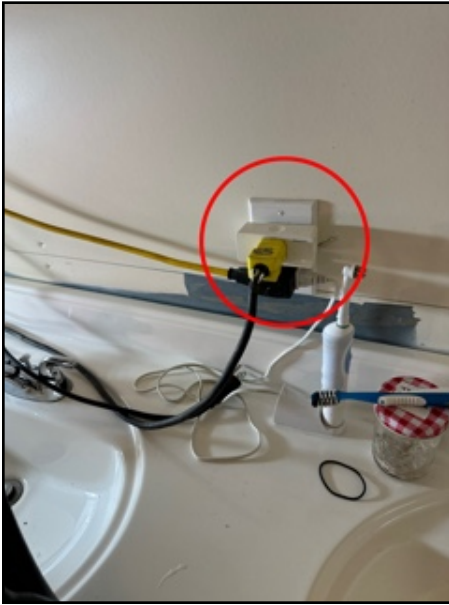
The bath tub for the hallway bathroom was not able to be tested due to the homeowner's plants on top. The outlet in this bathroom was also not able to be tested. This was a limitation to the inspection.

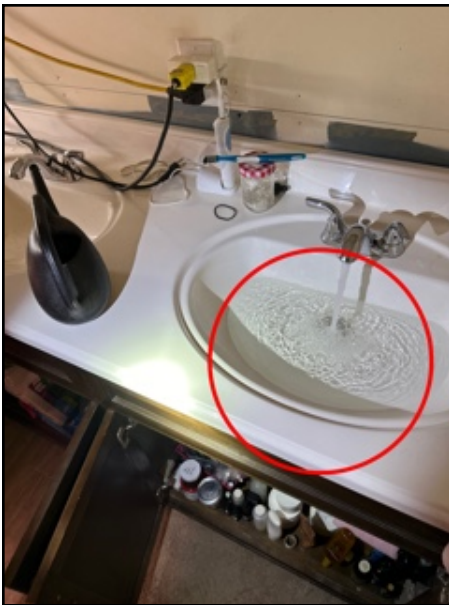
Figure 23-1

This sink is slow draining, possibly clogged. Servicing is needed by a handyman or plumber for maintenance.

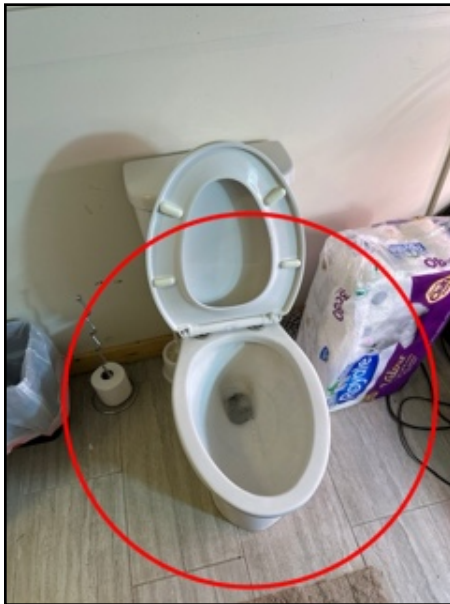
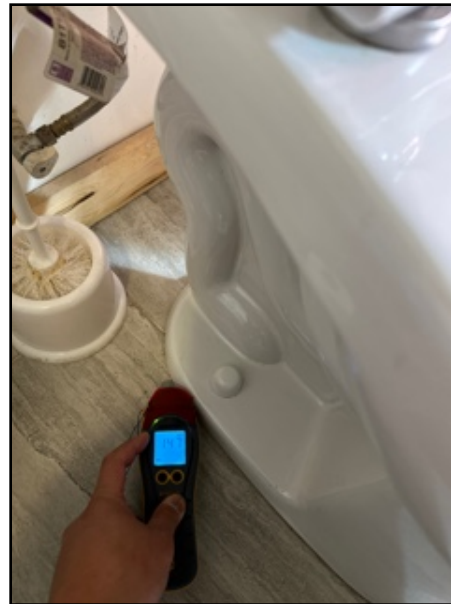
Location: hallway bathroom

**Comment 25:**
Toilet is not secured to floor. This can cause damage to the seal and plumbing of the toilet. Have repaired. Hidden damage is possible.

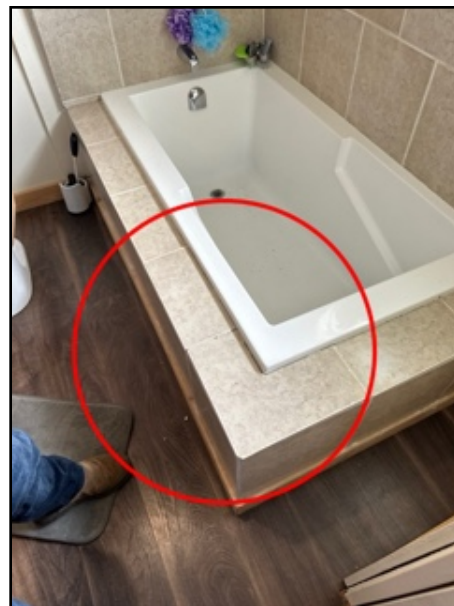
Figure 27-2

**Comment 27:**
The tiles around the tub surround are loose/damaged. Anticipate repairs.

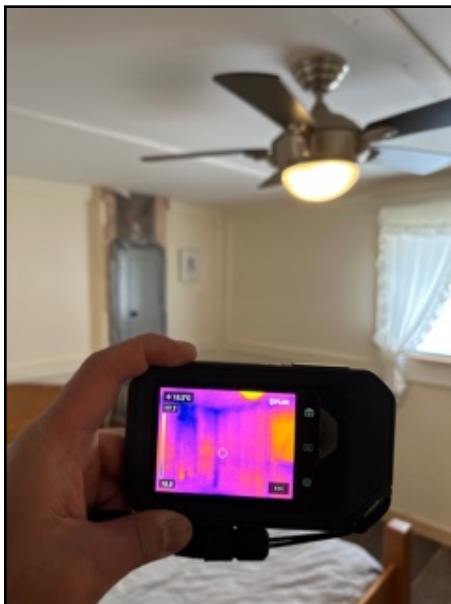
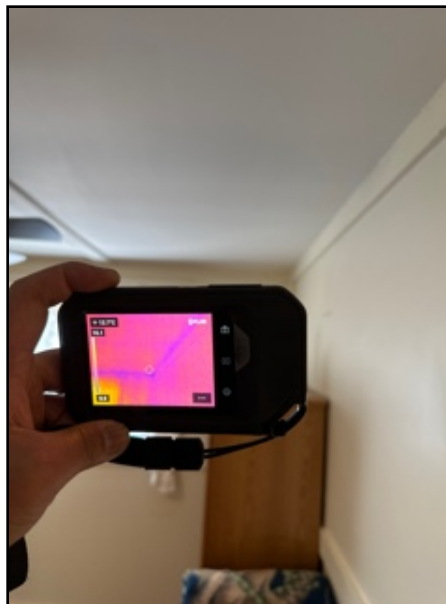
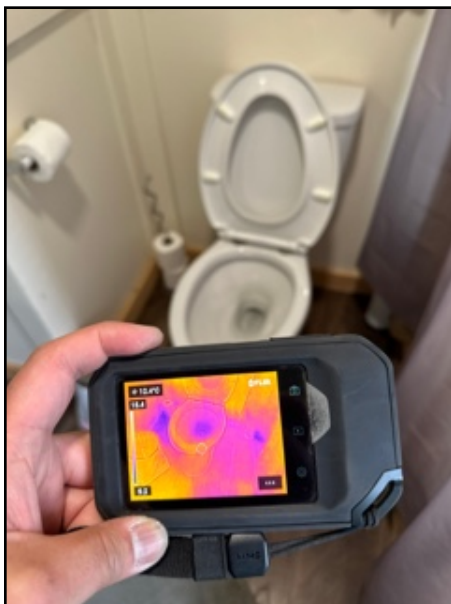
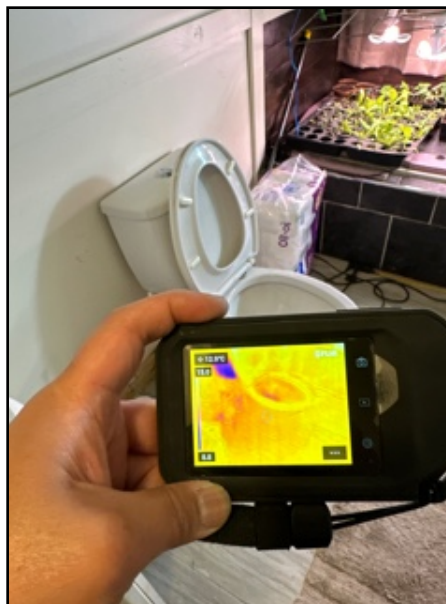
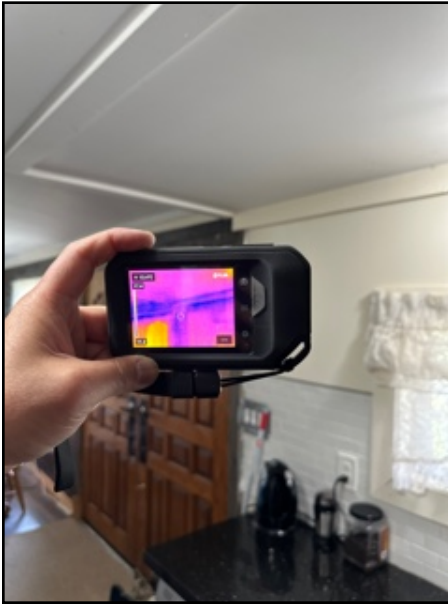
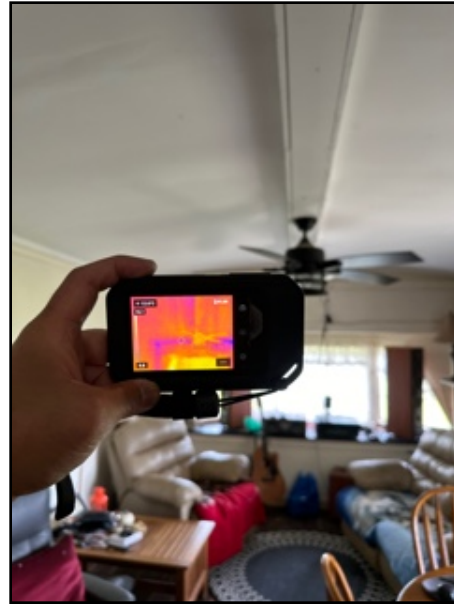
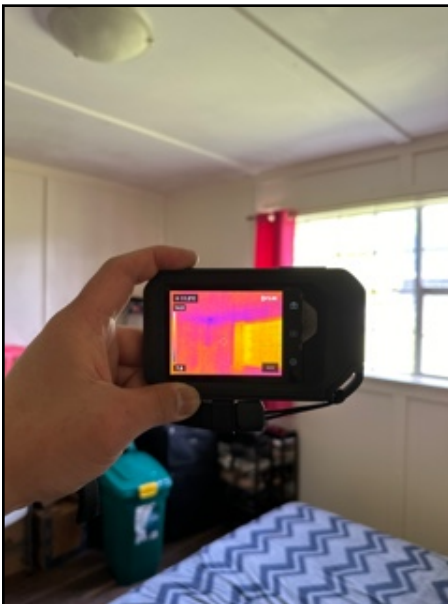
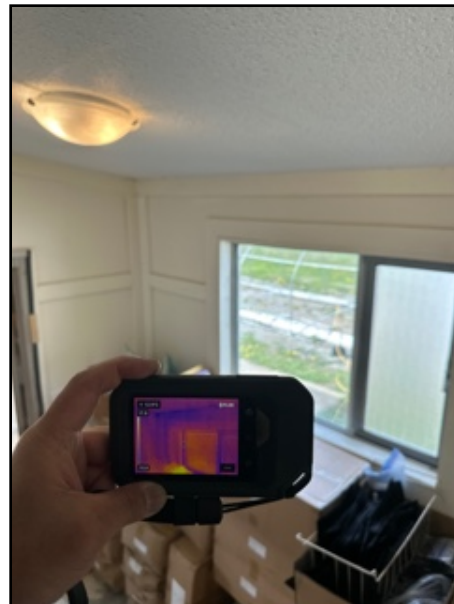
Thermal scan has been completed at the end of this inspection on the windows, ceilings, walls, and plumbing areas (bathrooms, kitchen, laundry). No leaks observed at time of inspection.

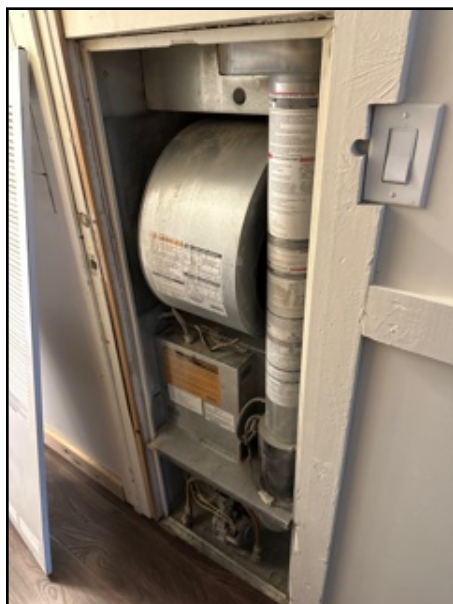
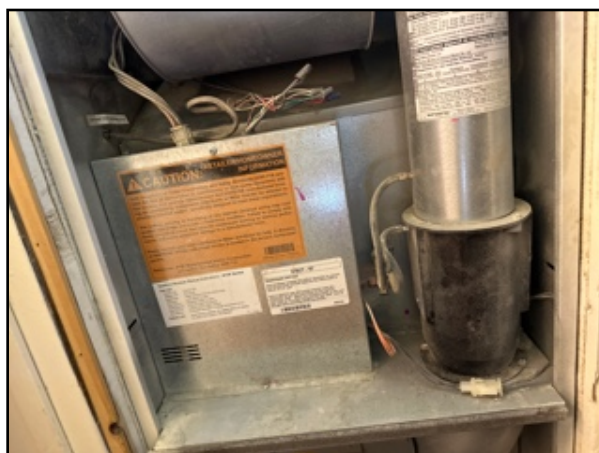
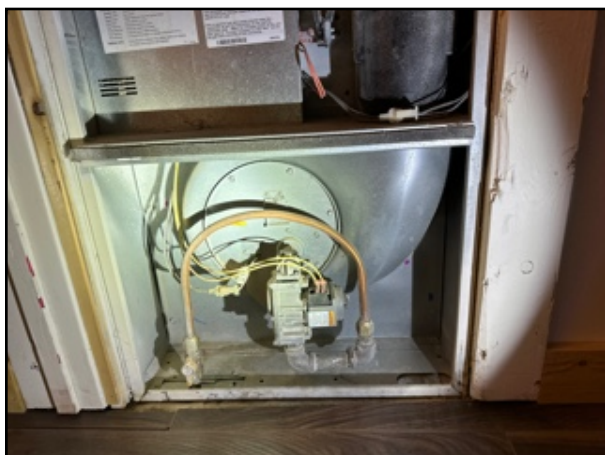
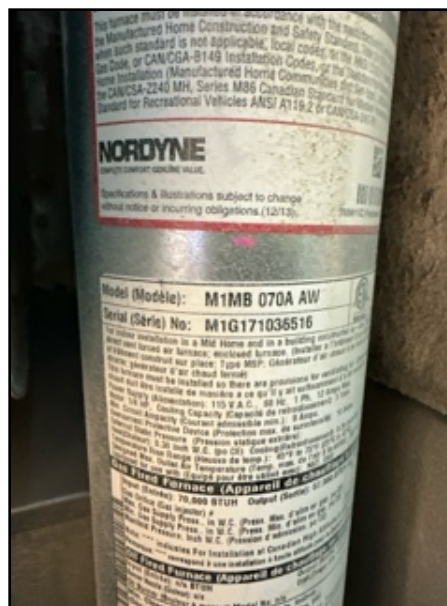
Filter is missing for this furnace. Have installed to prevent premature failure to the furnace components.

Due to the age I recommend continual servicing for the furnace and ducts cleaned.

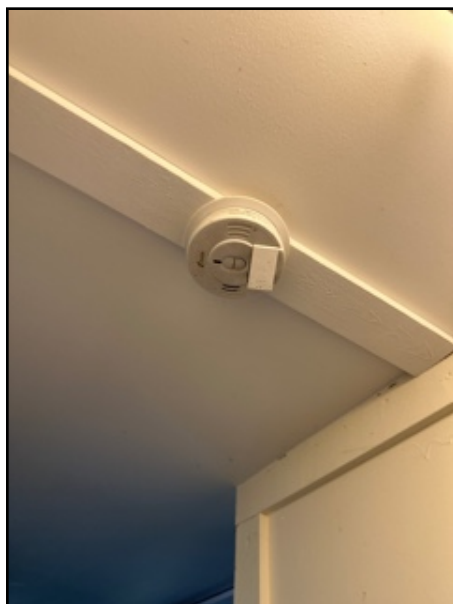
Figure 38-1

**Comment 38:**
Smoke alarm observed.

Install carbon monoxide detector near bedroom, on all floors, and test all smoke alarms upon move-in.

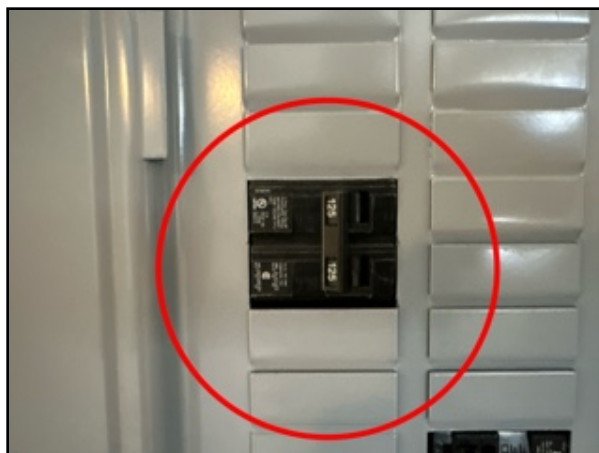
Figure 39-2

There is an exposed wire observed at the rear connected to a 125 amp breaker in the main panel. This is a life safety concern and a shock hazard in case this breaker is turned on. I recommend removal or properly terminating this loose wire by an electrician to prevent an accident.

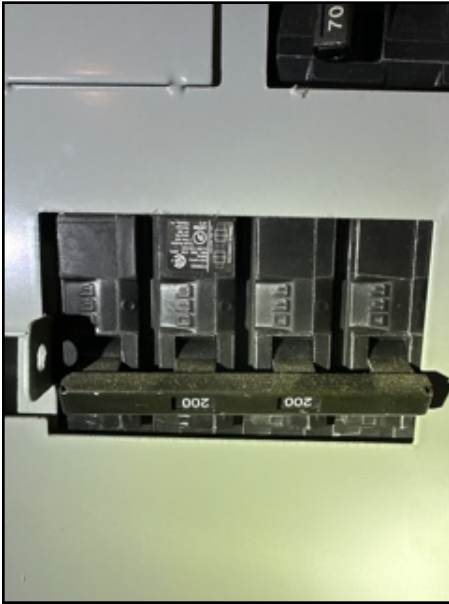
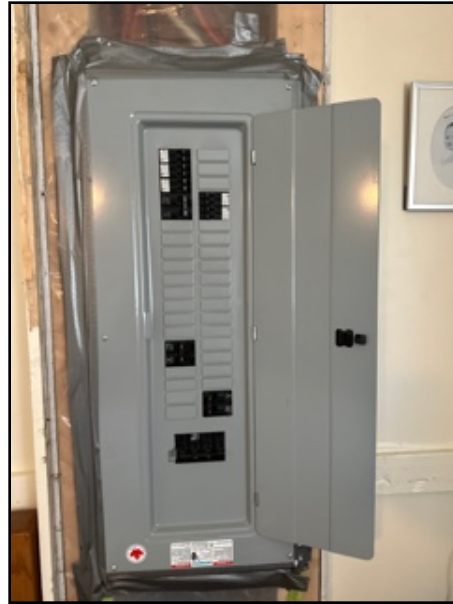
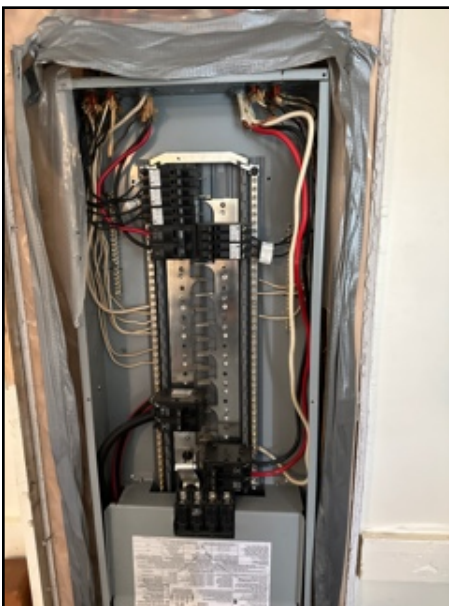
Breakers need to be labelled to identify which circuits they operate.

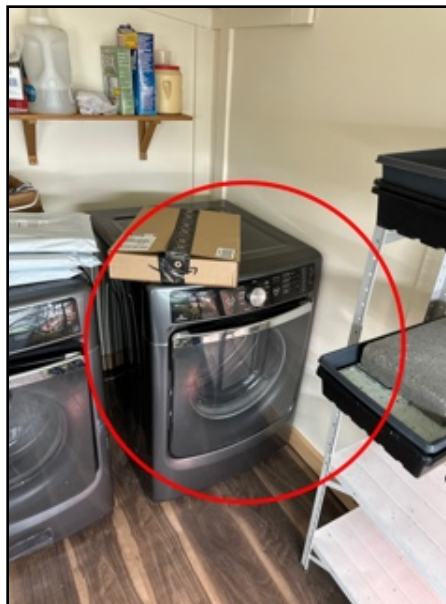
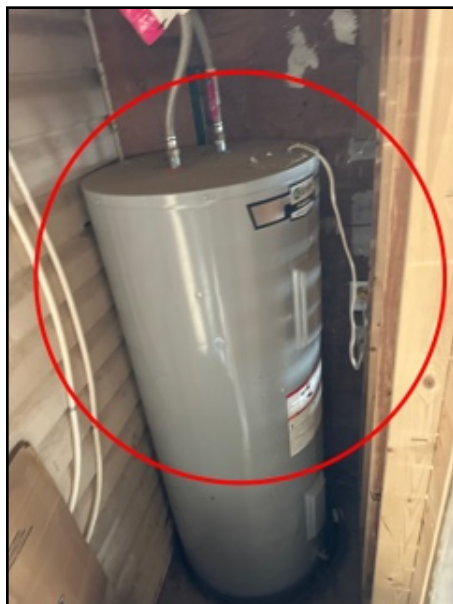
The dryer and the hot water heater are on the same circuit. This is a poor installation and a safety concern. Further evaluation is needed by an electrician for proper installation and repairs.

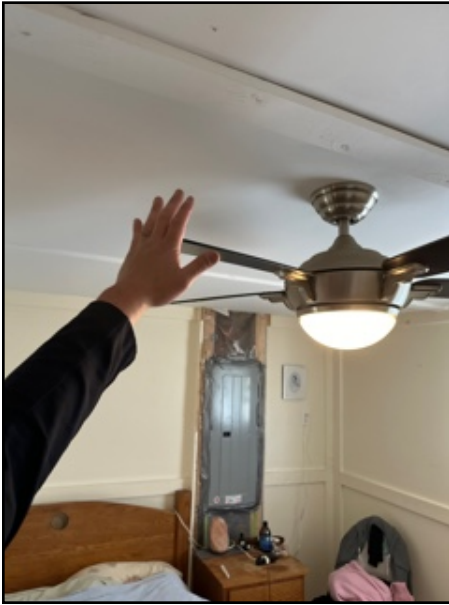
Figure 43-1

Ceiling fan in the bedroom is too low and is a risk for injury. I recommend raising the fan or replacing with a light fixture to prevent an accident.

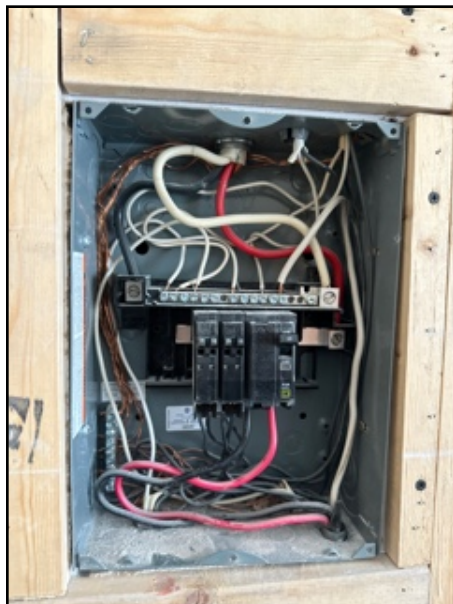
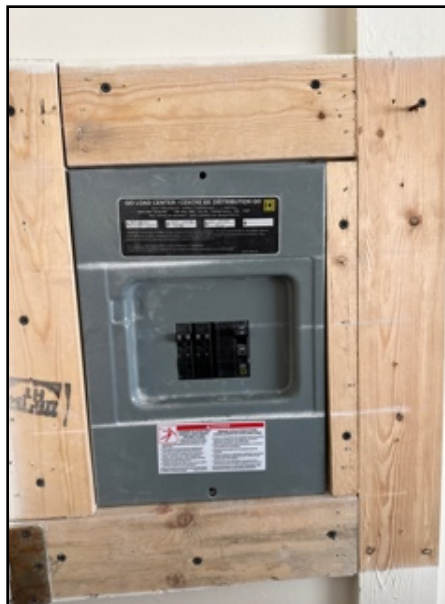
Sub panel located in guest bedroom.

70 amp disconnect with copper branch wiring.

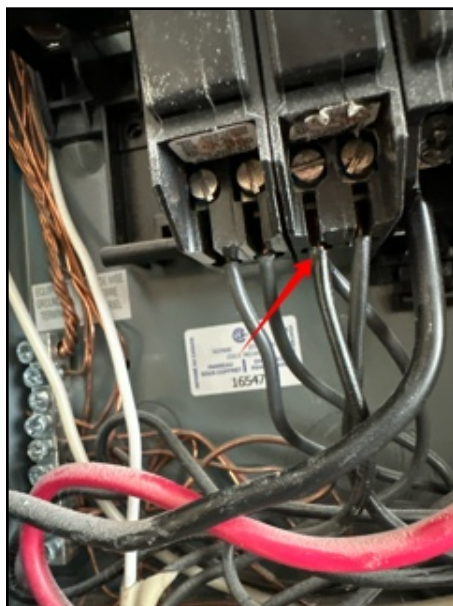
Figure 45-1

Location: sub panel

Have repaired by an electrician.

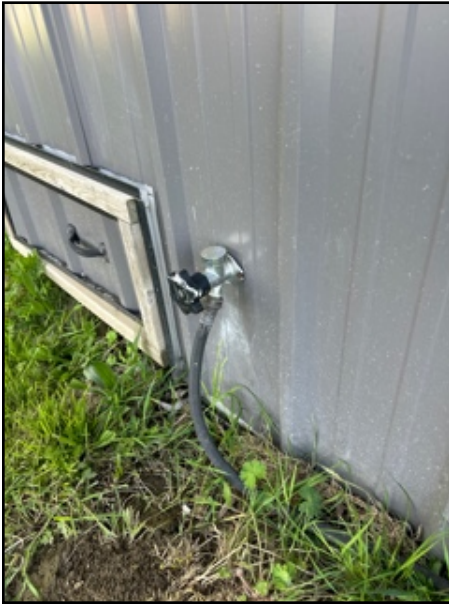
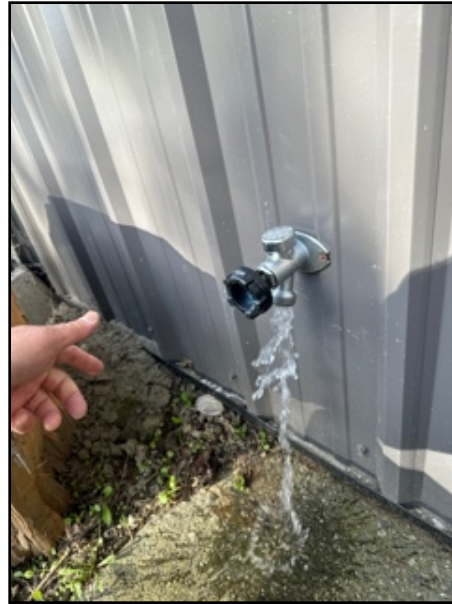
Comment 46:
Frost free hose bib observations.

Ensure to disconnect hose bibs during the winter time to prevent the possibility of freezing and potential damage to the tap.

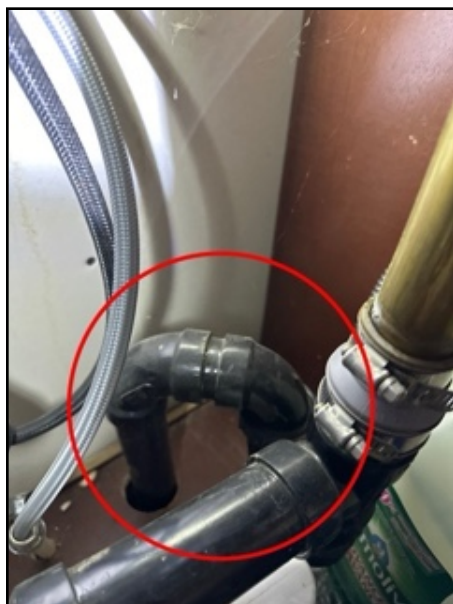
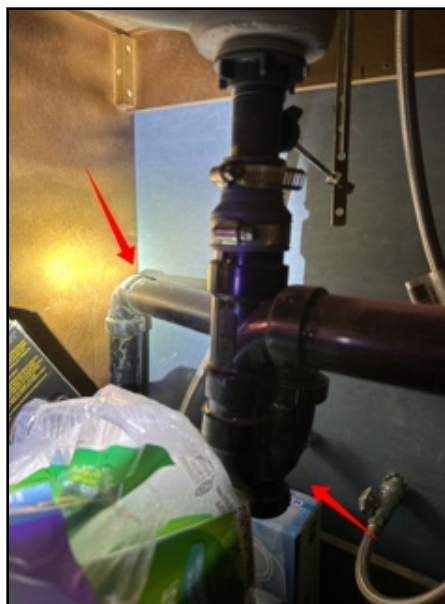
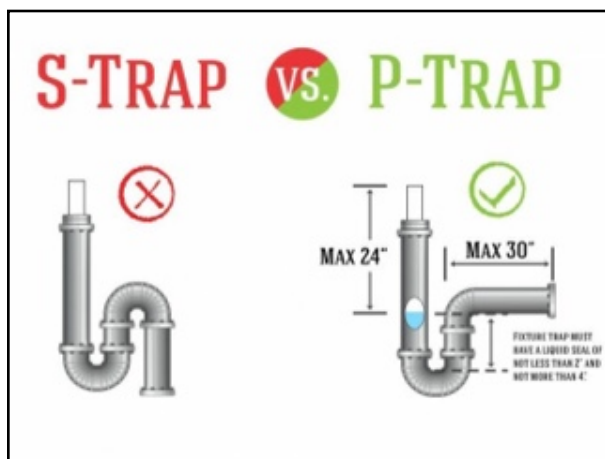
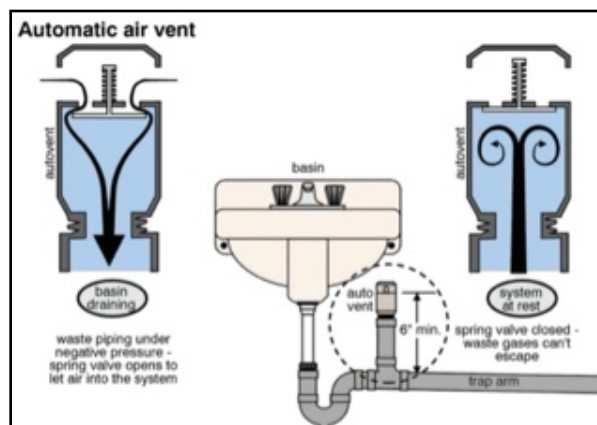
Comment 47:
Drain pipe under sink is in the form of an S trap and should be a P trap. This can allow siphoning of the drain and harmful gasses to enter the home. I recommend having an auto vent added.

Location: kitchen and bathroom sinks

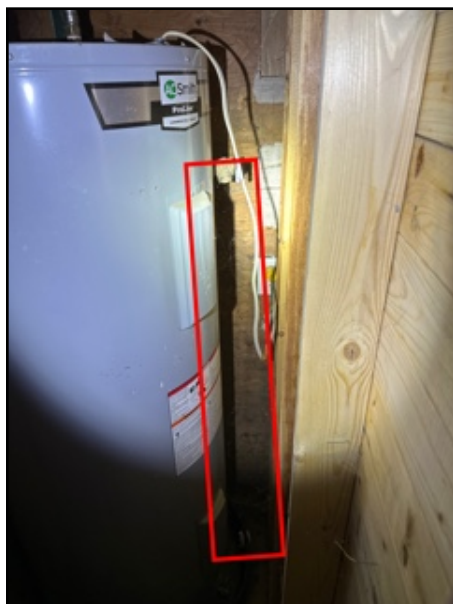
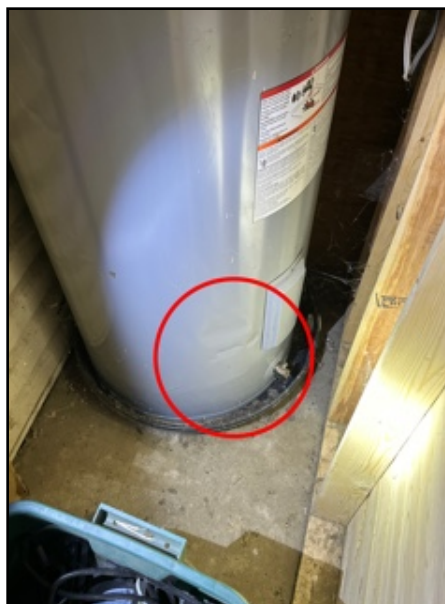
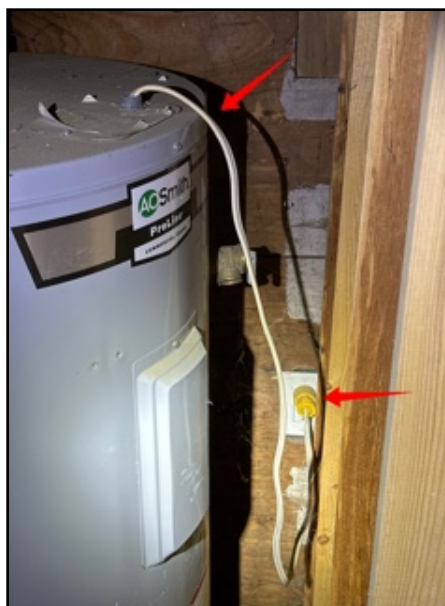
The vacuum breaker and the TPR discharge line is missing. There is denting observed to the exterior of this tank. This tank has been plugged into an outlet which is a poor installation. Normally, electric water heaters should be hard wired with its own dedicated circuit for proper installation. I recommend further evaluation by a plumber for improvements and repairs.

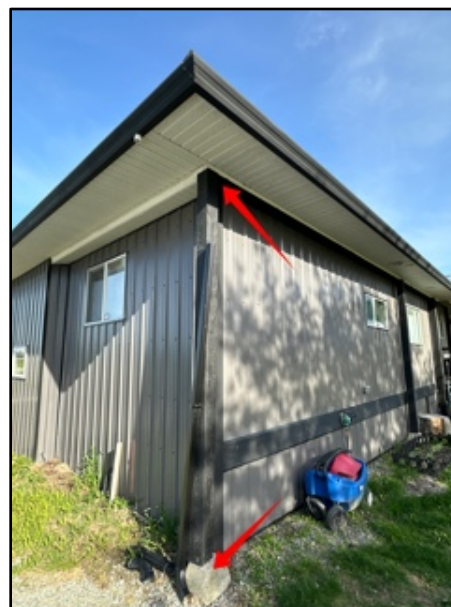
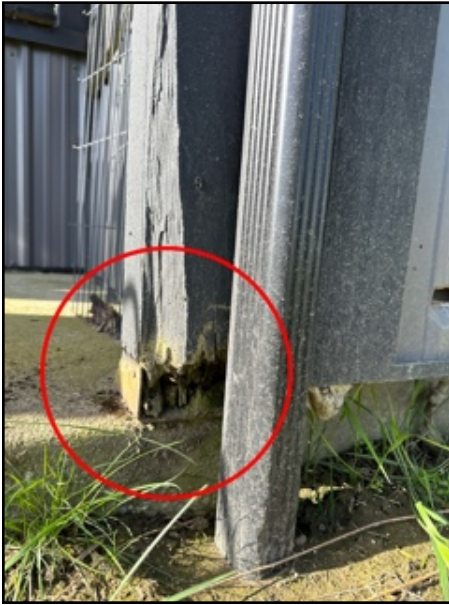
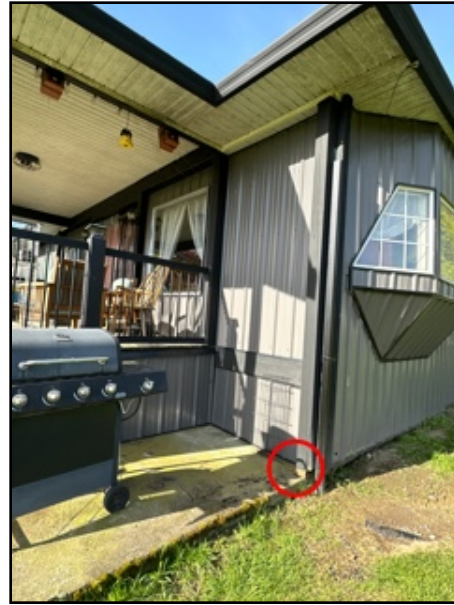
There are exterior posts noted around the home on the east side with pier block footings which appear to be structural support for the roof of the home. The post on the south east is loose from the footing and may be due to settlement. I recommend a general contractor further evaluate the structural integrity and installation of this roof for adequate load bearing support and safety.

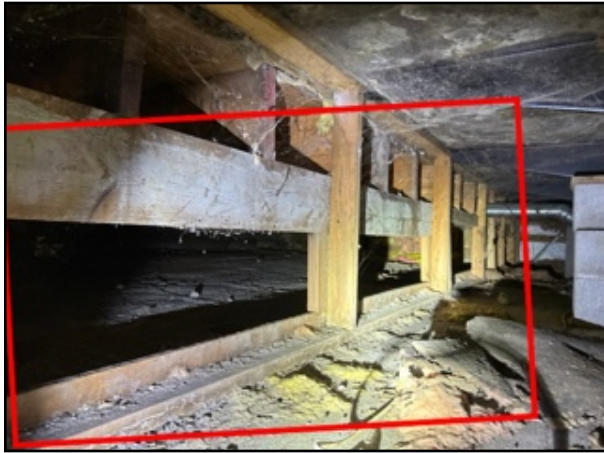
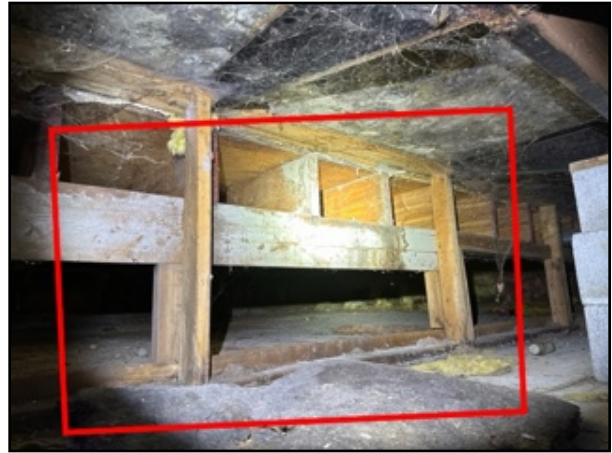
Poor structural support is noted for the addition side. The knee wall is inadequate and may not have the proper structural load bearing support needed for the addition floor.

I recommend further evaluation by a general contractor to determine the scope of work for the addition and any needed improvements for safety.

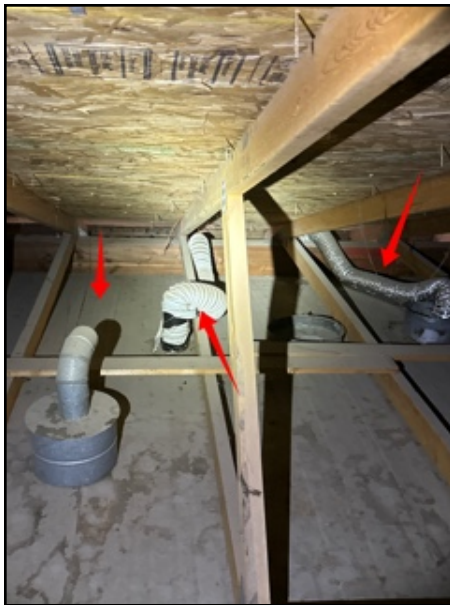
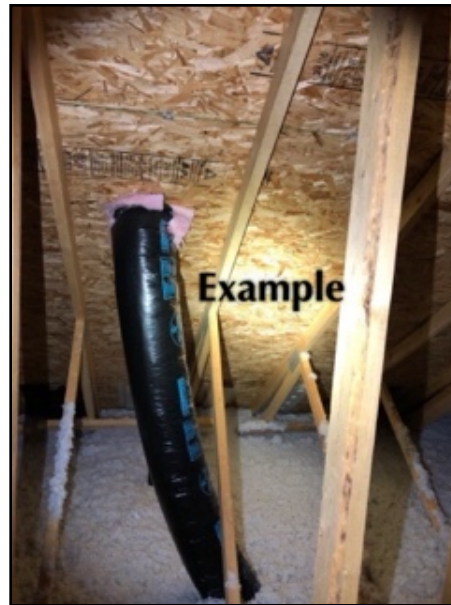
**Comment 51:**
Bathroom ducting material in the attic and its current installation needs improvements.

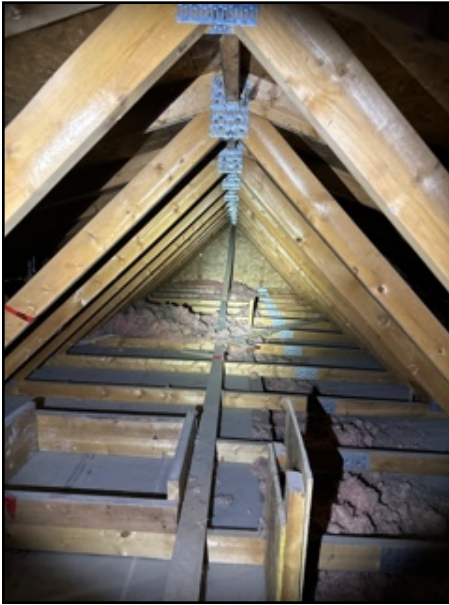
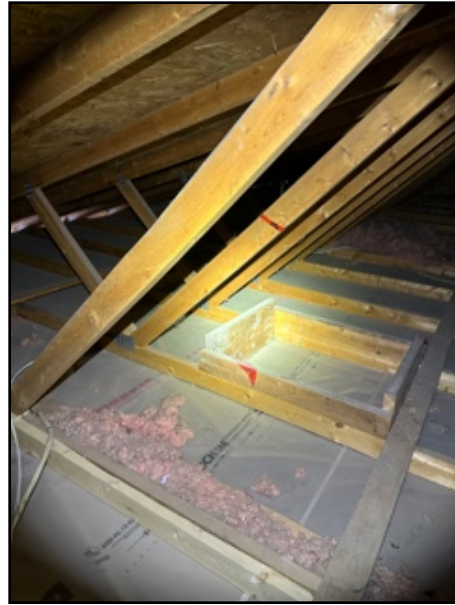
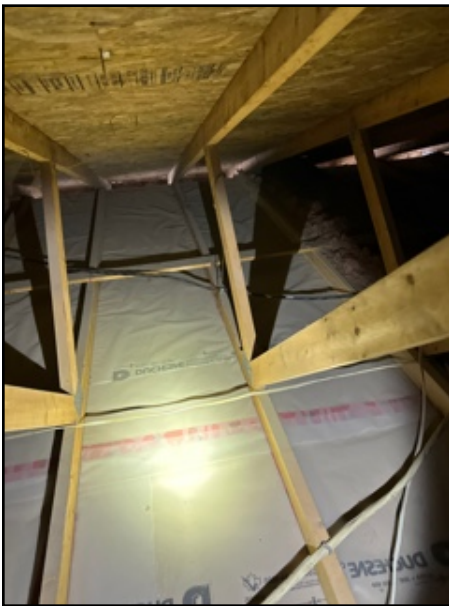
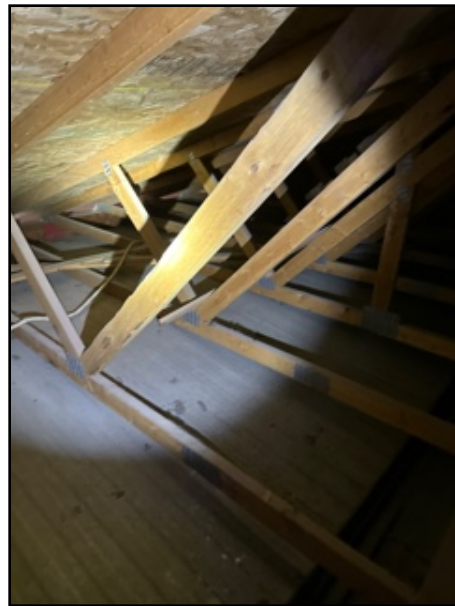
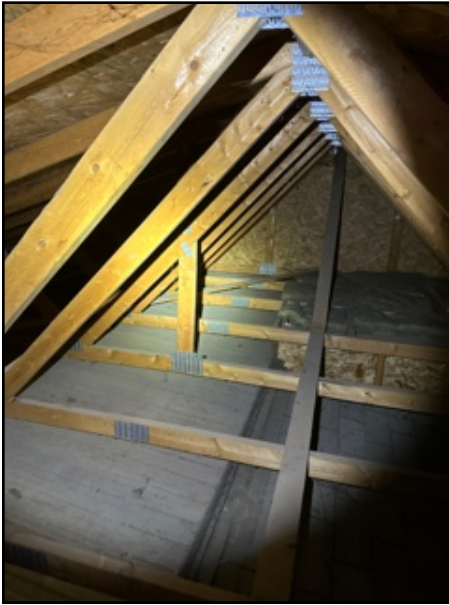
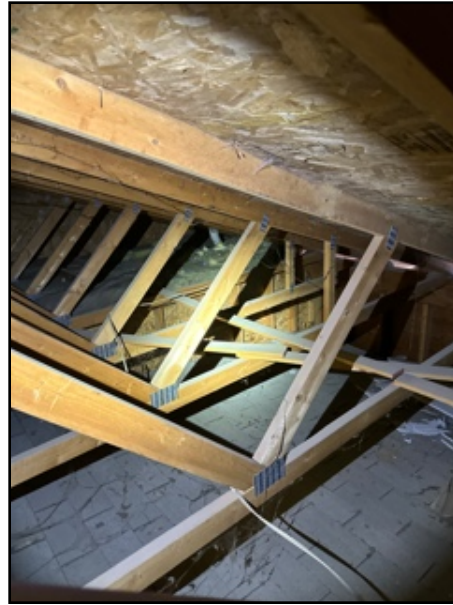
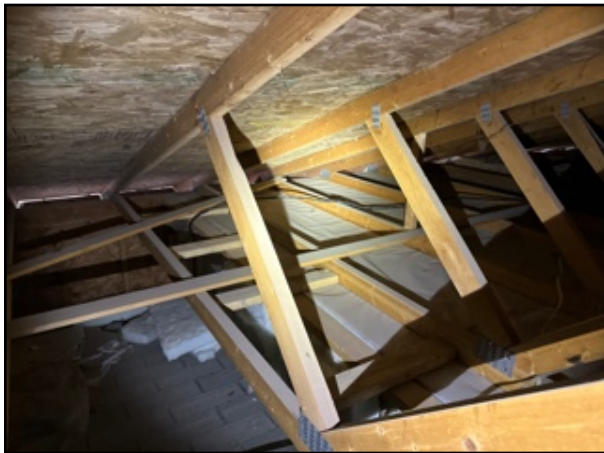
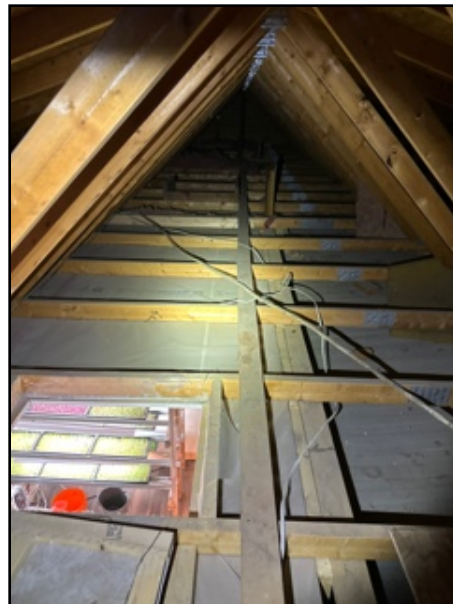
Insulation is missing at several locations of the attic floor. Repairs are needed for improved thermal efficiency.
