Home Inspection Report

38201 JONES ROAD (mobile home)

Mission, BC V0M1H0

Inspected on Tue, Apr 23 2024 at 08:45

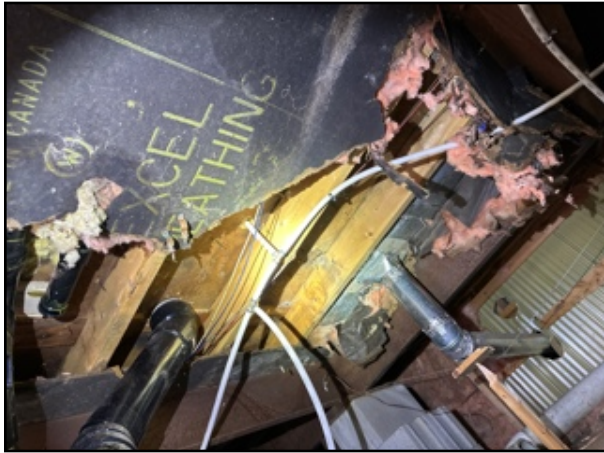
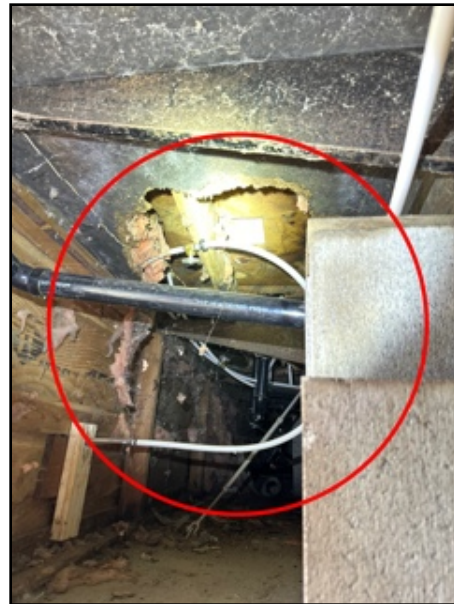
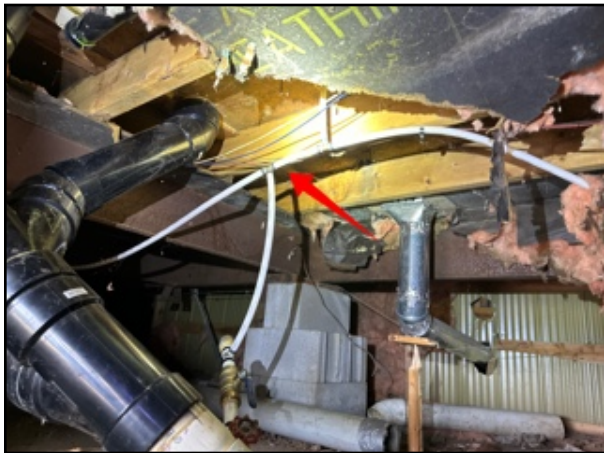
**Comment 56:**
Underbelly of the mobile home has been damaged at multiple locations and fibreglass insulation missing. Have installed and sealed for thermal efficiency.
- There are exposed water pipes in the crawlspace without insulation or heat tracing. These pipes are vulnerable to freezing. Anticipate improvements by a plumber.
- Damaged furnace ducting noted at one area. Repairs are needed by an HVAC contractor.

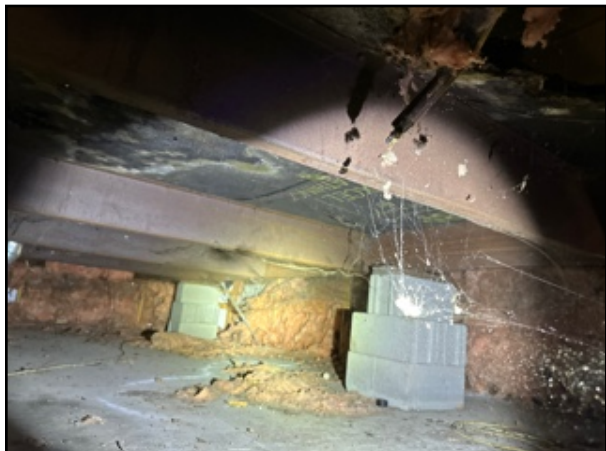
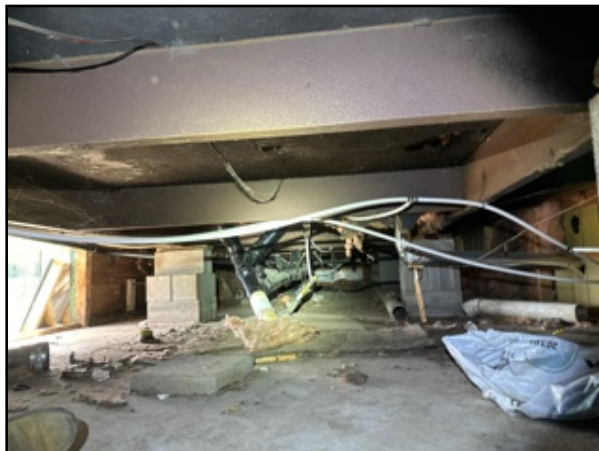
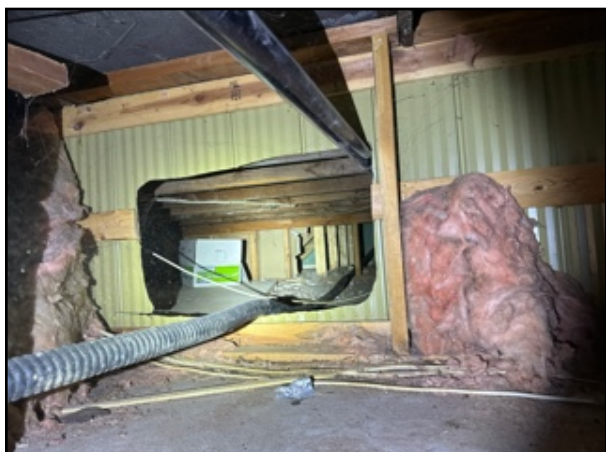
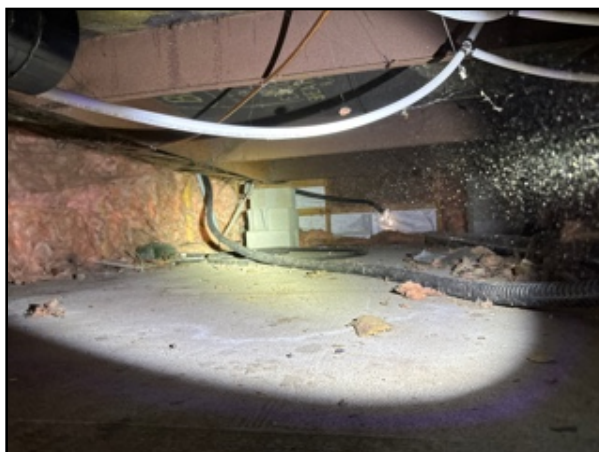
Crawlspace observations. Crawlspace was inspected from immediate area of the hatch due to low clearance.

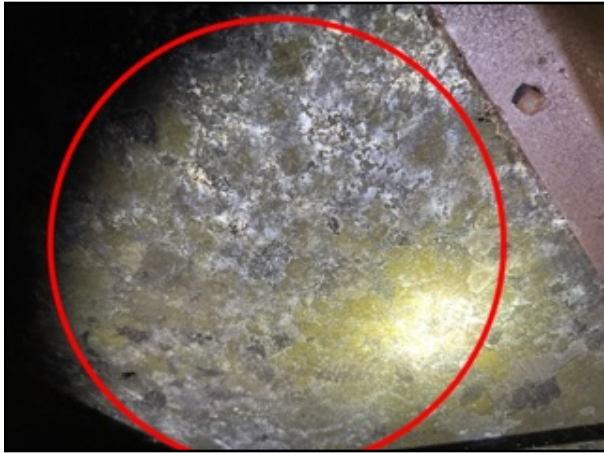
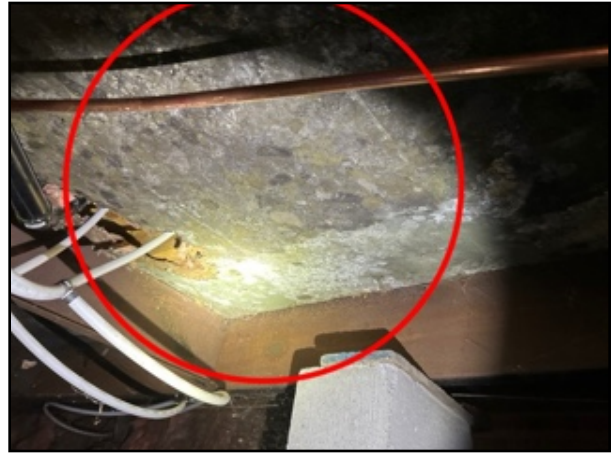
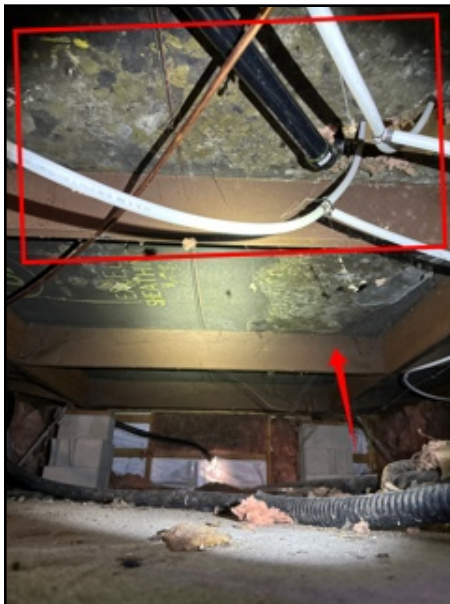
There is organic growth and moisture damage observed to the particle sub floor at several locations in the crawlspace. This could be due to past leaking issues. Inquire with current owner regarding past leaks on this area and repairs made.

Organic growth will need remediation and subfloor repaired or replaced.

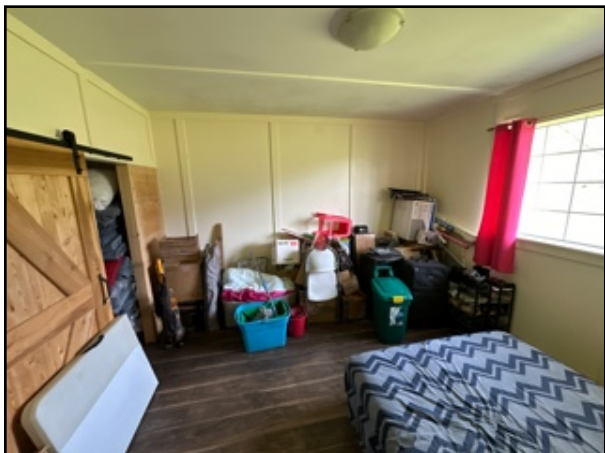
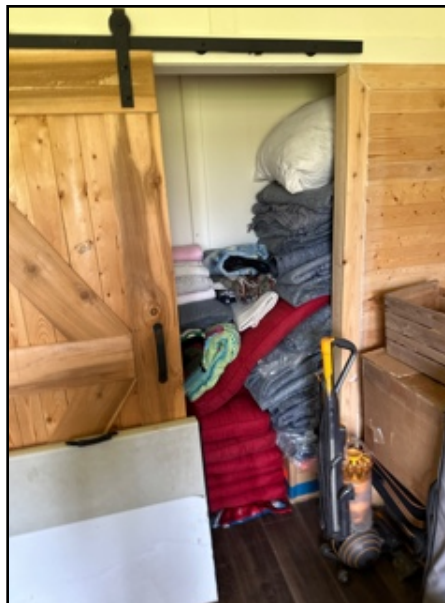
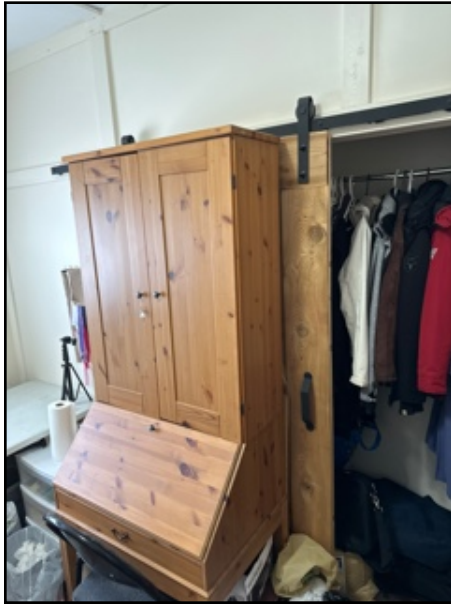
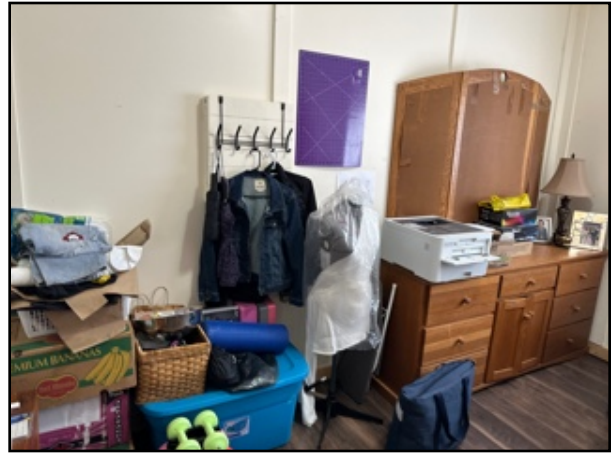
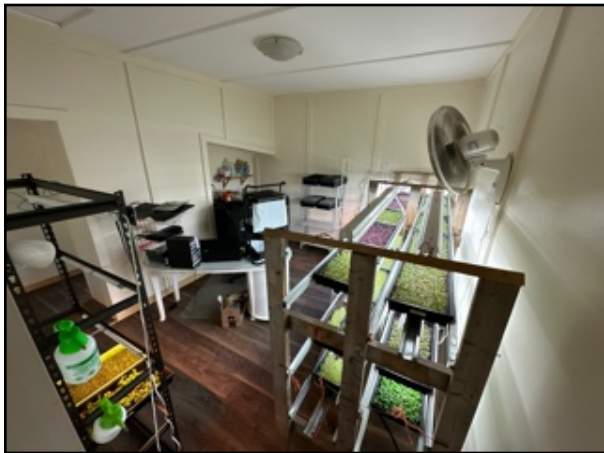
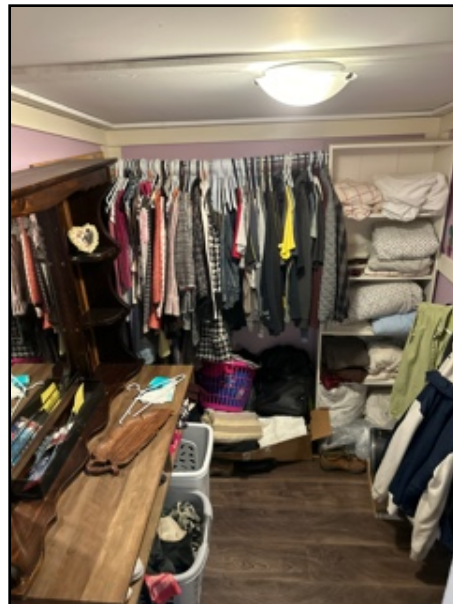
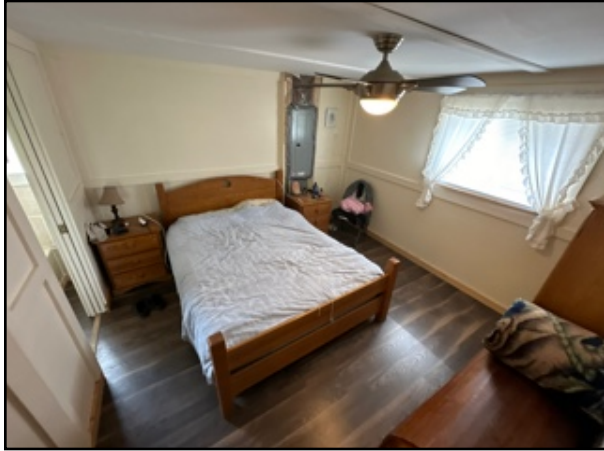
Comment 59:
Interior observations.
