Address of Property:

392055 Range Road 62
AB

2023-07-28

HouseMaster Serving Central Alberta

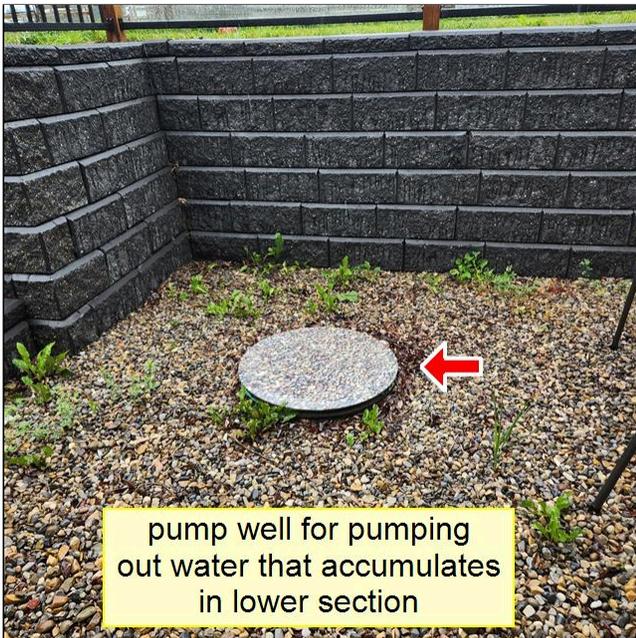
3.4 EXTERIOR FEATURES / WATER INTRUSION FACTORS (Picture 1)

*****Item 3.4. Inspector was confused. This sump functions correctly. The arena septic gets manually out when alarm sounds*****

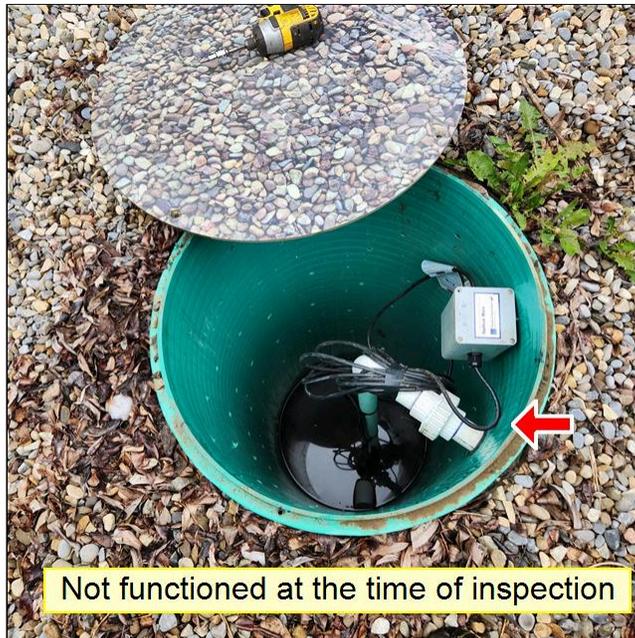
4.6 SUMP PUMP (Picture 1)

Item 4.6 - Sump pump does function correctly and was not turned off. Again he was confused about the explanation regarding manually pumping out. It is the arena septic tank that gets manually emptied.

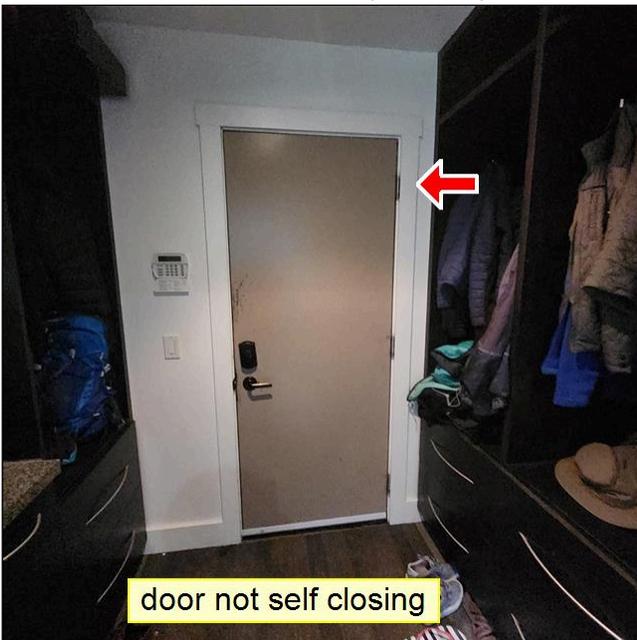
5.8 MAN DOOR (Picture 1)

door not self closing

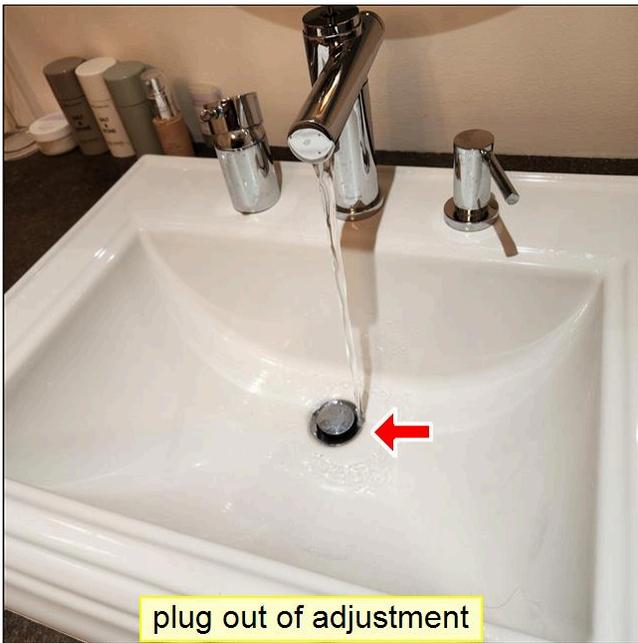
6.0.B SINK(S) (Picture 1)

plug out of adjustment

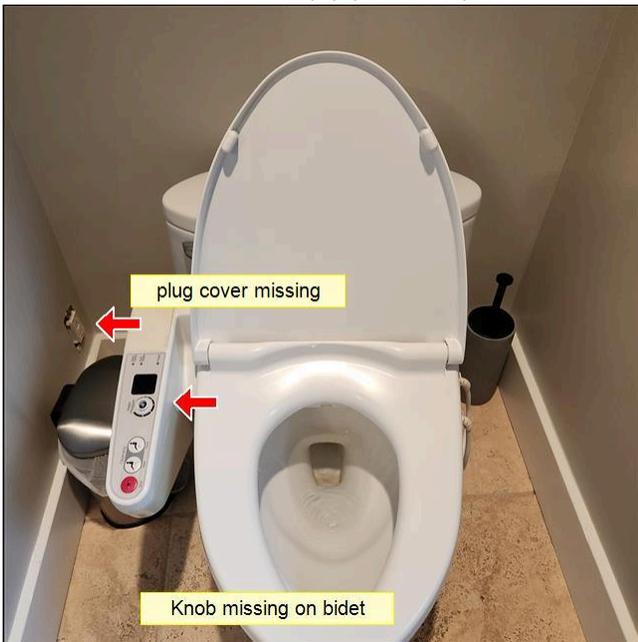
6.1.B TOILET (Picture 1)

plug cover missing

Knob missing on bidet

***Item 6.8B - Window fixed and closes.
***Item 6.1B - Fixed Cover

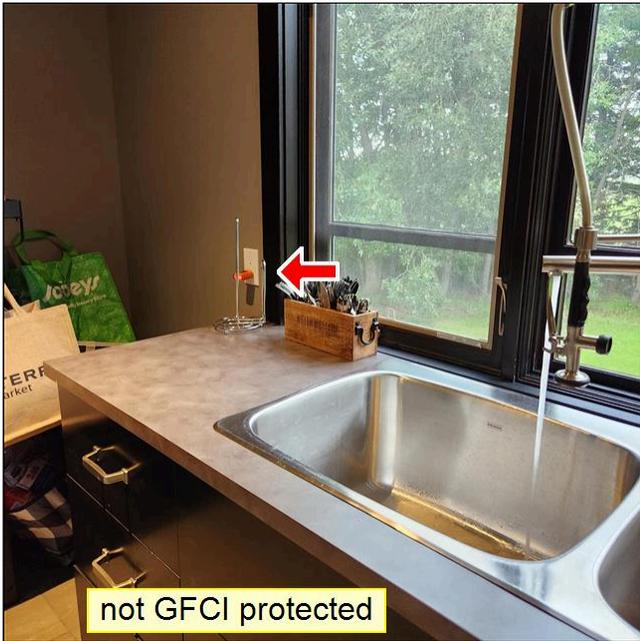
8.2 ELECTRIC / GFCI (Picture 1)

not GFCI protected

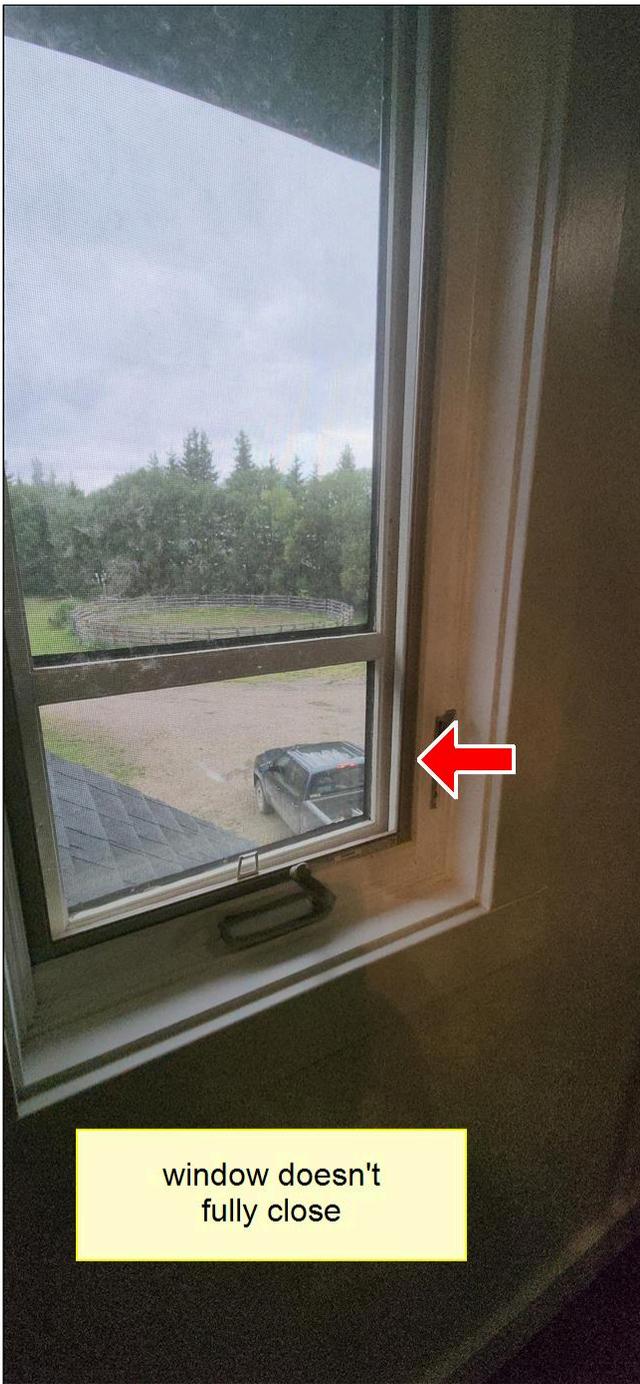
9.6 INTERIOR WINDOWS (Picture 1)

●					9.0 CEILINGS
●					9.1 WALLS
●					9.2 FLOORS
●					9.3 FLOORS (SLAB)
●					9.4 STAIRS
●					9.5 RAILINGS
	●				9.6 INTERIOR WINDOWS Window in master closet doesn't fully close. Recommend repair or adjustment by qualified window technician to ensure it closes correctly. The evaluation of windows is based on inspection of random, representative units and does not necessarily indicate the condition of all units.
●					9.7 INTERIOR ROOM DOORS Window in master bedroom doesn't close completely.
●					9.8 SMOKE DETECTOR Smoke detectors have a life span of ten years before replacement is needed. Recommend assessing all smoke detectors to ensure function
●					9.9 CARBON MONOXIDE DETECTOR
	●				9.10 BASEMENT WOOD FIREPLACE Fireplace has loose bricks and appears to be missing refractor brick missing. Recommend assessment by a qualified fireplace technician to pass WETT inspection.
●					9.11 ELECTRIC FIREPLACE Picture for reference.

window doesn't
fully close

*****Item 9.6 Window adjusted and fully closes**

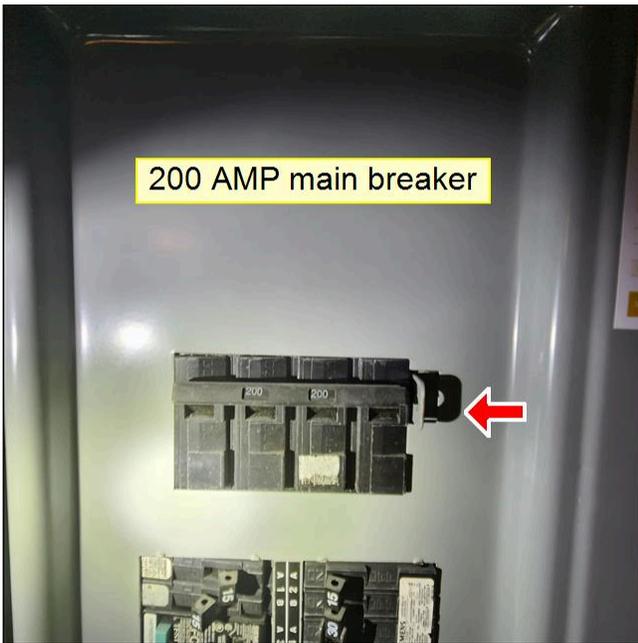
10.1 DISTRIBUTION PANEL (Picture 1)

●					10.0 SERVICE ENTRANCE / PANEL
	●				10.1 DISTRIBUTION PANEL 200 Amp main breaker. All copper wires noted through panel and house. Double tap noticed in panel. Double tap is when two wires are run to a single breaker. Recommend assessment by qualified electrician.
●					10.2 SERVICE GROUNDING PROVISIONS
●					10.3 SUBPANEL(S) 100 AMP sub panel next to 200 AMP main panel. Second sub panel wired
●					10.4 WIRING / CONDUCTORS (EXPOSED)
●					10.5 REPRESENTATIVE DEVICES
●					10.6 ARC-FAULT CIRCUIT INTERRUPTER TEST
●					10.7 GROUND-FAULT CIRCUIT-INTERRUPTER TEST
●					10.8 IMPORTANT NOTE (1) The inspection of the electric systems is limited to readily visible and accessible elements as listed herein. Wiring and other components concealed from view for any reason cannot be inspected. The identification of inherent material defects or latent conditions is not possible. (2) The description of wiring and other components and the operational testing of electric devices and fixtures are based on a limited/random check of representative components. Accordingly, it is not possible to identify every possible wiring material and type or all conditions and concerns that may be present.

*****Item 10.1 Double Tap changed out to all singles**

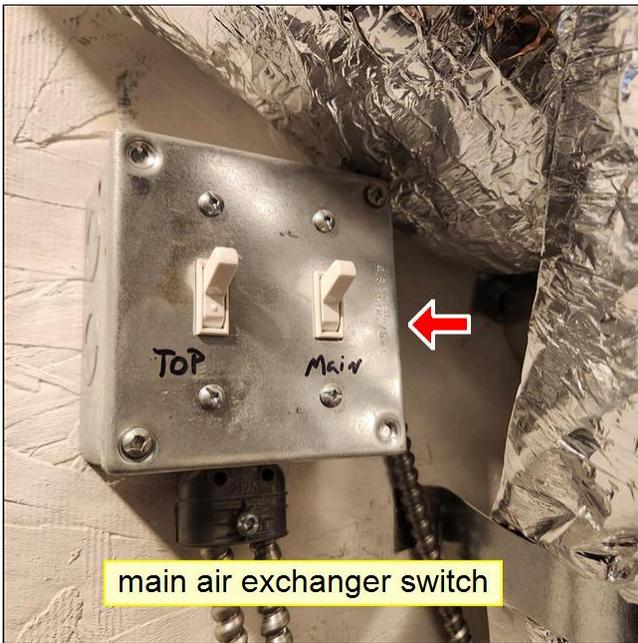
13.0 HEATING UNIT (Picture 5)

main air exchanger switch

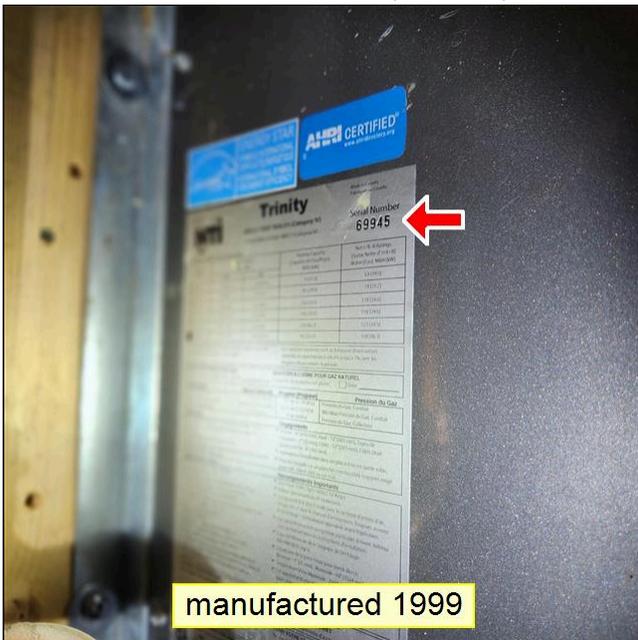
13.0 HEATING UNIT (Picture 7)

●						<p>13.0 HEATING UNIT Manufacture of NTI Trinity Boiler 1999 . Nu-Air Ventilation system is an integrated air handler with heating coils. Manufacture date 2005. Recommend having boiler and HRV/heat exchangers serviced prior to closing.</p>
●						<p>13.1 BURNER</p>
●						<p>13.2 FUEL LINE AT UNIT</p>
●						<p>13.3 COMBUSTION AIR PROVISIONS</p>
●						<p>13.4 VENT CONNECTOR</p>
●						<p>13.5 BLOWER Filter size 16x25x1 Recommend filters be replaced every 2-3 months when used. Recommend ducting be cleaned every 2-3 years.</p>
●						<p>13.6 THERMOSTAT</p>
				●		<p>13.7 HUMIDIFIER Not plugged in at the time of inspection.</p>
●						<p>13.8 DISTRIBUTION SYSTEM (EXPOSED)</p>
●						<p>13.9 FURNACE ROOM DOOR</p>
●						<p>13.10 ----- BOILER SYSTEM 1 -----</p>
●						<p>13.11 CIRCULATOR PUMP</p>
●						<p>13.12 IMPORTANT NOTE (1) A standard home inspection does not include a heat loss analysis, heating design or adequacy evaluation, energy efficiency assessment, installation compliance check, chimney flue inspection or draft test, solar system inspection, or buried fuel tank inspection. Furthermore, portable units and system accessories or add-on components such as electronic air cleaners, humidifiers, and water treatment systems are not inspected, unless specifically indicated. (2) Additional information related to the heating system may be found under other headings in this report, including the INTERIOR ELEMENTS and COOLING SYSTEMS sections.</p>

manufactured 1999

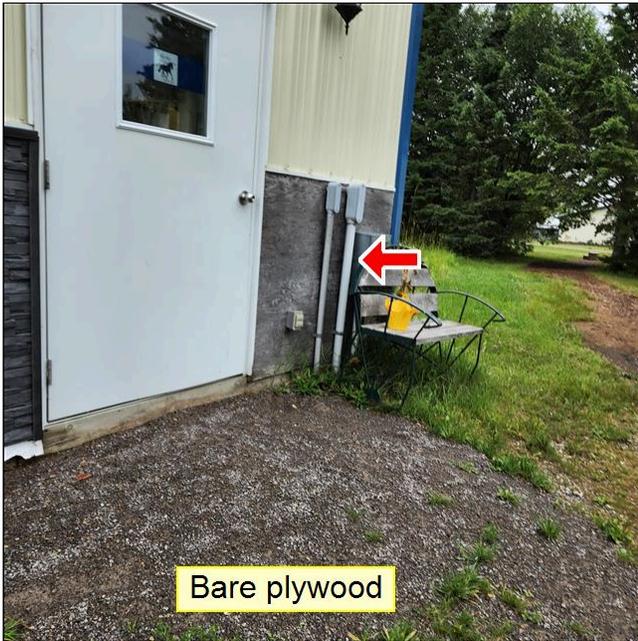
14.3(1) SIDING/EXTERIOR RIDING ARENA (Picture 1)

Bare plywood

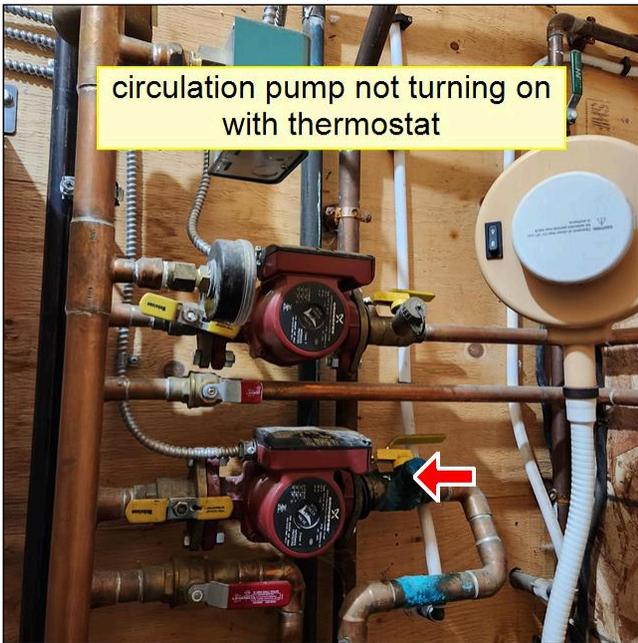
14.4 STABLE INFLOOR HEATING/PLUMBING (Picture 1)

Kitec piping

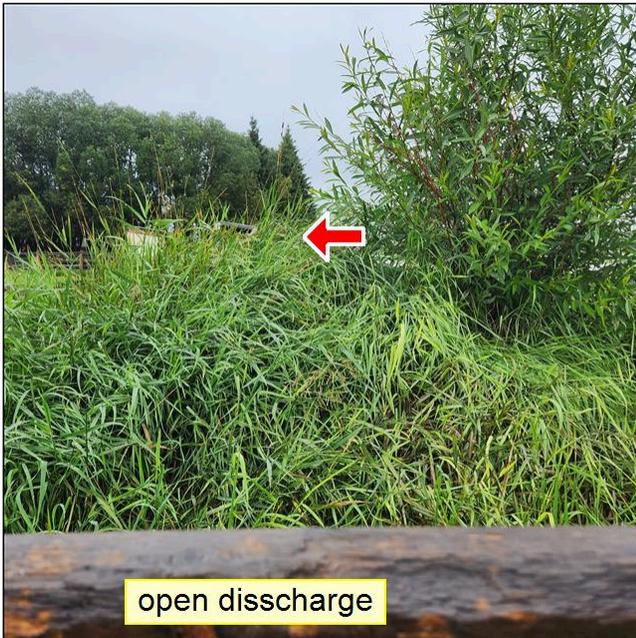
16.1.A CONDITIONS AT FIELD (Picture 1)

●					16.0.A DRAINAGE FROM FIXTURES
●					16.1.A CONDITIONS AT FIELD Open discharge at mound.
●					16.2.A INSPECTION PORT Settling tank is high in solids at the time of inspection. Recommend having tank pumped out. Septic tanks appear to be in newer condition possibly within the last 5 years. System working correctly at the time of inspection.
●					16.3.A TANK LID / BAFFLES
●					16.4.A LIFT PUMP

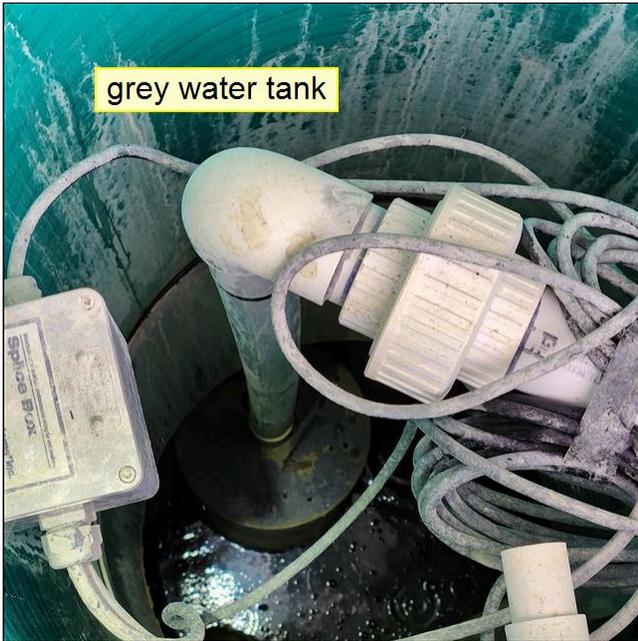
16.2.A INSPECTION PORT (Picture 2)

grey water tank

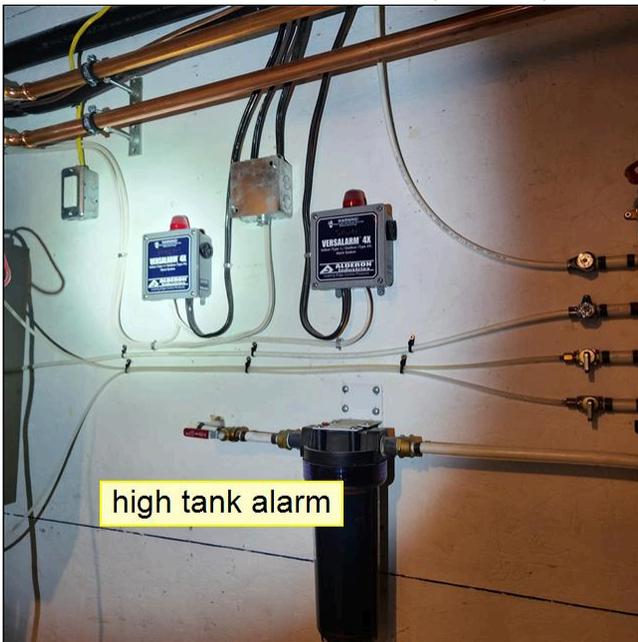
16.2.A INSPECTION PORT (Picture 4)

high tank alarm

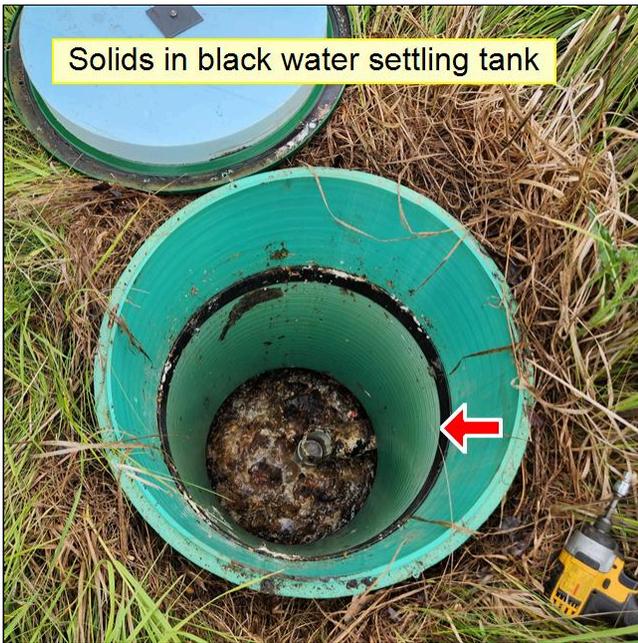
16.2.B INSPECTION PORT (Picture 3)

●					16.0.B DRAINAGE FROM FIXTURES
			●		16.1.B CONDITIONS AT FIELD
	●				16.2.B INSPECTION PORT Black water holding tank and grey water holding tank appear to be newer. Estimated less than 10 years. Black water holding tank appears to have a lot of solids in it at the time of inspection. Recommend having tanks sucked out and cleaned. Tanks are for containment with no field or discharge present.
●					16.3.B TANK LID / BAFFLES
			●		16.4.B LIFT PUMP Lift pump present but not functioned. Owner explained prior to inspection that he pumps tank out manually when tank alarm shows grey water holding tank is full. Pump is equipped with float, but there is no hose connected to outlet.

Solids in black water settling tank

*****Item 16.2.B Tanks emptied Sep 20/23**

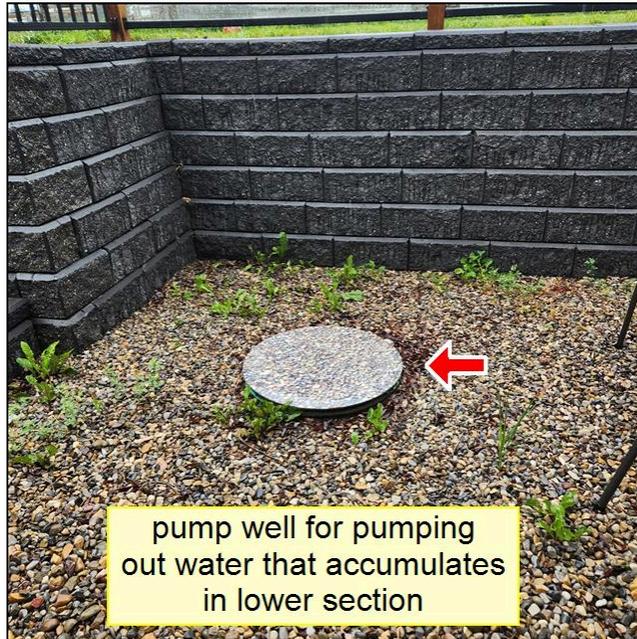
3.4 (Picture 1)

Pump to pump out water that accumulates in lower section. High water alert in basement beside septic pump. Not functioned at the time of inspection due to power being turned off. Owner told me before inspection that he turns the pump on and pumps it out manually when high alarm sounds.

Pump functioning correctly. Inspector confused on the manually pump out when high alarm sounds. That is the arena septic tank.

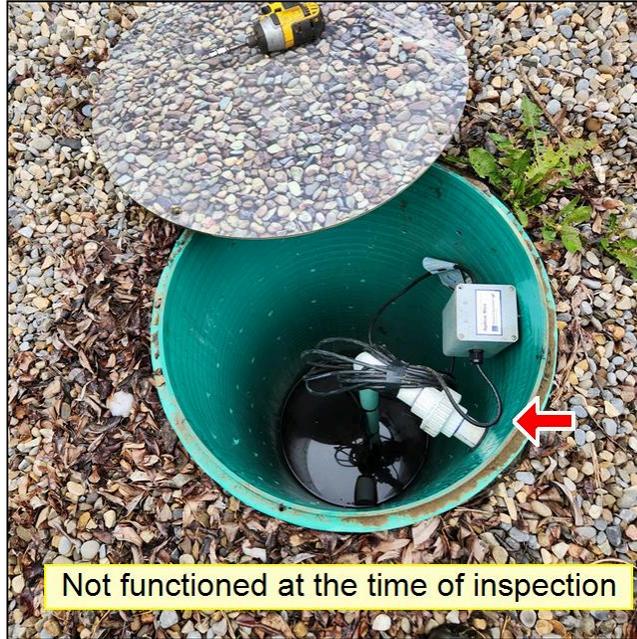
4.6 (Picture 1)

Located outside of basement walk out doors. Not functioned at the time of inspection due it being turned off. Owner explained prior to inspection that he turns pump on manually when high water alarm turns on.

Pump functioning correctly. Inspector confused on the manually pump out when high alarm sounds. That is the arena septic tank.

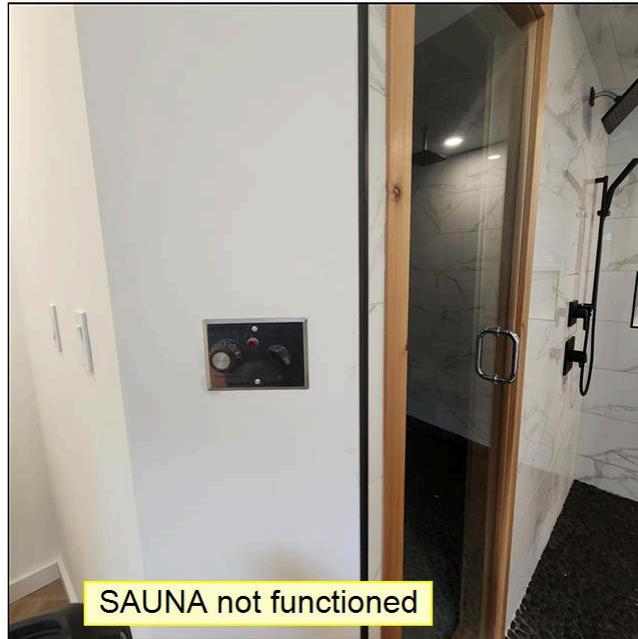
6.12.D (Picture 1)

Sauna not working at the time of inspection. Shut off at the breaker box.

Sauna on and functioning correctly

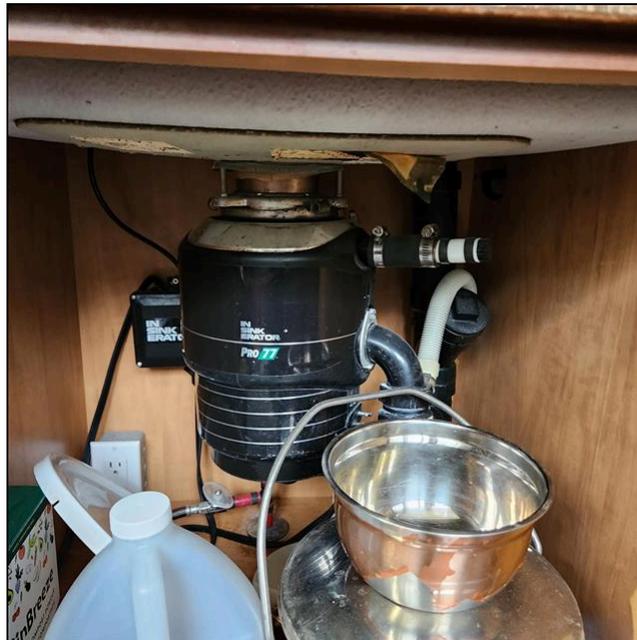
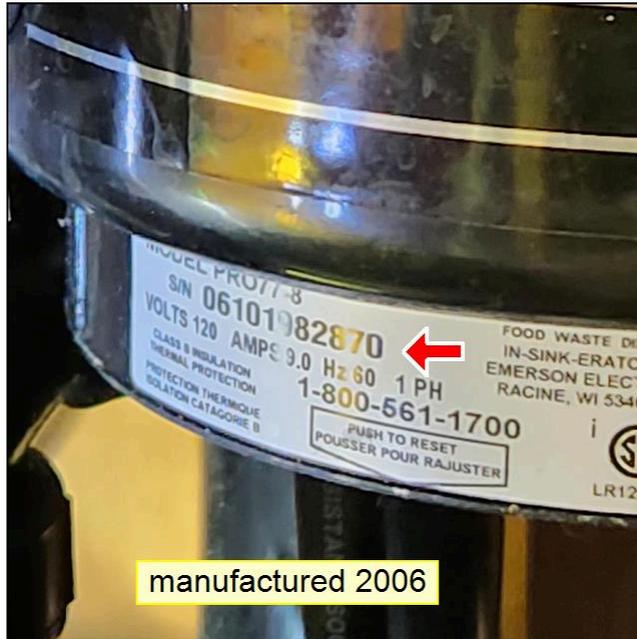
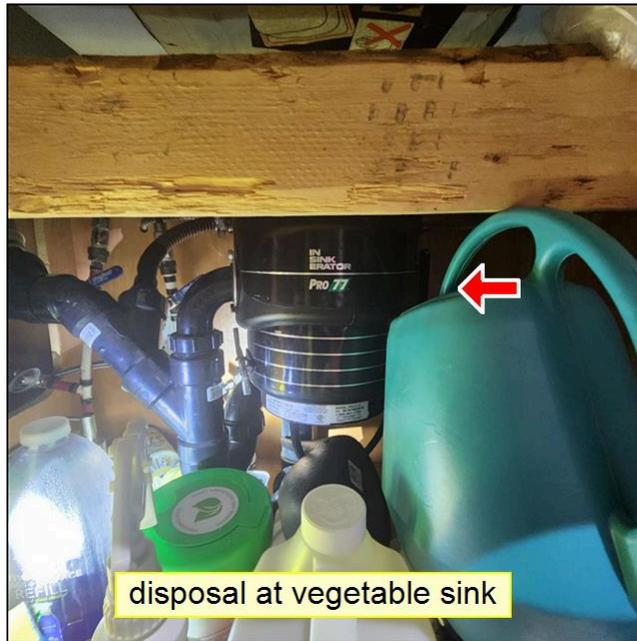
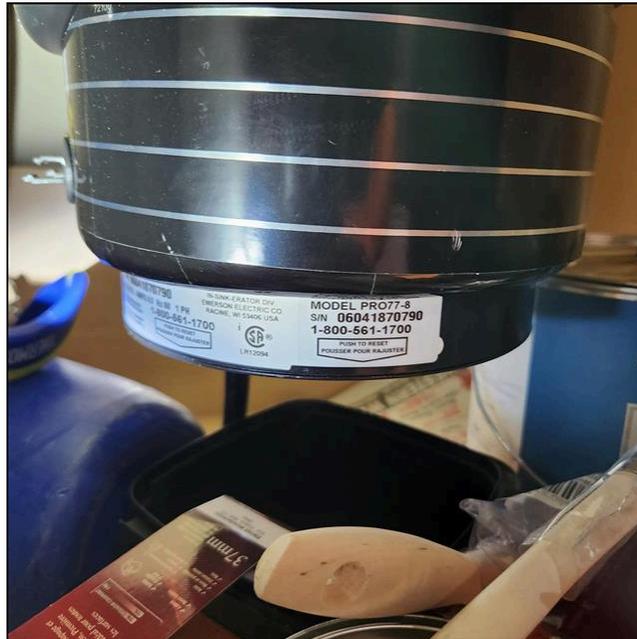
Three disposals present at the time of inspection. Manufactured 2006. The disposal closest to the window in the kitchen made a tickling sound when functioned.

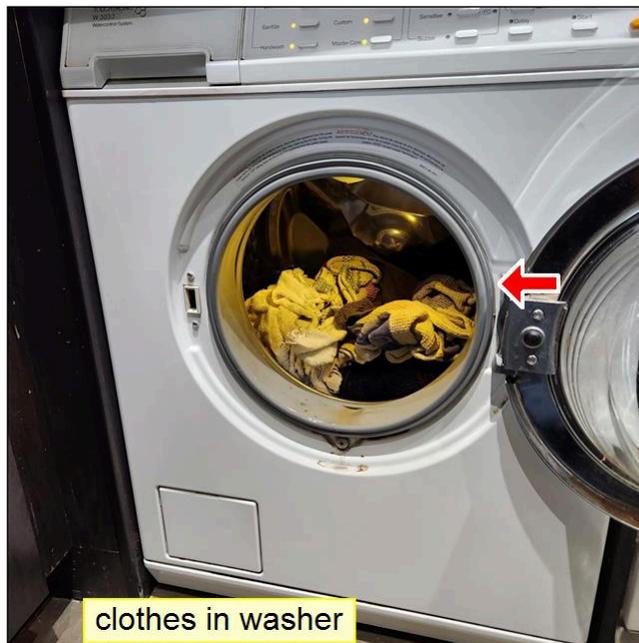
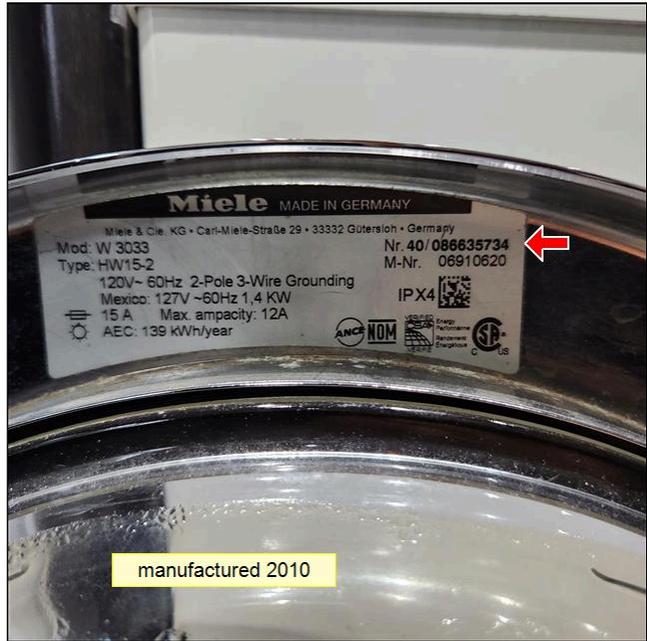
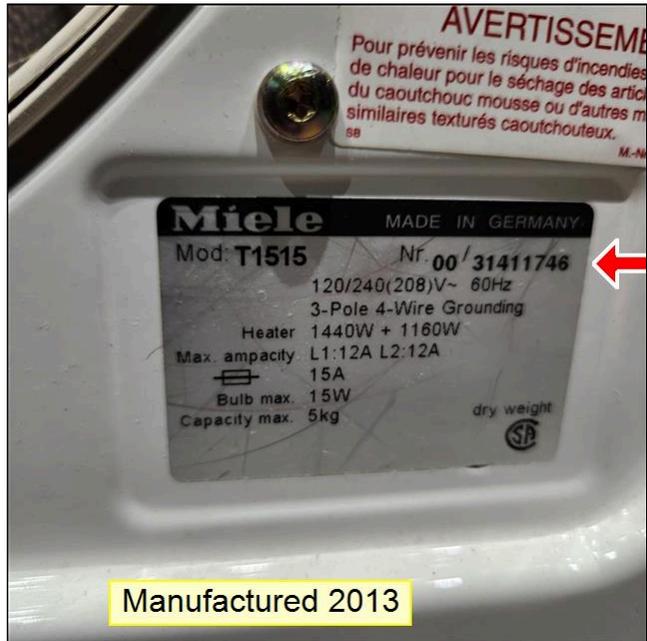
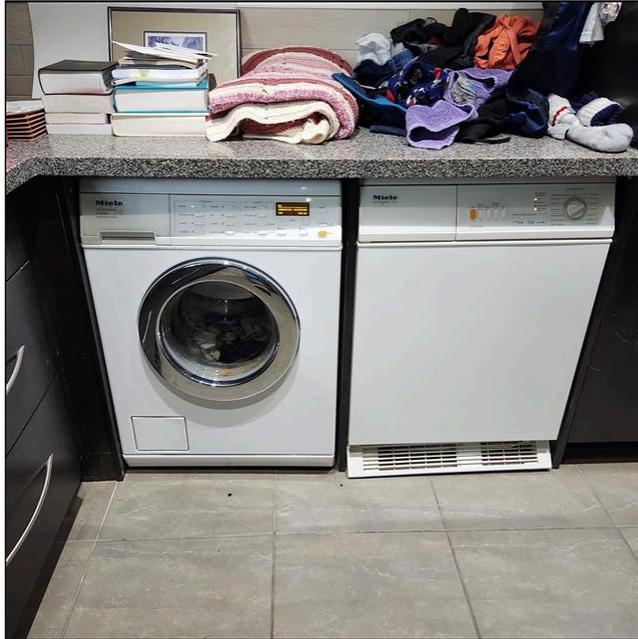
Clothes in washer at the time of inspection. Tested dryer for function. Washer estimated manufacture 2010, Dryer estimated manufacture 2013.

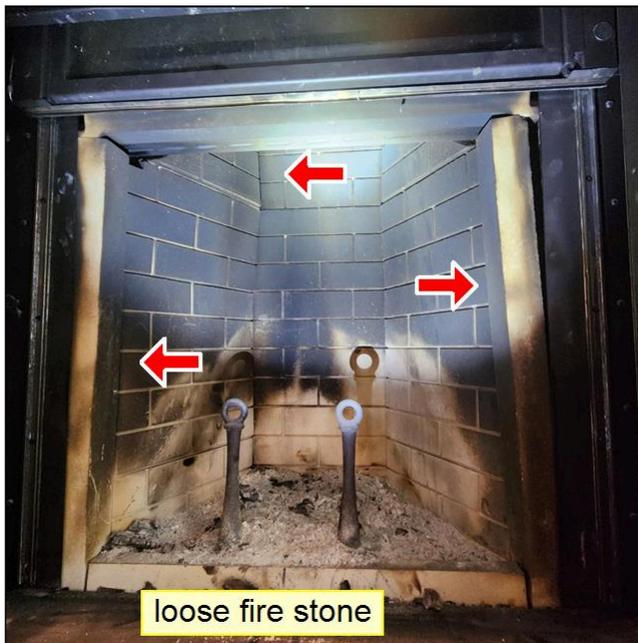
9.10 (Picture 2)

Fireplace has loose bricks and appears to be missing refractor brick missing. Recommend assessment by a qualified fireplace technician to pass WETT inspection.

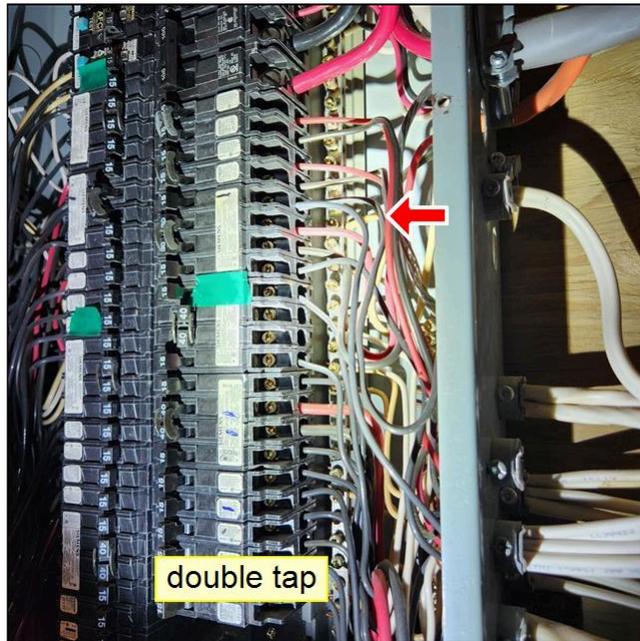
10.1 (Picture 2)

200 Amp main breaker. All copper wires noted through panel and house. Double tap noticed in panel. Double tap is when two wires are run to a single breaker. Recommend assessment by qualified electrician.

Double tap changed out to single

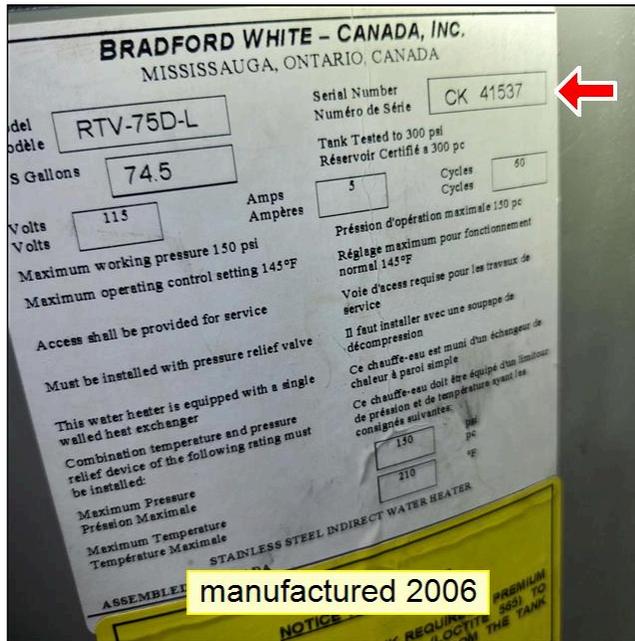
12.0 (Picture 1)

manufacture date 2006 . Hot water tank heated by boiler system.

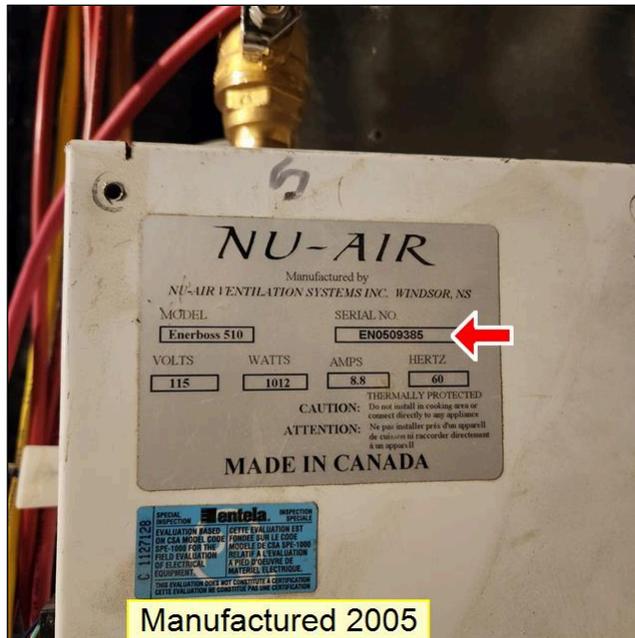
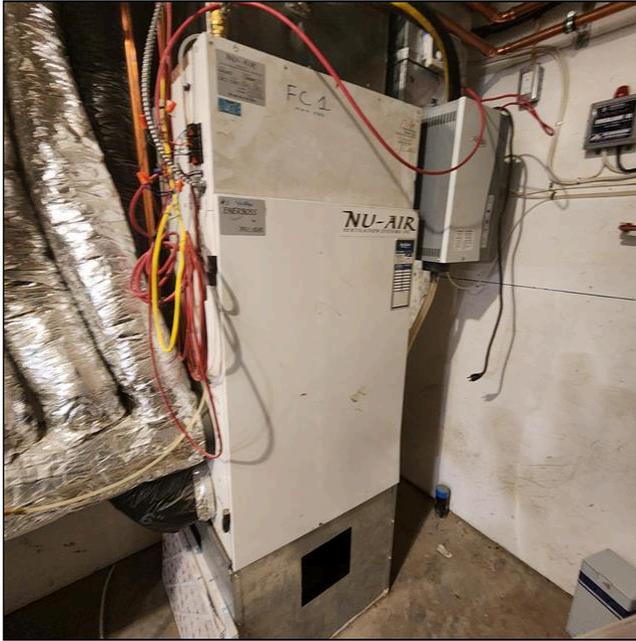
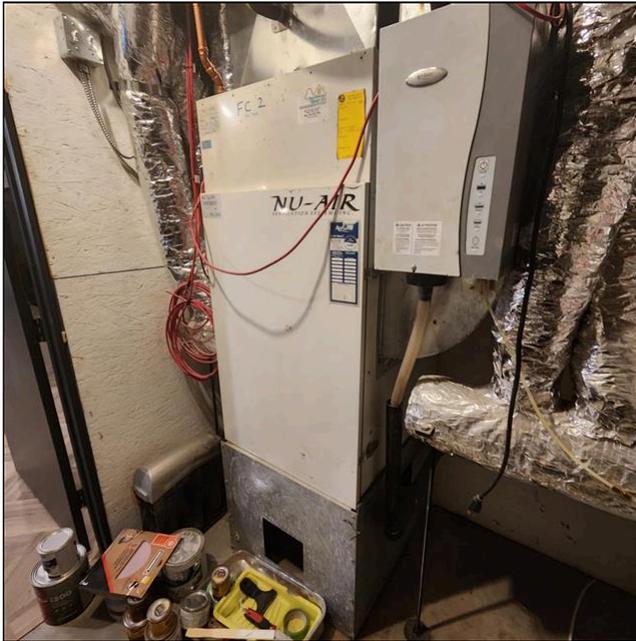
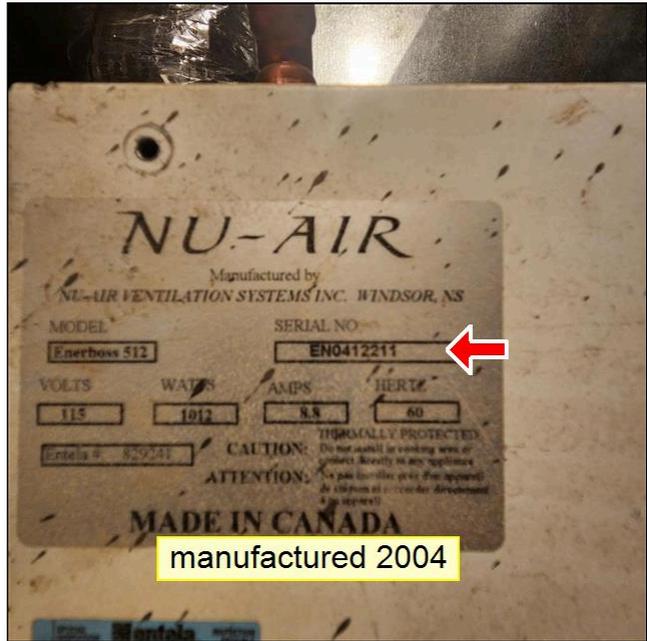
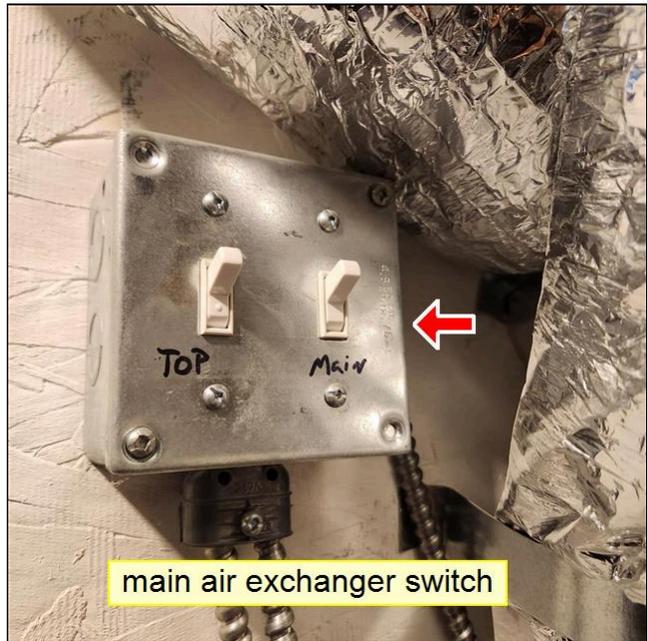
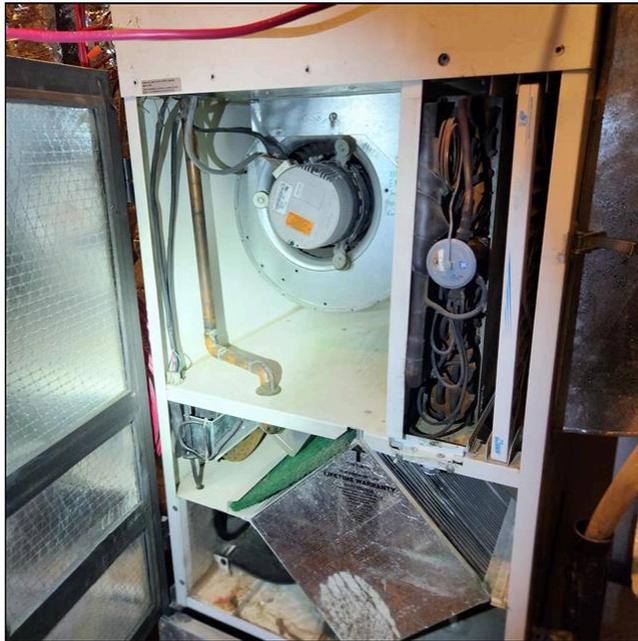
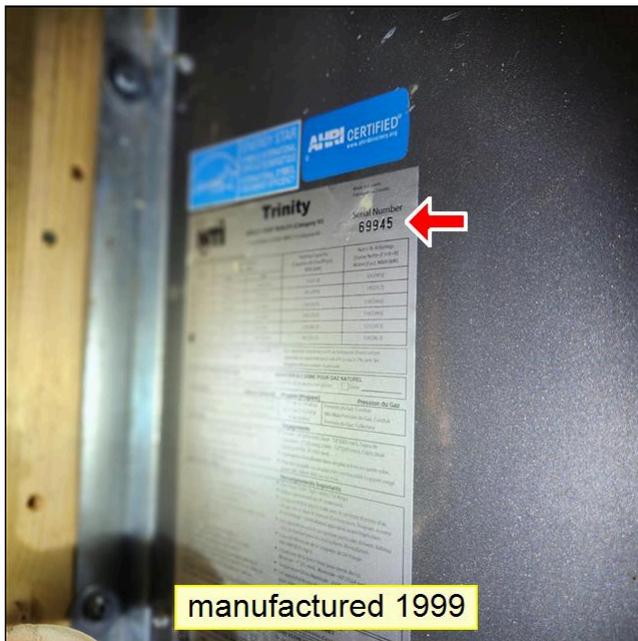
Manufacture of NTI Trinity Boiler 1999 .

Nu-Air Ventilation system is an integrated air handler with heating coils. Manufacture date 2005. Recommend having boiler and HRV/heat exchangers serviced prior to closing.

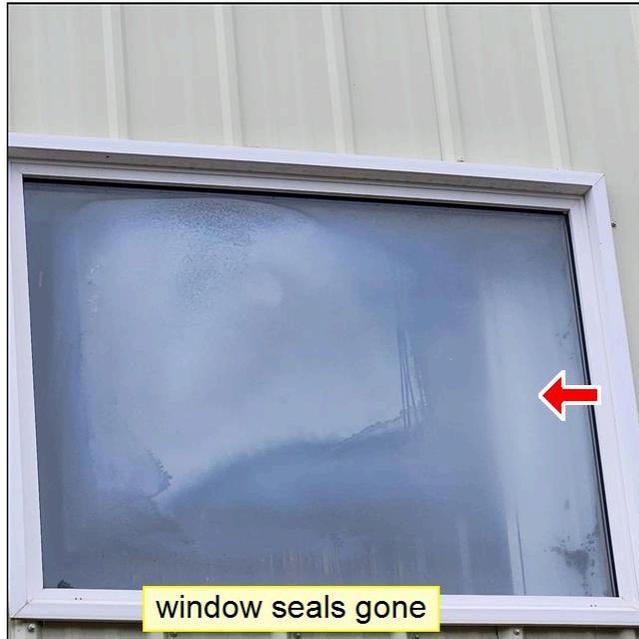
14.1 (Picture 2)

Noticed cracked windows and windows missing window seals (6 units) in riding arena. Recommend assessment of window units by a qualified window and door technician.

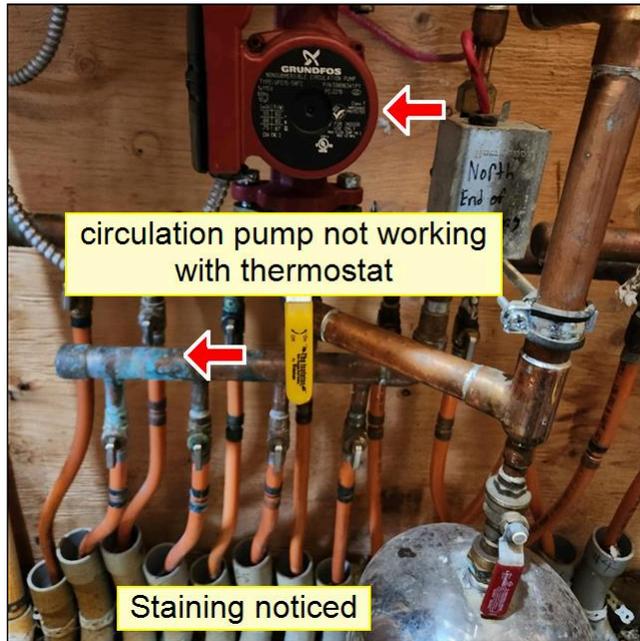
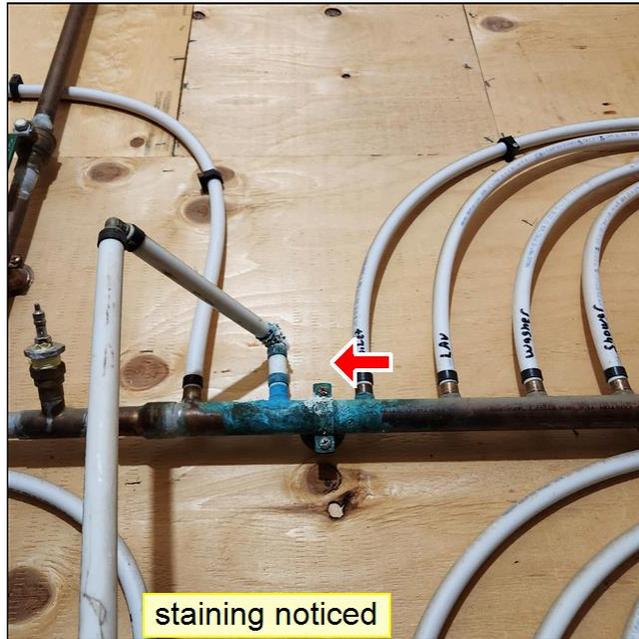
Stable in floor heating didn't turn on zoning valves/circulation pumps with thermo stats. Recommend having assessment and possible repair of components.

Kitec piping used for in floor used for in floor heating. Kitec piping sometimes has a reaction with crimped fittings which will show as white water staining at the crimp. Recommend assessing periodically to see if staining is starting to occur and if its observed having crimped ring replaced by plumber.

In floor heat inspected and repaired

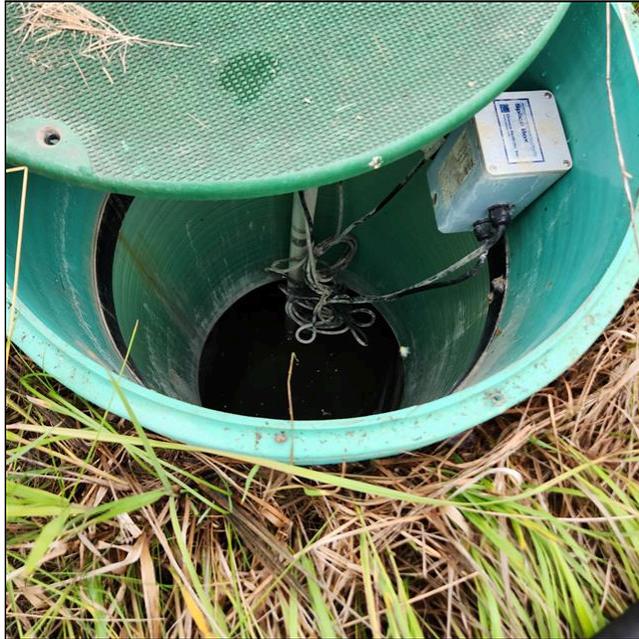
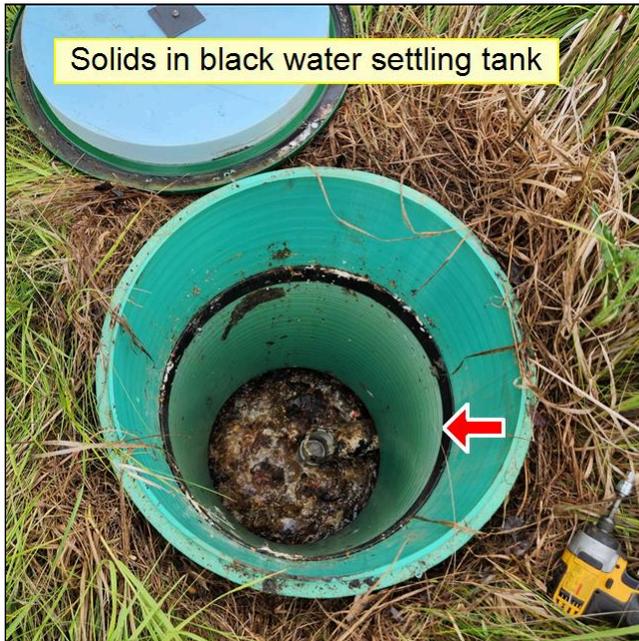
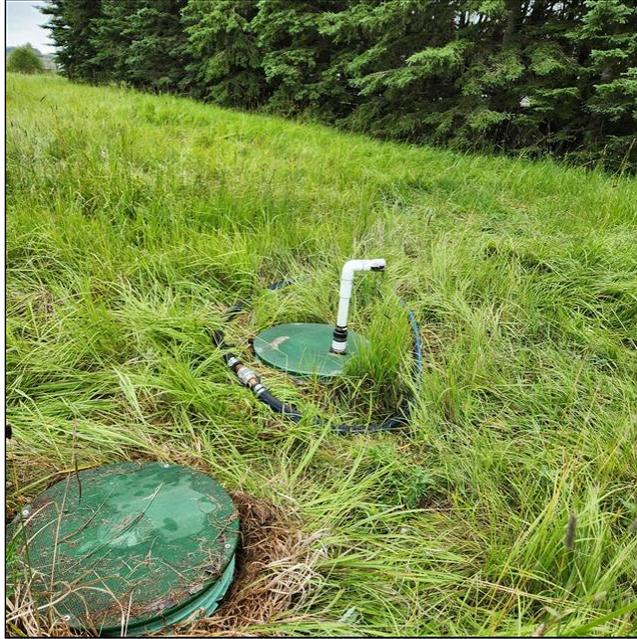
Black water holding tank and grey water holding tank appear to be newer. Estimated less than 10 years. Black water holding tank appears to have a lot of solids in it at the time of inspection. Recommend having tanks sucked out and cleaned. Tanks are for containment with no field discharge present.

Tank emptied Sep/23
