**SCOPED PHASE II
ENVIRONMENTAL SITE ASSESSMENT
20421 113 AVENUE NW
EDMONTON
ALBERTA**

Project Number: 2189

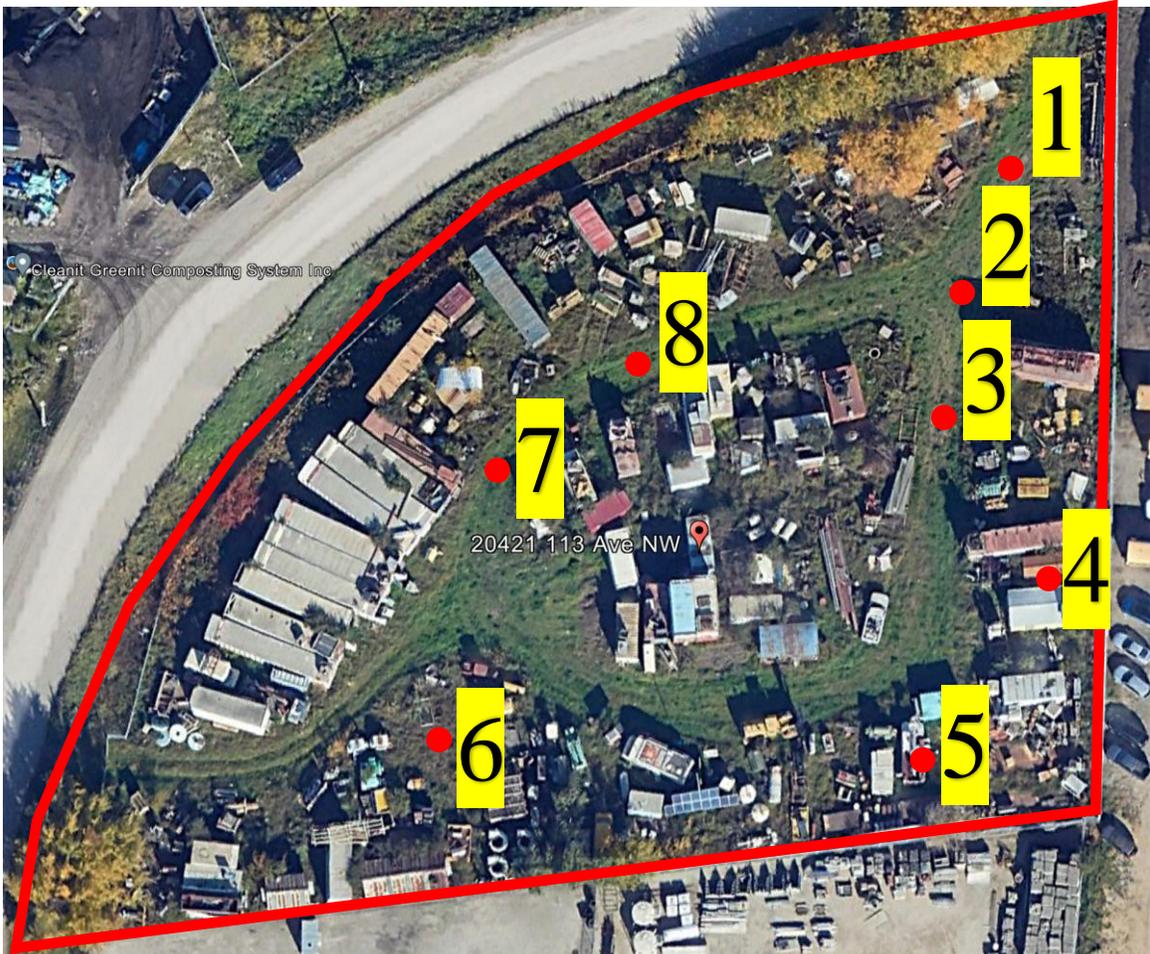
Figure 1: Site boundaries and locations of sampling sites

The site represents a storage yard which was used for many years as a storage yard for machinery and other items. The site location and location of the boreholes is shown below.

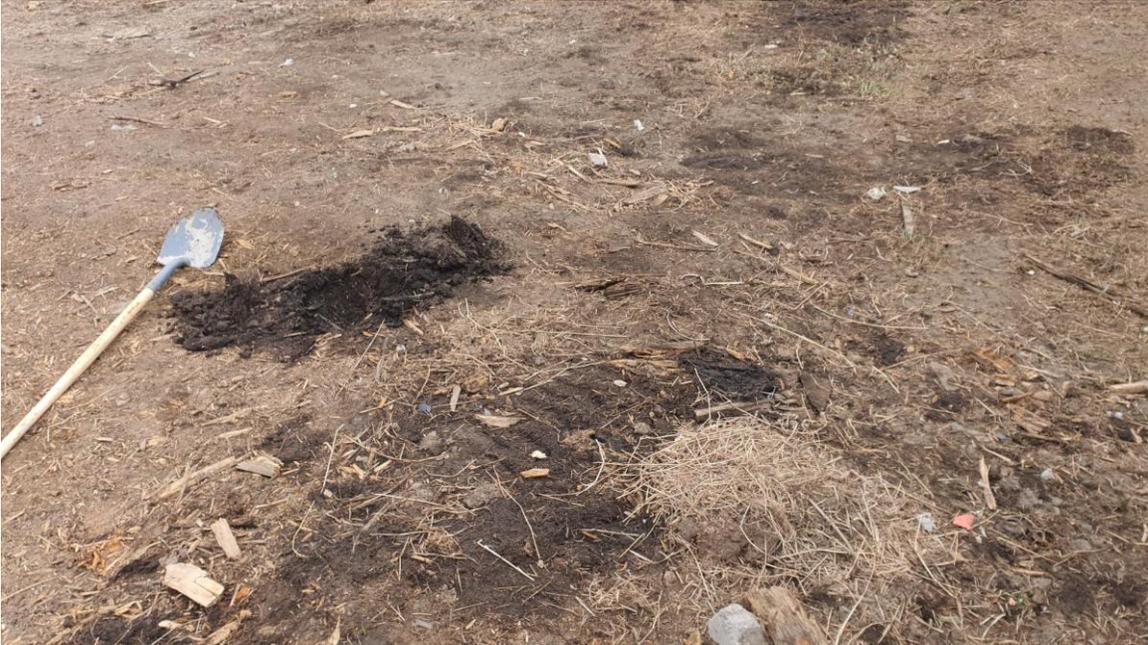
These results indicate contamination of the site at these locations by hydrocarbons potentially from spillage of oil and gasoline/diesel. Based on the staining on the surface which is present in some locations this is the most likely hypothesis. The soils were clayish material with the clay becoming more plastic with depth. The clay would likely form a confining layer to the movement of hydrocarbons and no staining was encountered in any of the boreholes beyond approximately 0.5m bgl. Soil samples were taken as a composite sample of material from 0.0-0.5m bgl.

Photo 1: Soil Staining with what appears to be oil

The site will require further delineation and removal of the contaminated material. This would be best undertaken with an excavator with confirmation sampling to ensure all the material has been removed. Visual staining is present however it is recommended that an excavator be used to dig trenches in a grid fashion to determine any further contamination for removal. Validation sampling to ensure removal and landfill classification laboratory testing would be required. It is likely that any contaminated material from hydrocarbons is only to a depth of approximately 0.5 metres.

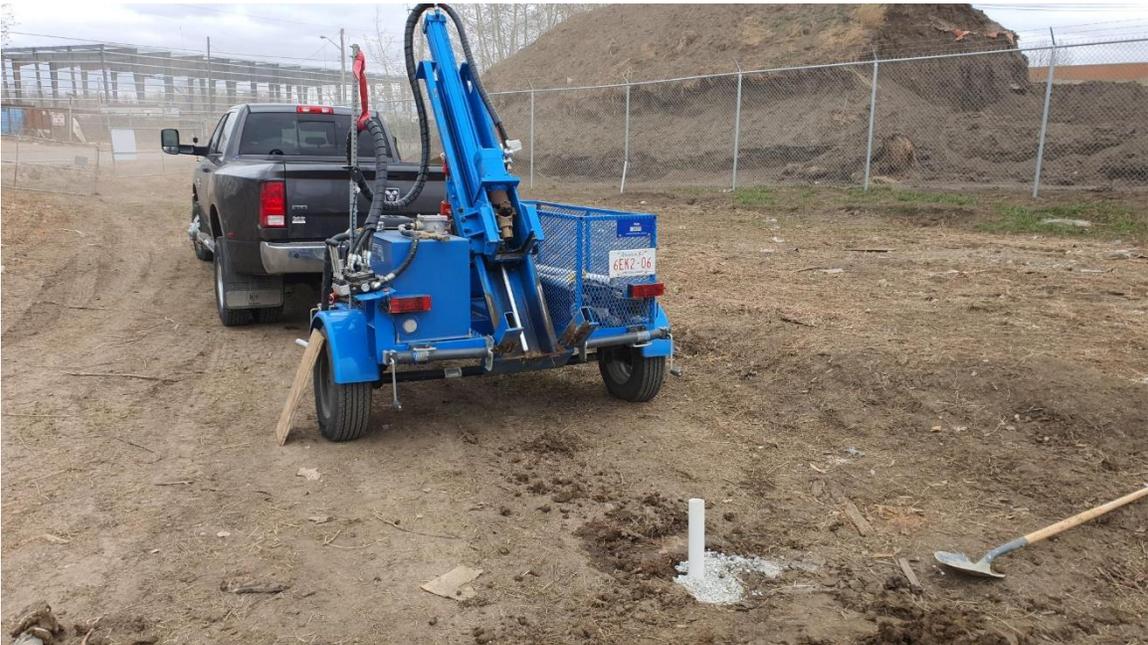
The groundwater monitoring well was drilled to 25 feet however despite moist soil no groundwater recharged into the well. As such a groundwater sample could not be obtained.

Photo 2: BH3 – Monitoring Well
